Gresham Fire Department

Serious Injury Incident Investigation

1327 SE 182nd Avenue Duplex Fire
Gresham, Oregon
May 30, 2024

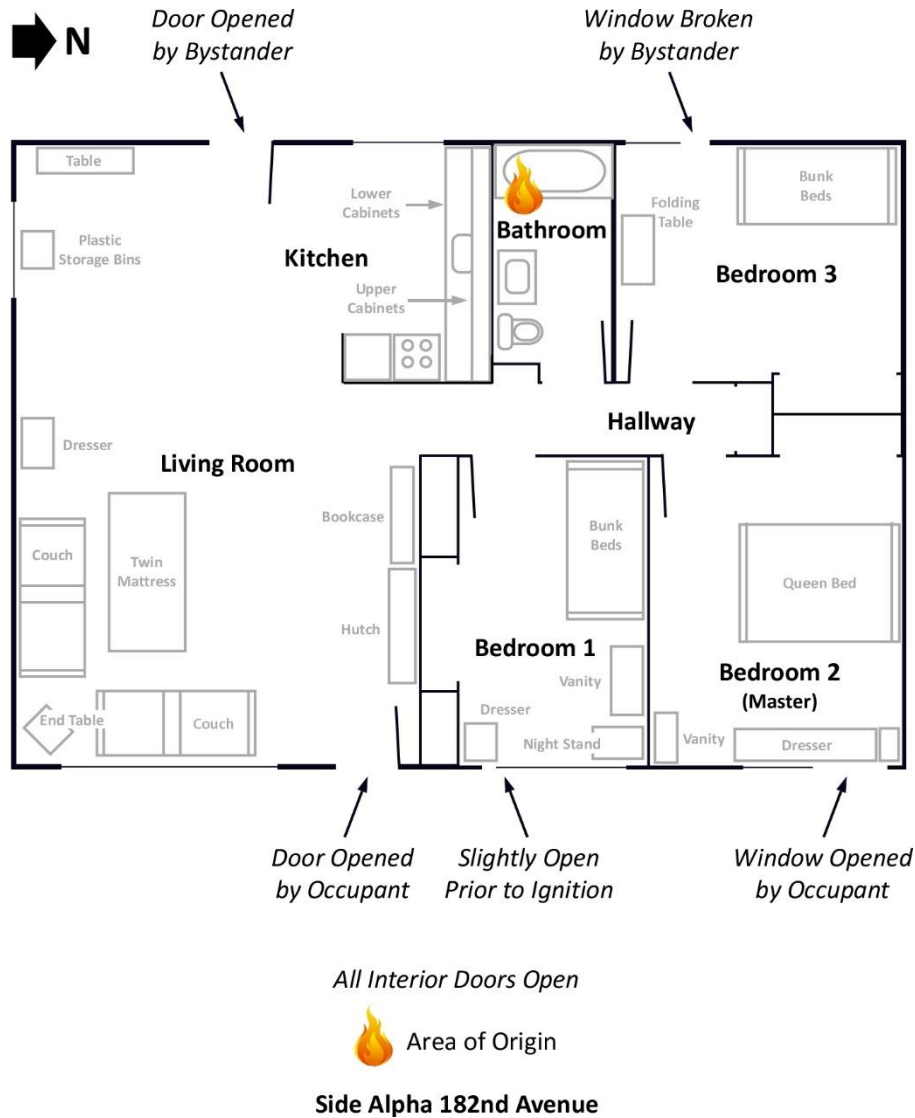
The fire occupancy, Unit A contained a living room, kitchen, bathroom, and three bedrooms. The fire originated in the bathroom and an occupant and bystanders opened windows and doors prior to the arrival of the fire department as illustrated in Figure 22.

Figure 22. Floor Plan 1327 SE 182nd Ave #A and Ventilation Profile Prior to Rapid Fire Progression

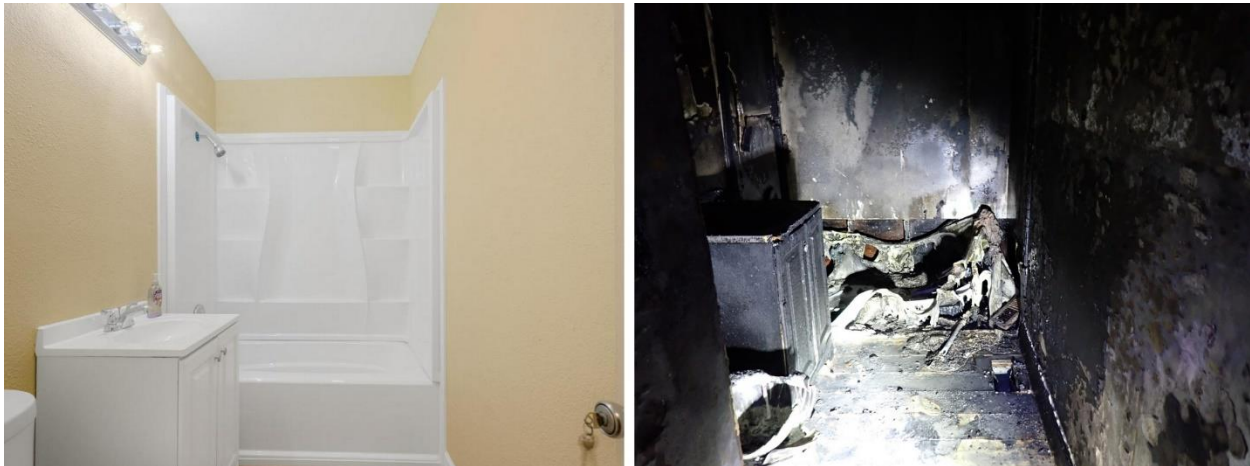
Figure 25. Pre- and Post-Fire Photos of the Bathroom

The shower curtain was plastic and purchased by the occupant at Dollar Tree. It is likely that the shower curtain was made of polyethylene vinyl acetate (PEVA) and was like that illustrated in Figure 26¹ (Dollar Tree, 2024). PEVA is not listed in the Underwriters Laboratories Fire Safety Research Institute Materials Database.

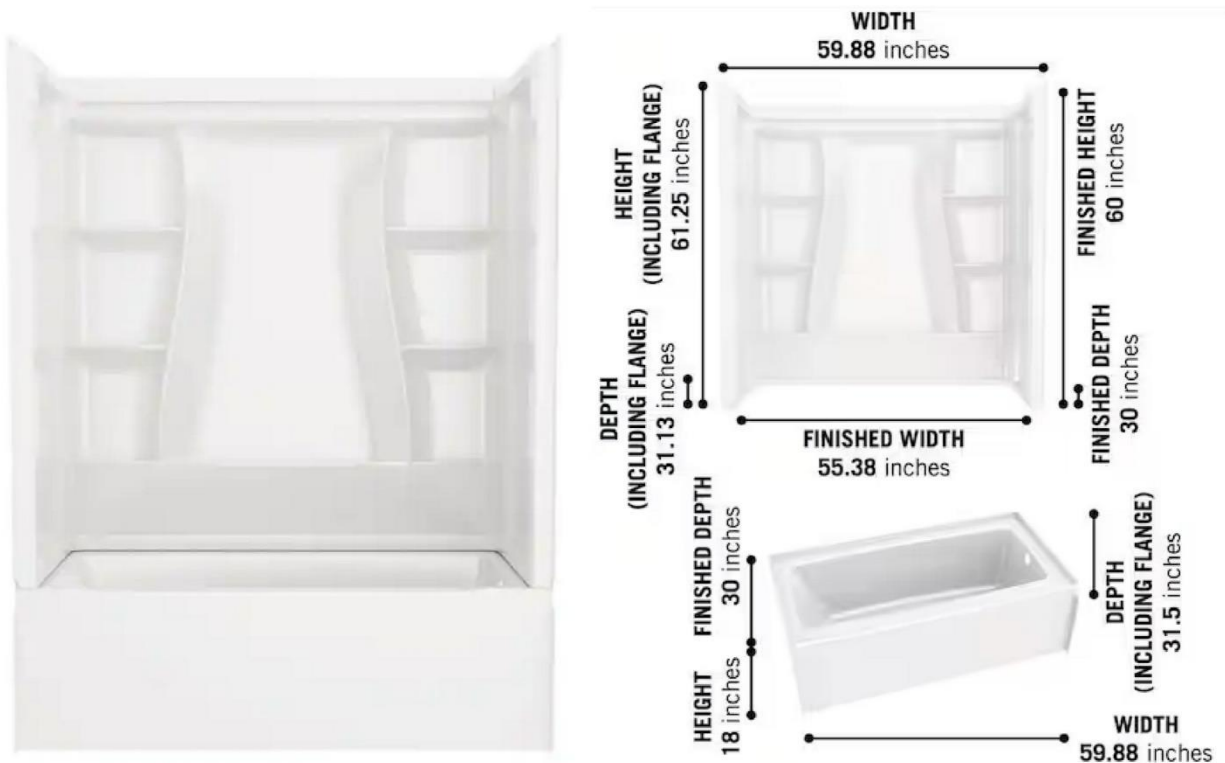
Figure 27. Delta 500 Bathtub and Surround

If flames were impinging on the wall panels of the tub surround, at the peak burning rate (heat release rate (HRR) per unit of surface area) they could produce 1800 kW/m^2 . Based on the dimensions of the wall surround (Home Depot, 2024), it had a surface area of approximately 4.7 m^2 . If all surfaces of the tub surround were burning at once and had sufficient oxygen to support flaming combustion, HRR would be approximately 8 MW more than 4 times what would be needed to transition to flashover based on the doorway ventilation. Even with a lower input heat flux, the HRR/unit of surface area would still be approximately 900 kW/m^2 which could generate a HRR of approximately 4 MW of heat release rate, which is more than enough HRR to flashover the bathroom (D. Madrzykowski, personal communication, June 27, 2024).

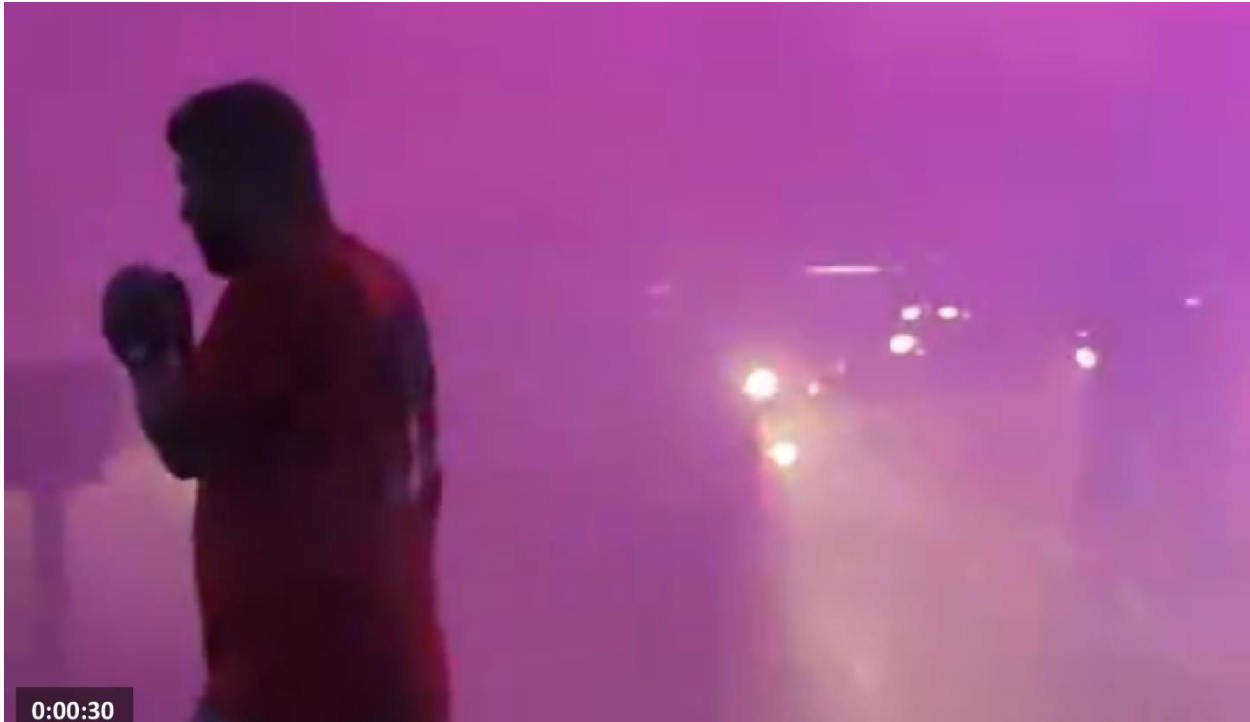
The volume of smoke from the building increased dramatically after entry and was pushed across SE 182nd Avenue by the northwest wind at 10 mph (see Figure 31).

Figure 31. Conditions Immediately Post Entry (Parallel to Side Alpha Looking North on 182nd Avenue)

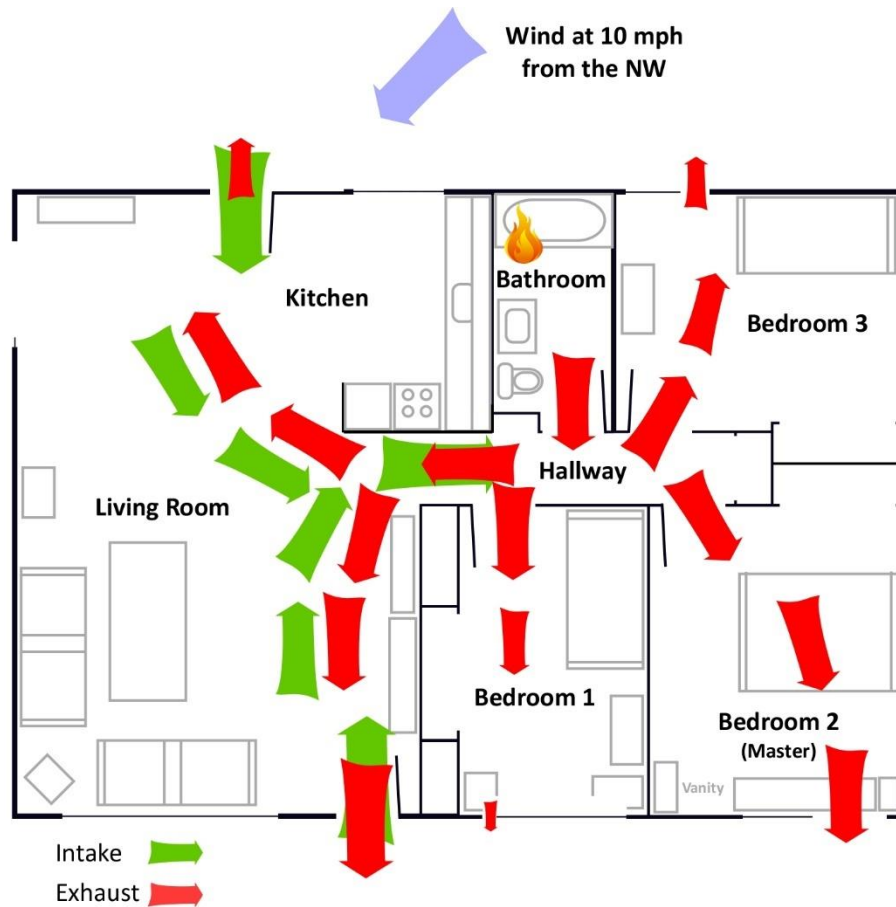
Prior to Firefighters Tejedas and Pilarski entry through the door on Side Alpha, there were multiple flow paths between the fire in the bathroom and hallway as illustrated in Figure 32. Air was entering from the bottom of the door on Side Alpha and from the door on Side Charlie (no report of the level of the neutral plane, but likely predominantly an inlet due to wind speed and direction and limited smoke above the roofline prior to flashover). Smoke was exiting from the upper area of the door on Side Alpha and bedroom windows on Sides Alpha and Charlie.

Figure 32. Dominant Flow Paths Prior to Flashover

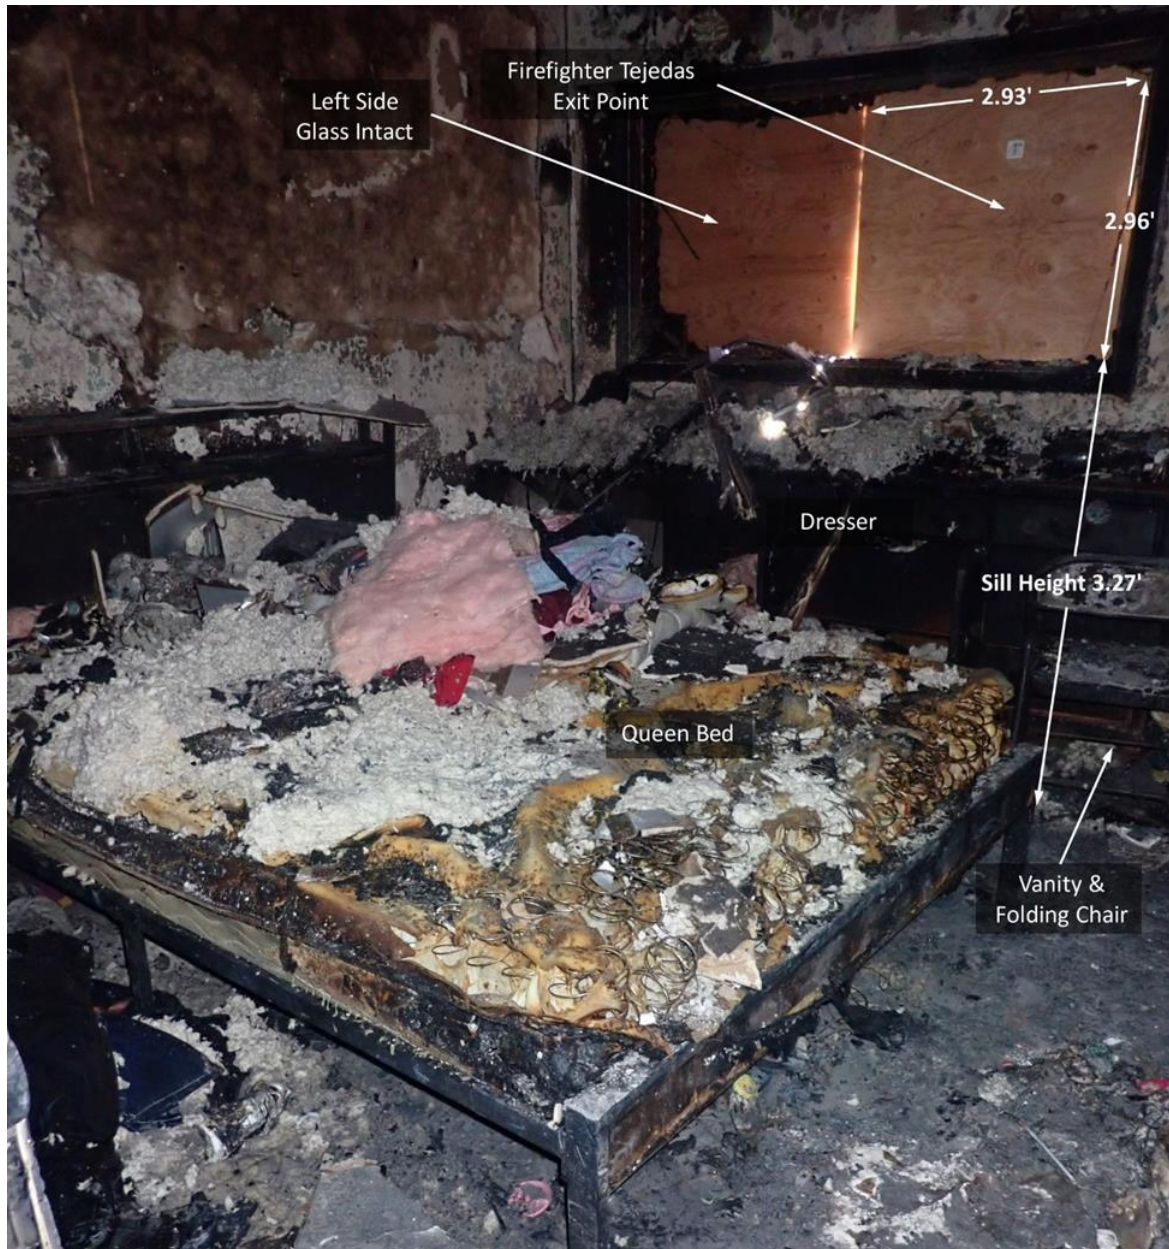
Figure 38. Bedroom 2 Exit Point

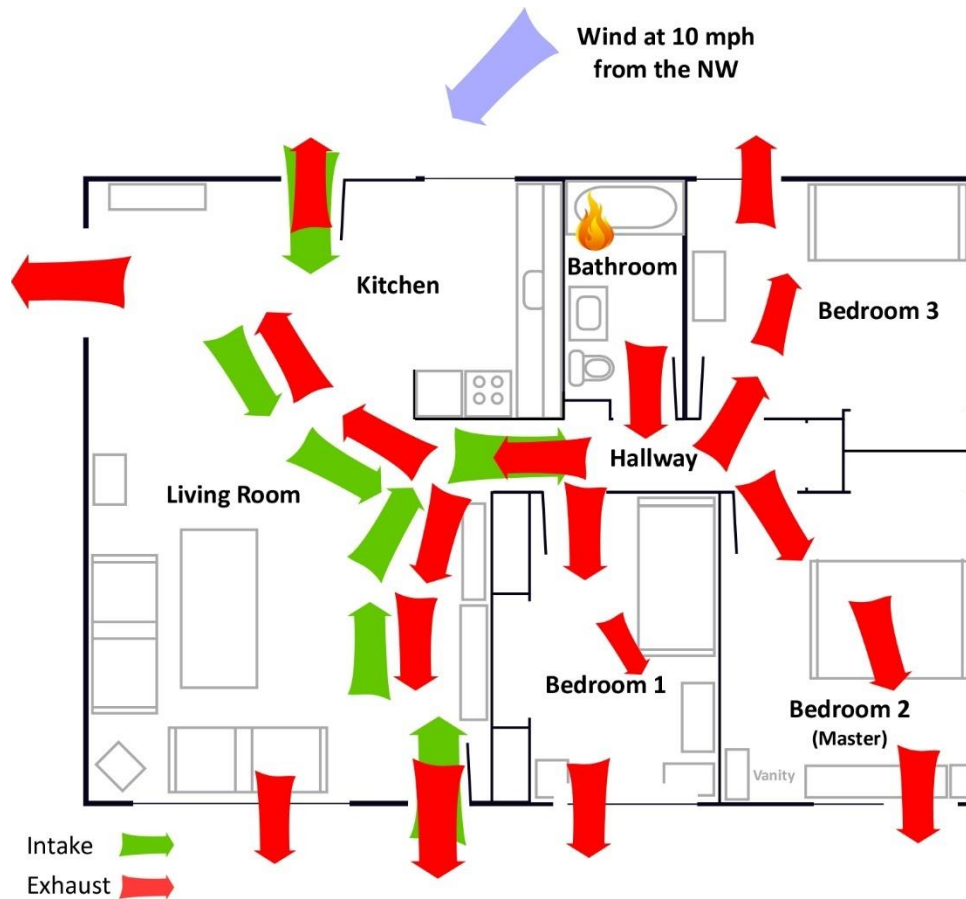
Figure 42. Post-Flashover Flow Paths

Initial water application occurred post flashover but was ineffective due to severe kinking in the attack line that resulted in low pressure and flow rate. The lack of flow and pressure negatively impacted water mapping within the living room. Fire in the hallway, kitchen, and bedrooms was shielded from exterior water application from the doorway on Side Alpha.

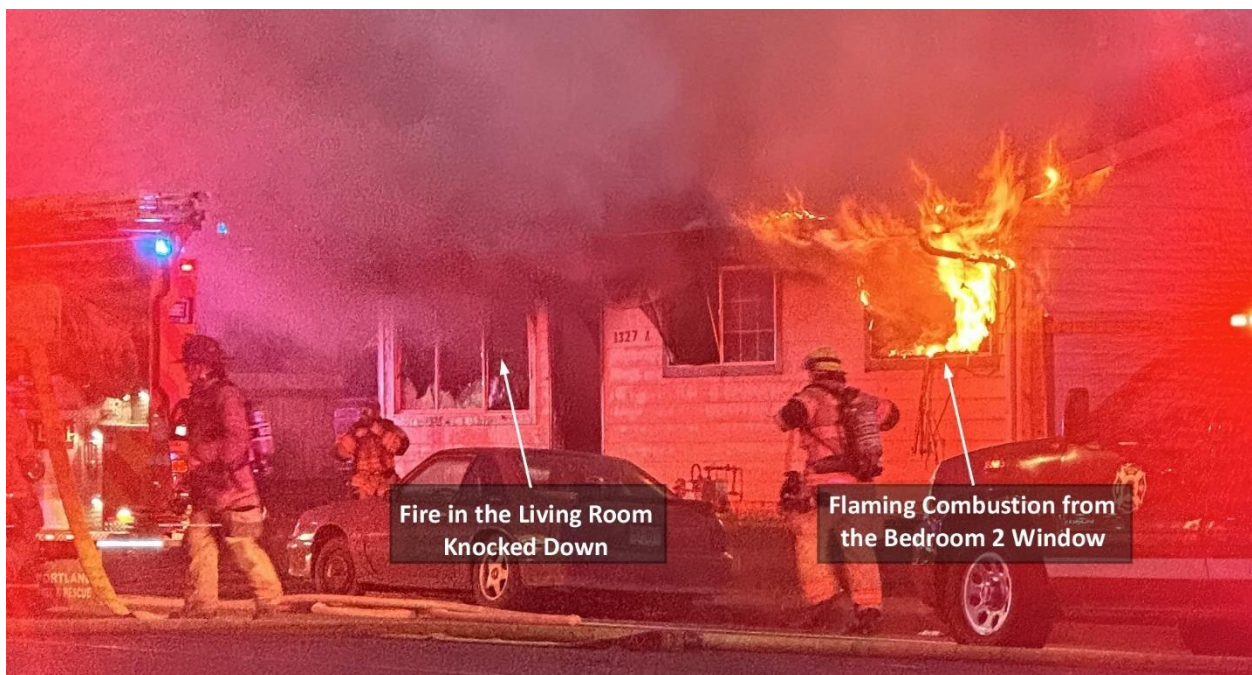
Figure 47. Fully Developed Fire in Bedroom 2

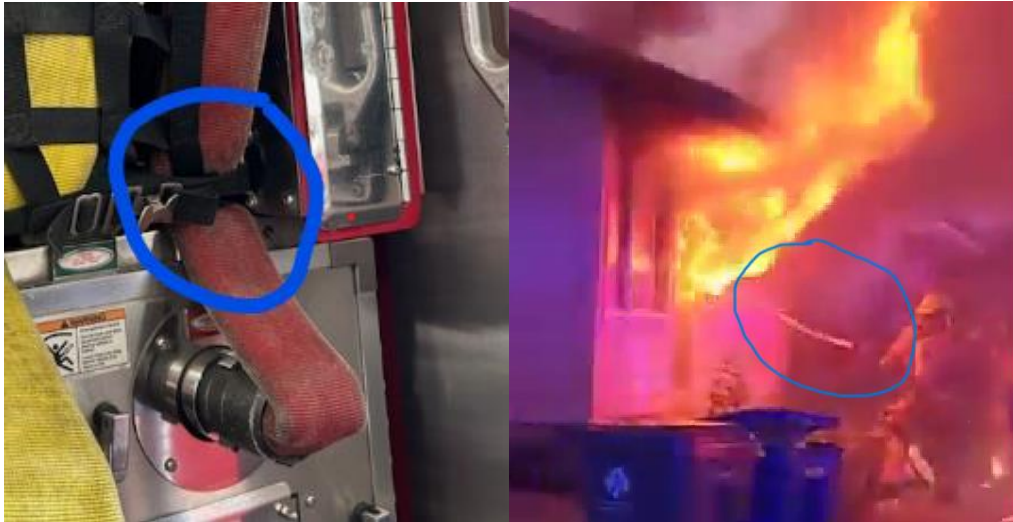
Figure 69. Strap that caused hose to have significant kink causing reduced water flow.

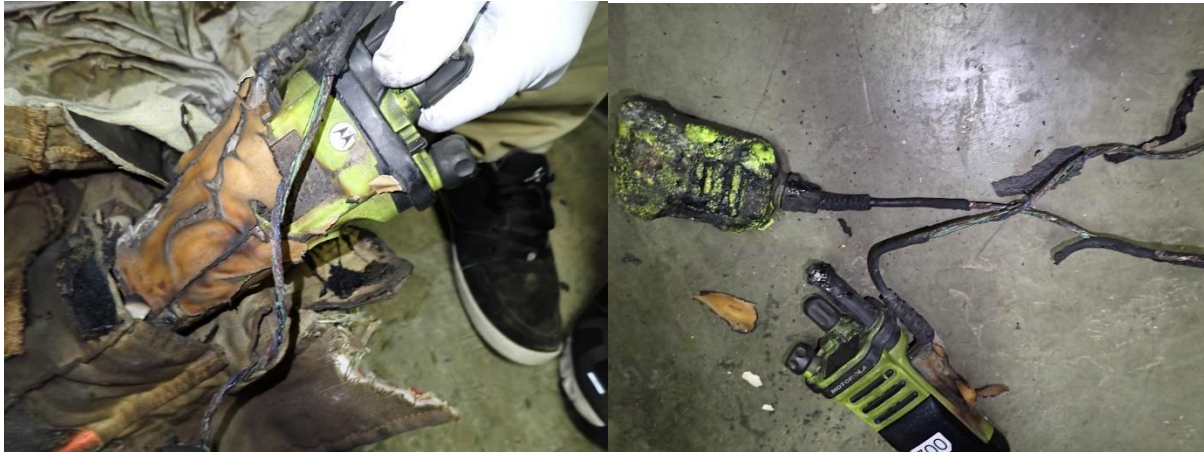
Figure 71. Tejedas radio cord burned

- *Develop a communications SOG to correct tactical errors noted by the IC up to and including emergency traffic.*
- *Develop a policy and train companies to ensure radios will be carried to prevent remote mic cord thermal damage. Purchase individual holders and straps for all individuals. Standardize how radios are carried.*
