Durango Fire & Rescue Authority
Fire Investigation (Explosion) Report
Incident #00001-2008-000718-00
Address: 750 Main Avenue
Date & Time: February 22, 2008 @ 1340 Hours

Submitted by:
Karola J. Hanks
Fire Investigator DFRA

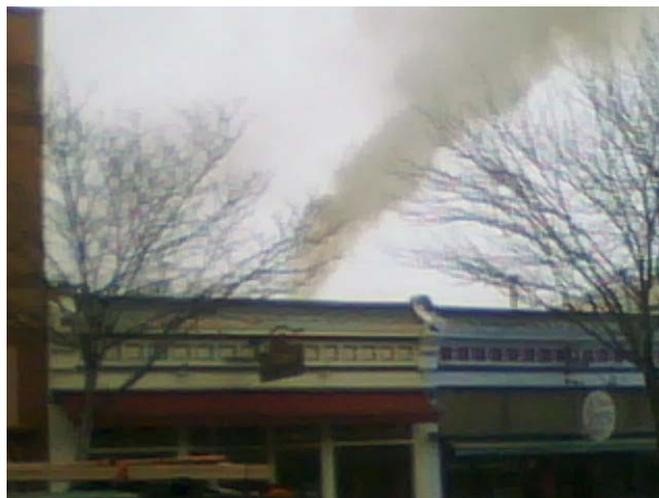
Figure 2: Ellis Photo from across street prior to Fire Department arrival

Figure 2 shows smoke and flames on the Seasons Grill roof in the area of the exhaust fan. Multiple reports from individuals both in Durango and in areas as far away as Kentucky have indicated that the smoke from Seasons Grill was seen up to one hour before Fire Department arrival on the downtown camera located on the building across the street. The camera output was displayed on a web site operated by Brainstorm Internet. The camera footage was not recoverable from the web. The calls to dispatch at 1340 hours were generally from individuals inside the restaurant when smoke became visible in the dining area with the exception of a meter reader who entered the building to tell them to evacuate because she could see smoke on the roof. At the time the fire department arrived the smoke column had decreased in size and the majority of the flames were no longer visible.

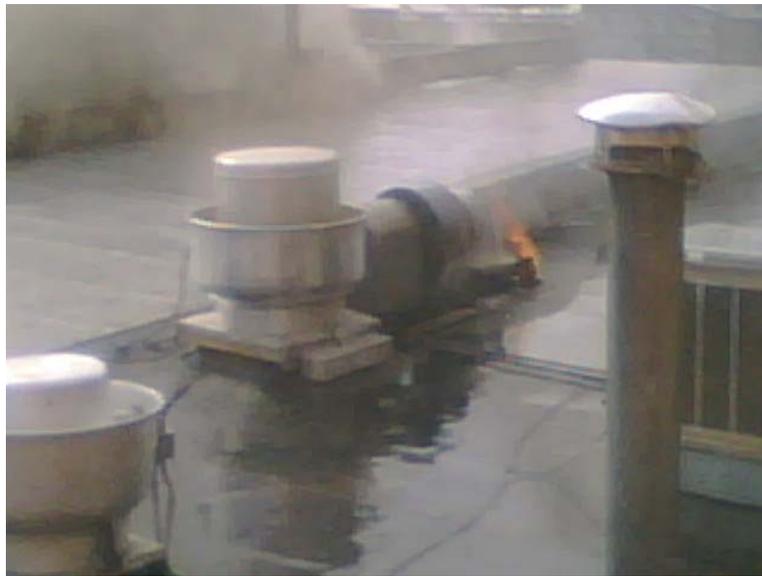
Figure 3: Ellis photo of Seasons Grill roof

Ellis took the photo shown in figure 2 prior to the arrival of the Fire Department. She then ran across the street and took the photo shown in Figure 3 from the bathroom window in the Gardenschwartz building located at 780 Main Avenue.

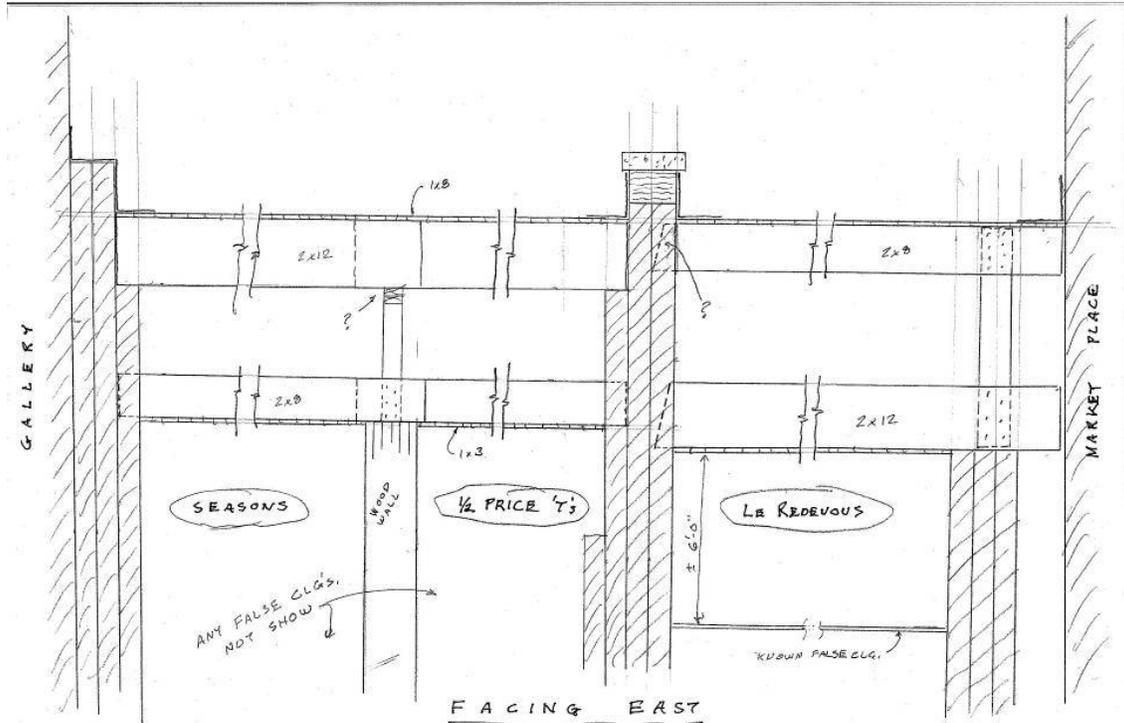
Figure 4: Drawing showing a rough construction design of attic spaces of destroyed buildings. Not drawn to scale by Fire Captain Bob Harms

Fire Captain Bob Harms produced a rough construction design of attic spaces in the destroyed buildings, see Figure 4. It can be seen in this drawing that there is a common

attic between 764 Main Avenue (Seasons Grill) and 758 Main Avenue (1/2 Price T's). The drawing does not show false ceilings in 764 and 758 Main Avenue as this evidence was consumed by fire following the explosion.

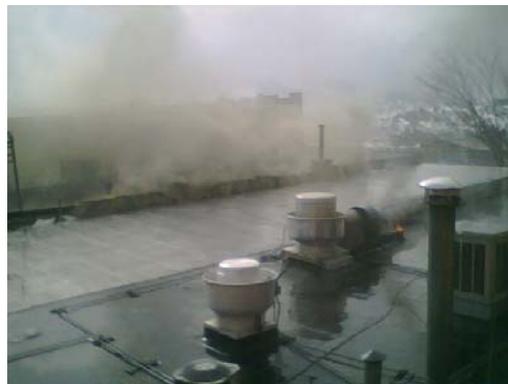
Figure 5: Ellis photo of roof top of 764, 758, and 750 Main Avenue

It can be assumed at this point that the fire had a significant head start on firefighters. How far it had progressed prior to their arrival can be seen in the photo taken by Ellis in Figure 5. In Figure 5 heavy smoke can be seen emanating at the wall between 758 Main Avenue and 750 Main Avenue (Le Rendezvous).

This photo indicates that there is significant smoke in the vertical and horizontal void spaces in 764 and 758 Main Avenue. Both buildings at this time had minimal smoke at the main level.

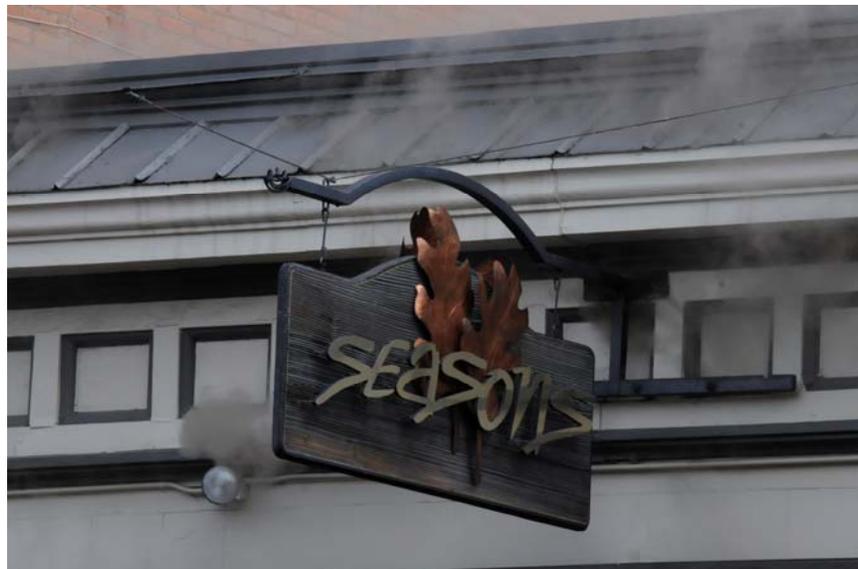
Figure 6: Seasons Grill Facade at 1359 hours

Figure 6 shows smoke at the facade and roof line of Seasons Grill. The smoke is not under extreme pressure and is gray in color. During this ten minute time period there were no additional reports of flame showing and no confirmation if the fire had progressed into the attic spaces of Le Rendezvous. No true ventilation has occurred at this time.

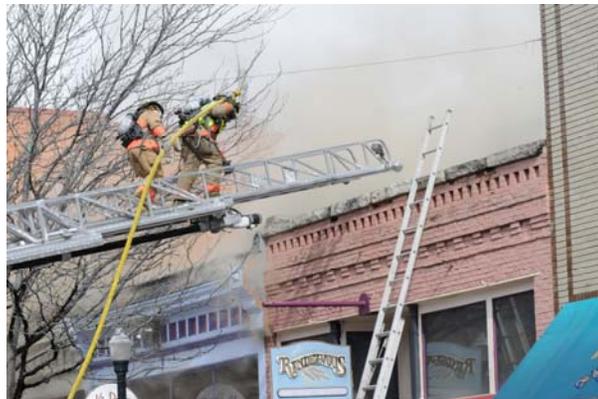
Figure 7: Crew taking hose to roof

Figure 7 shows light brown smoke emanating from the area between 758 Main Avenue and 750 Main Avenue. Smoke has been visible at this location for the last ten minutes. Light brown smoke on the roof is not coming from one location but along the entire wall separating 758 Main Avenue and 750 Main Avenue from A to C side. Natural Gas has not been shut off in either of these buildings.

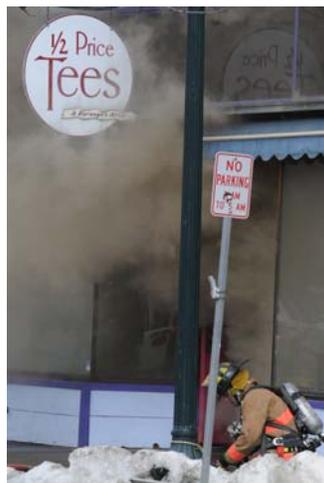
Figure 8: Door open to 1/2 Price T's

Figure 8 shows heavy smoke in ½ Price T's prior to closing the door. Figure 9 shows the dark windows in Seasons Grill and ½ Price T's. The windows in Le Rendezvous continue to have legible advertising in them.

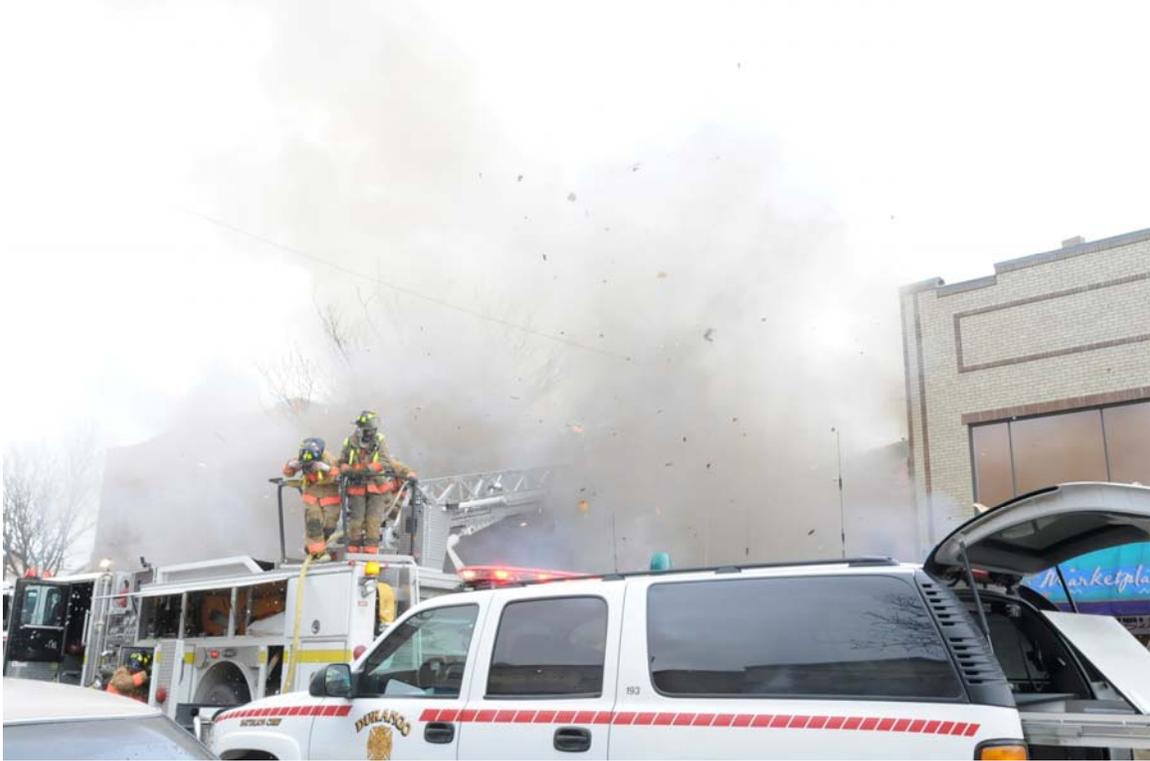
Figure 10: Explosion from A side

the skylight. Firefighter Brennan, on the ground by the L2, hears a pop that sounds like someone popping gum but louder. There is an explosion at approximately 1427 hours, 47 minutes after the first report to dispatch regarding a fire at the Seasons Grill but perhaps up to 1 hour and 47 minutes after the fire started. See Figure 10.

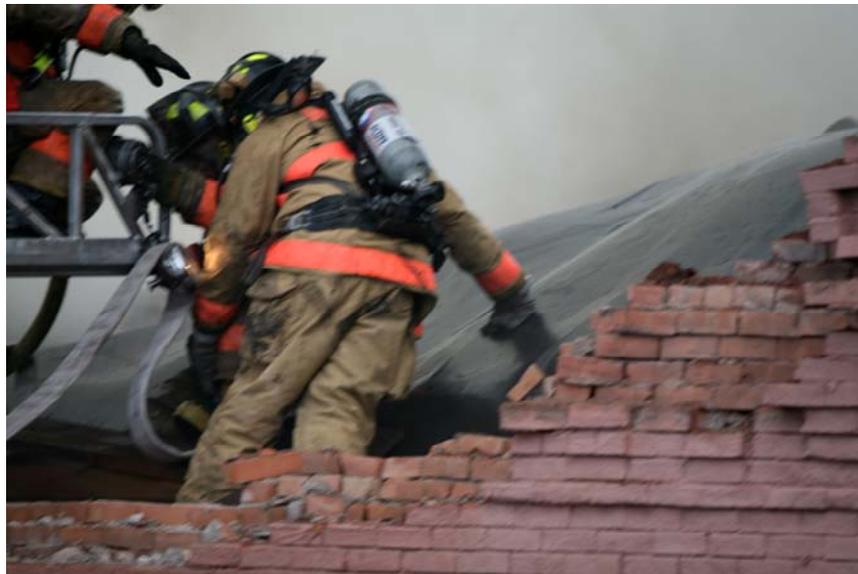
Figure 11: A side of Le Rendezvous roof line at the upper void level after the explosion

Figure 11 shows the remaining roofing after the explosion and before the fire that followed the explosion. Crews were able to crawl across the roof and slide down to the aerial following the explosion. The explosion sent debris across Main Avenue which is 32 feet in width plus sidewalks. It did not break windows on the other side of Main Avenue although this may have been because the Ladder truck was in the middle of the street parallel to the buildings.

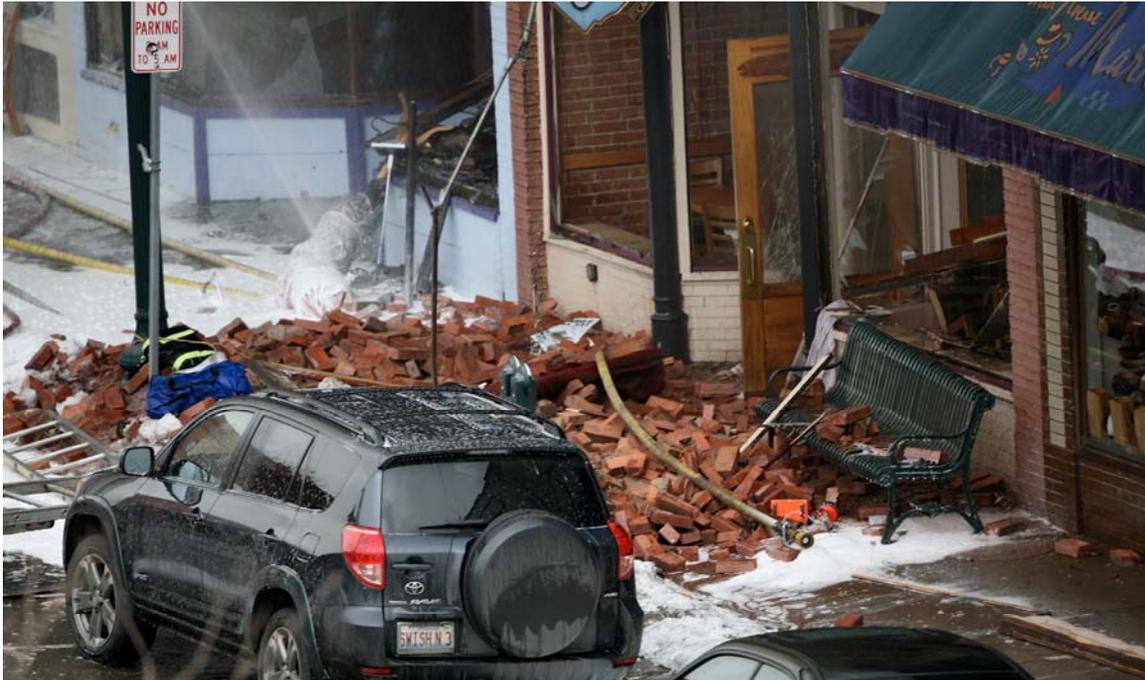
Figure 12: Following explosion and rescue

Figure 12 shows the upright table and chair in the corner of Le Rendezvous and glass, although broken, still in the door.

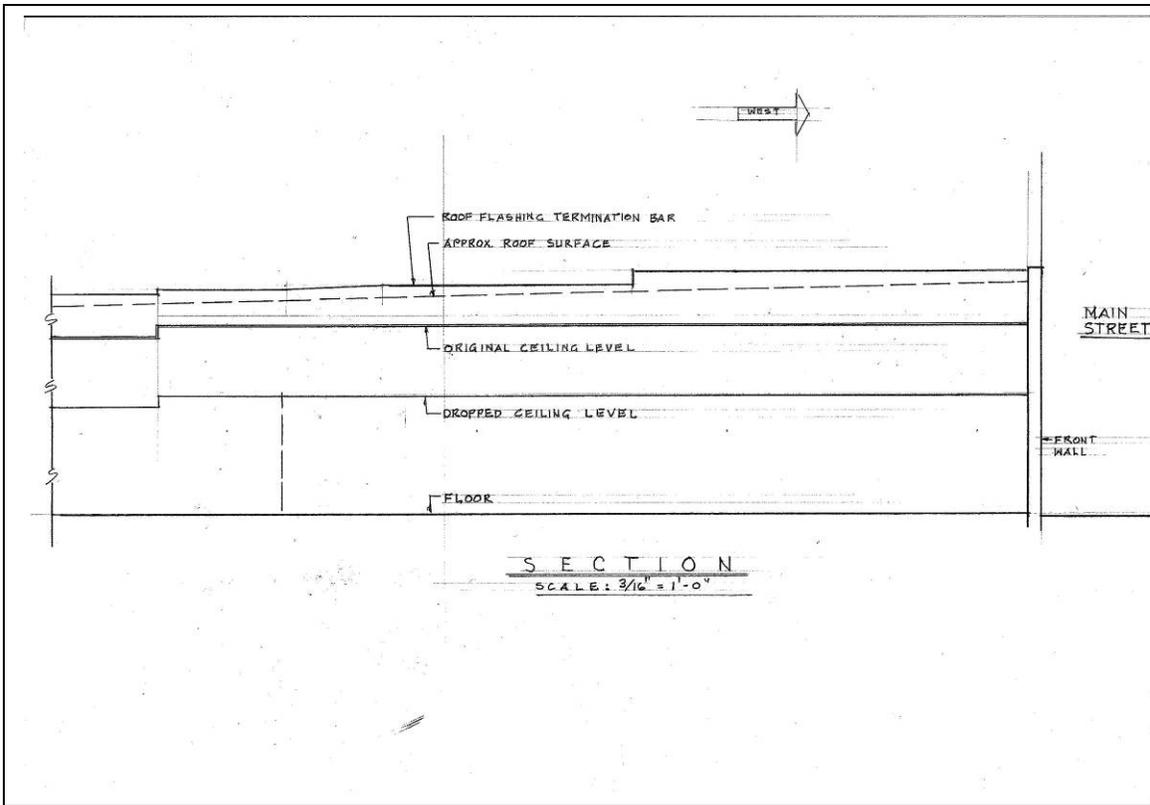
Figure 13: Cross Section of Le Rendezvous front area where explosion occurred

The explosion investigation began with a walk around of the site beginning at the front and proceeding to the rear. It became obvious that the explosion occurred in the void spaces above the ceiling and therefore we would need to be able to recreate the layout of the ceiling up to the roof layer. Captain Bob Harms agreed to draw this out. The cross section of Le Rendezvous is seen in Figure 13. The drawing includes the roof layer, the original ceiling level, and the dropped ceiling. The drawing does not include the rear of the building.

It is estimated to be 61 to 62 inches between the dropped ceiling and original ceiling. There is then approximately 47 to 48 inches between the original ceiling and the roof surface. The first drop in the roof line is 31 feet 2 inches from the A side of the building. The second drop in the roof line is 38 feet towards the C side from the first drop. The drop ceiling was composed of drywall, plaster and multiple layers of paint.

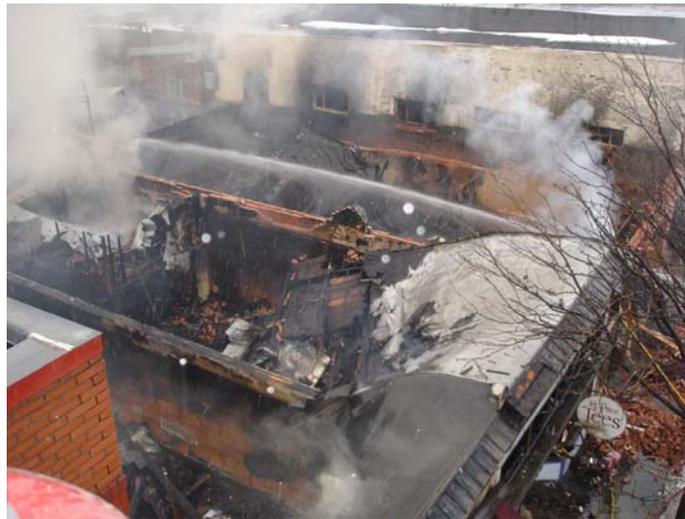
Figure 14: Aerial view after fire and explosion

Figure 14 was taken the evening of the fire and explosion. The bottom of the picture is Seasons Grill and the top is Le Rendezvous. Le Rendezvous was the only building to suffer the explosion and the explosion appeared to have occurred in one or more of the void spaces. This allowed for the elimination of a large portion of the building to explode for cause of the explosion.

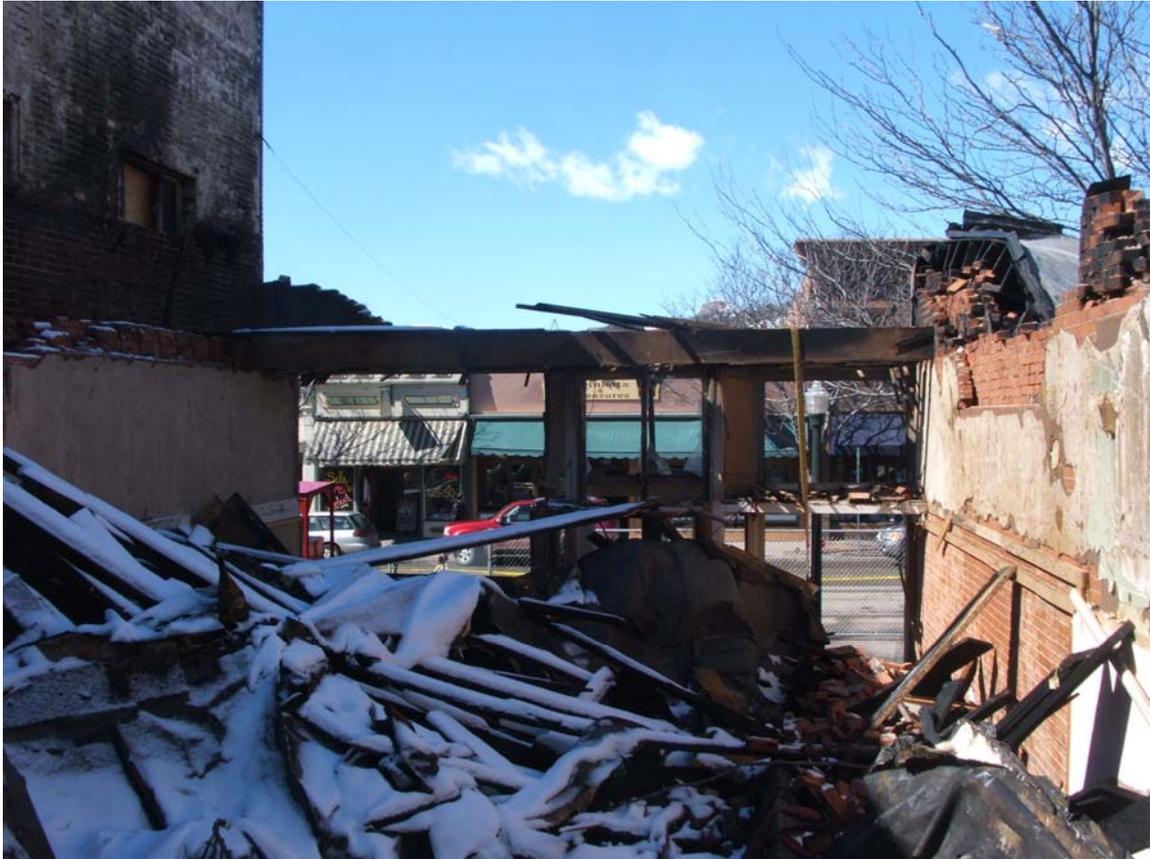
Figure 15: View from kitchen toward the front of Le Rendezvous

Figure 15 indicates that the explosion most likely occurred in the void space between the roof and the original ceiling. The upper façade on A side (street side) is the portion of the wall that collapsed onto the firefighters below. Firefighter Wickes was standing on the original ceiling structure following the explosion. The natural gas lines that extended into Le Rendezvous were located in the space above the drop ceiling, not the space above the original ceiling. It is unknown what penetrations might have existed in the original ceiling that would have allowed for gasses to travel from above the original ceiling to below it or vice versa.

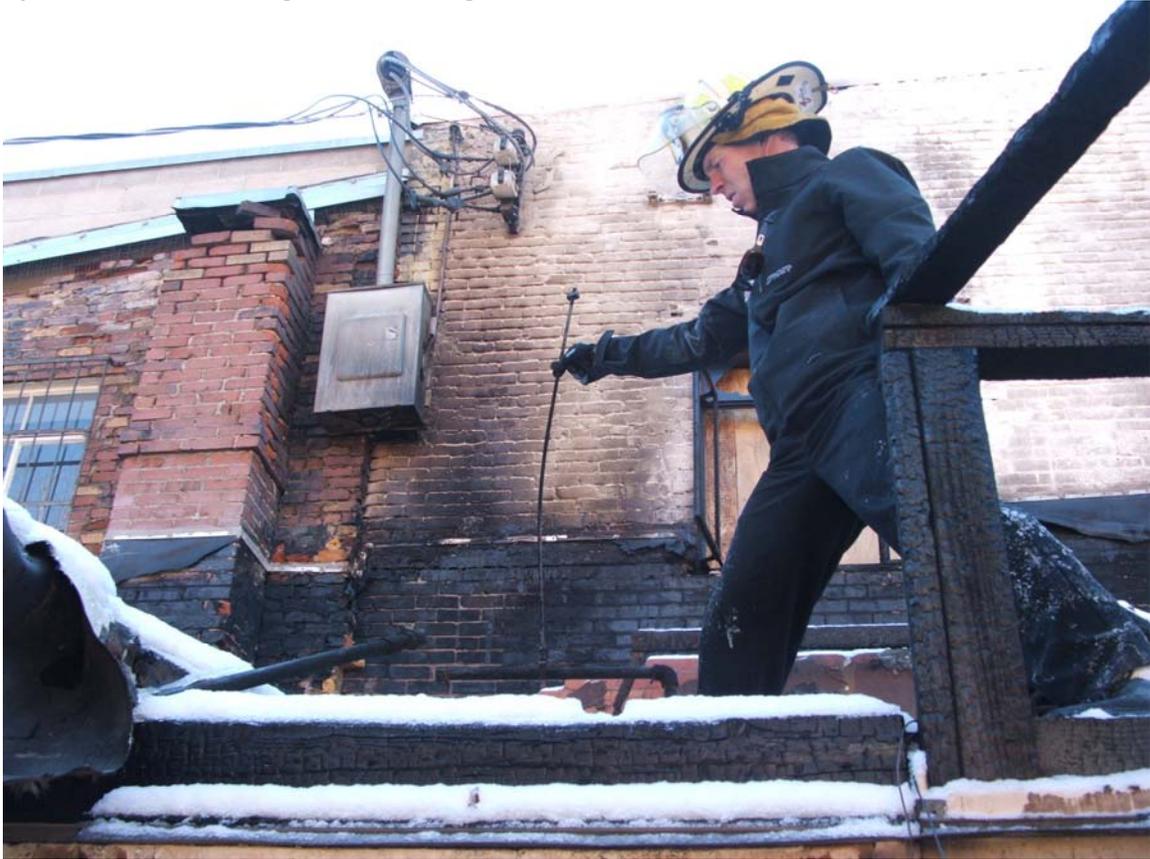
Figure 16: Broken natural gas line and the corresponding hangar

During the investigation we were aware of the issues regarding whether or not the natural gas had been shut off to this building. As we inspected the debris, we looked for broken natural gas lines that might have contributed to the spread of natural gas. A broken line was found in the space between the drop ceiling and the original ceiling. In examining this line we were able to determine that it had been sheared and that the nylon ball valve appeared not to have been exposed to flame. Whether or not this line was leaking prior to

the explosion is undetermined as we were unable to pressure test the line with a method that would indicate that the line was leaking prior to the explosion. The valve was taken by the NIOSH investigators. See Figure 16.

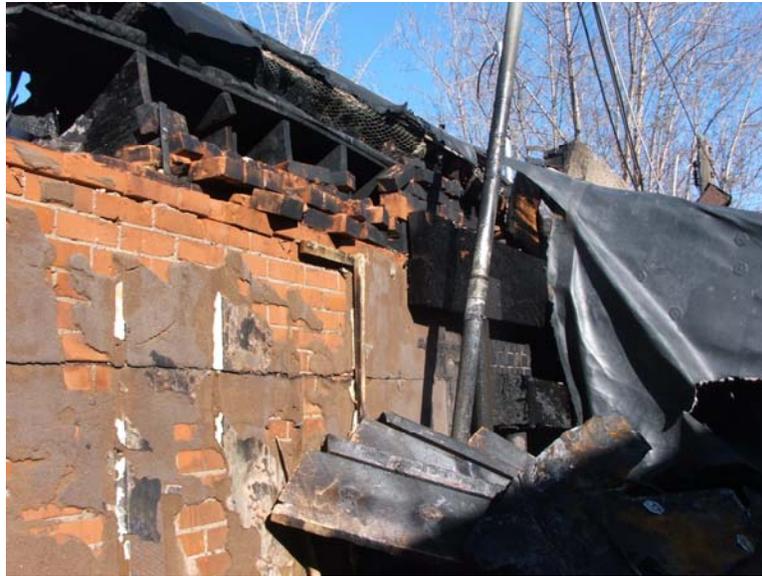
Figure 17: Wall between Le Rendezvous and 1/2 Price T's above kitchen

An investigation of the walls between Le Rendezvous and ½ Price T's showed numerous areas where smoke and heat could penetrate from one side to the other. These included areas where cuts were made during construction of both buildings to accommodate support timbers. These cuts were made into the brick. As the lots for the buildings all front the sidewalk area, the support structures for each building tend to line up with each other. This places the cuts into the brick adjacent to each other in many instances.

The mortar used in Durango during the 1890's and early 1900's used a sand/silt product from a gravel pit south of the town. It was used because "it spread like butter". This type of mortar does not withstand time as well as other types of mortar. Many of the bricks can be removed without finding any remaining mortar indicating that the entire wall in itself would have allowed smoke to spread from one building to another. Figure 17 shows the bricks and missing mortar.

As can be seen in Figure 17, the fire in ½ Price T's was in the assembly and smoke most likely penetrated into the void space above the original ceiling in Le Rendezvous filling the void with smoke and gasses. As we were unable to reconstruct possible penetrations

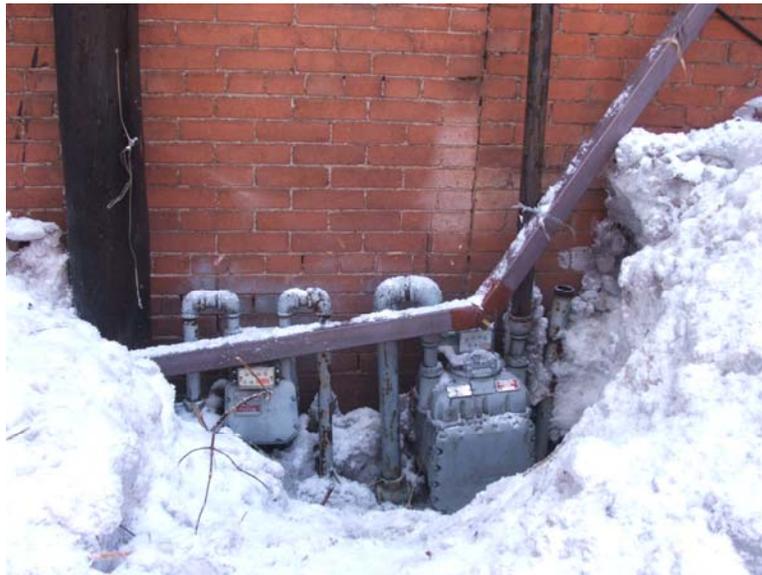
Figure 18: 1/2 Price T's and Le Rendezvous Gas Meters

Figure 18 shows the gas meters after they were dug out of the snow and ice for ½ Price T's and Le Rendezvous. Firefighter Mattison who worked on these two meters during

the fire stated that neither one was ever turned off. ATMOS Energy says that the natural gas for ½ Price T's (the one on the left) was turned off at 1420 hours and the natural gas for Le Rendezvous was turned off at 1440 hours. The gas to Seasons Grill was turned off at 1355 hours. The Le Rendezvous meter read 56625 the day following the fire. The previous reading was February 11, 2008 and it read 56394. The meter was also read on January 13, 2008 and at the time read 55642. This data indicates that there was not a major leak in the building prior to the fire.

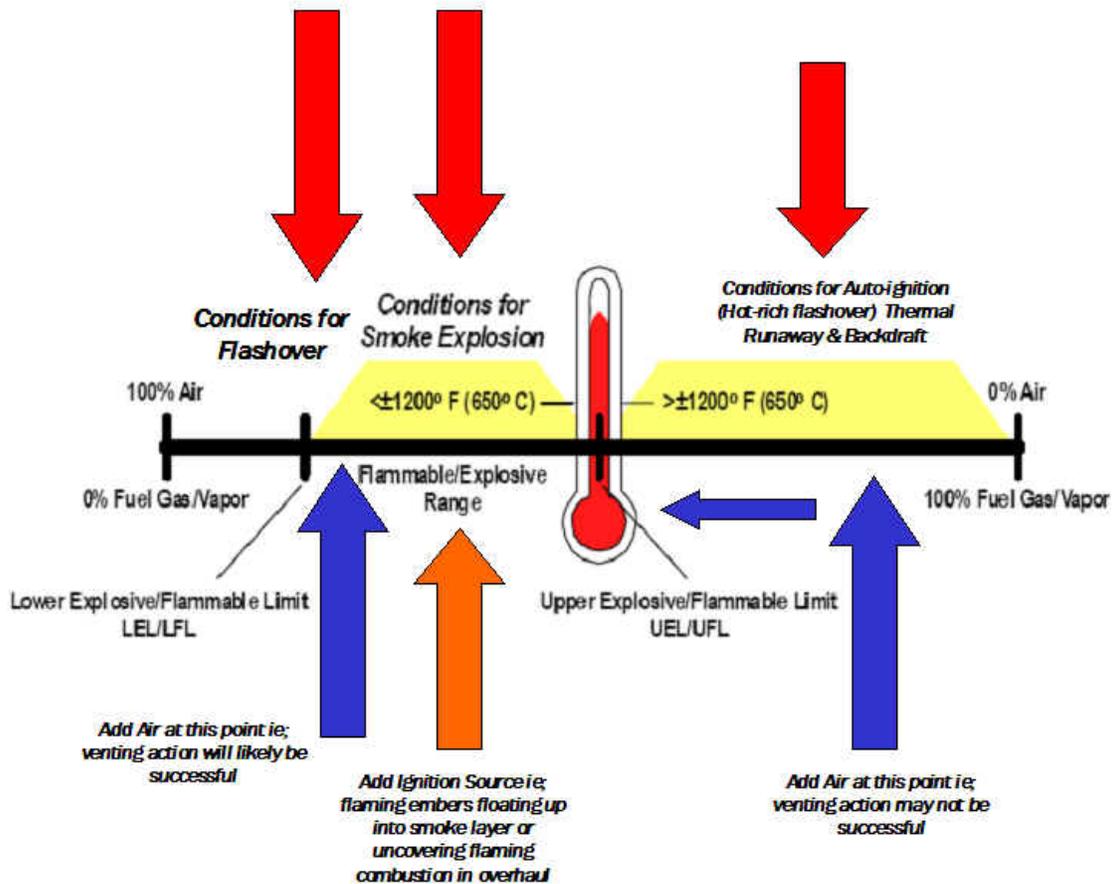
Figure 19: Cold Smoke Explosion

Figure 19 shows the differences between a flashover, cold smoke explosion and back draft. This investigator has not been able to disprove the first hypothesis but I have been concerned about the report of the pop that was heard by Firefighter Brennan. The first hypothesis does not take this account. The second hypothesis would require an influx of oxygen and I have not found evidence or firefighter activities that indicate that this occurred. The third hypothesis provides the most complete answer and is supported by photos and video that shows smoke changes on the c-d corner of 758 Main Avenue that occur virtually simultaneously with the explosion. It also explains why firefighters on the C side of the incident thought it was their side of the incident that had suffered an explosion.
