Fire Behavior Case Study

On February 29, 2008 Firefighter Brad Holmes and Lieutenant Scott King were assigned to perform primary search of Exposure Bravo at a fire in a wood frame duplex in Grove City, PA. During their search, rapidly deteriorating conditions trapped the search crew. After being rescued by the Rapid Intervention Team, both members were transported to Pittsburgh's Mercy Hospital Burn Unit. Firefighter Brad Holmes had burns over 75% of his body, and died from his injuries on March 5, 2008. Lieutenant King suffered less serious injuries and was treated and released. A 44 year old female occupant of the dwelling was trapped trying to rescue a pet and also died.

Figure 1. 132 Garden Avenue-Side Alpha

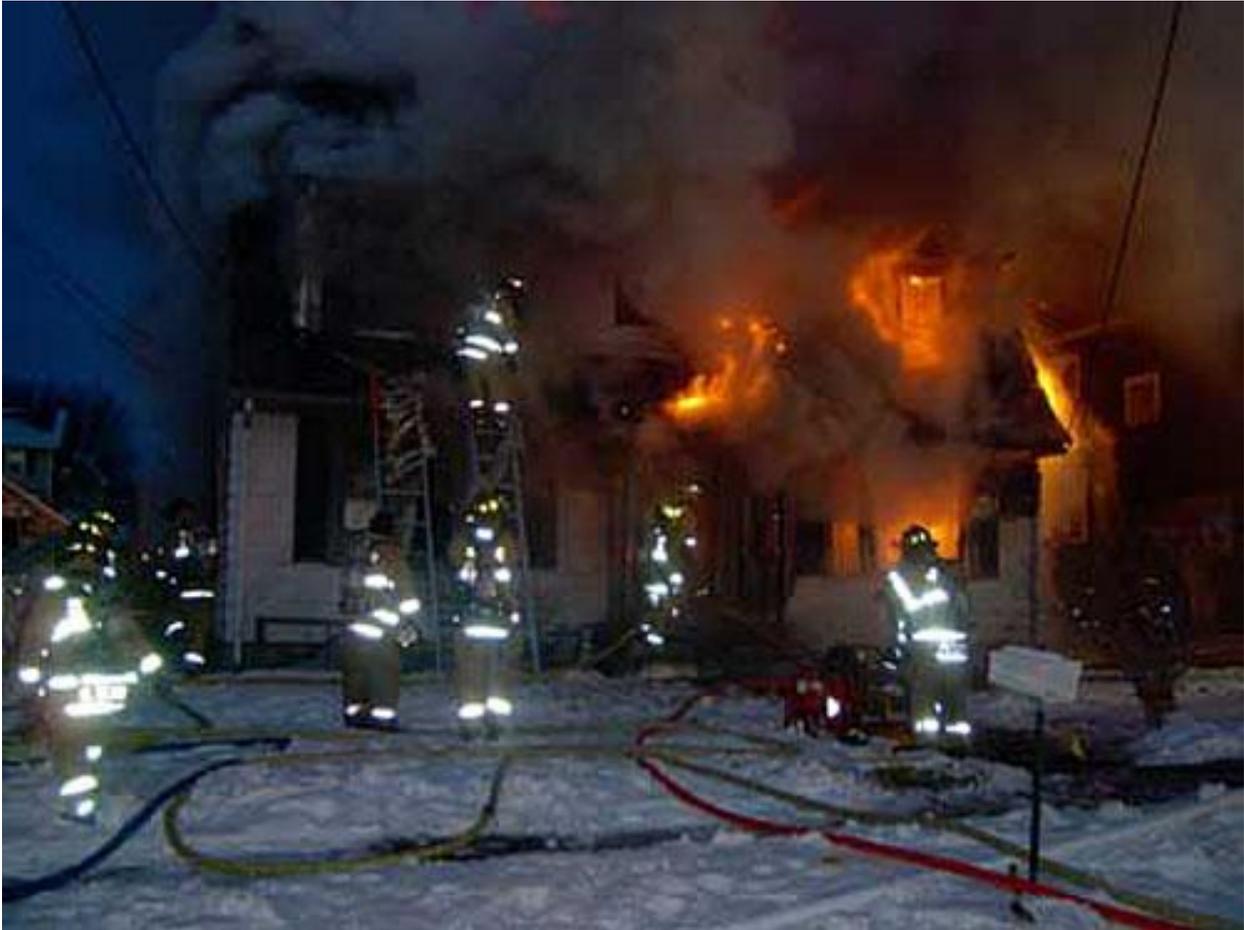
Note: Fire Department Photo - NIOSH Death in the Line of Duty Report F2008-06. This photo likely illustrates conditions after 0635, while Firefighter Holmes and Lieutenant King are searching Floor 2 of Exposure B.

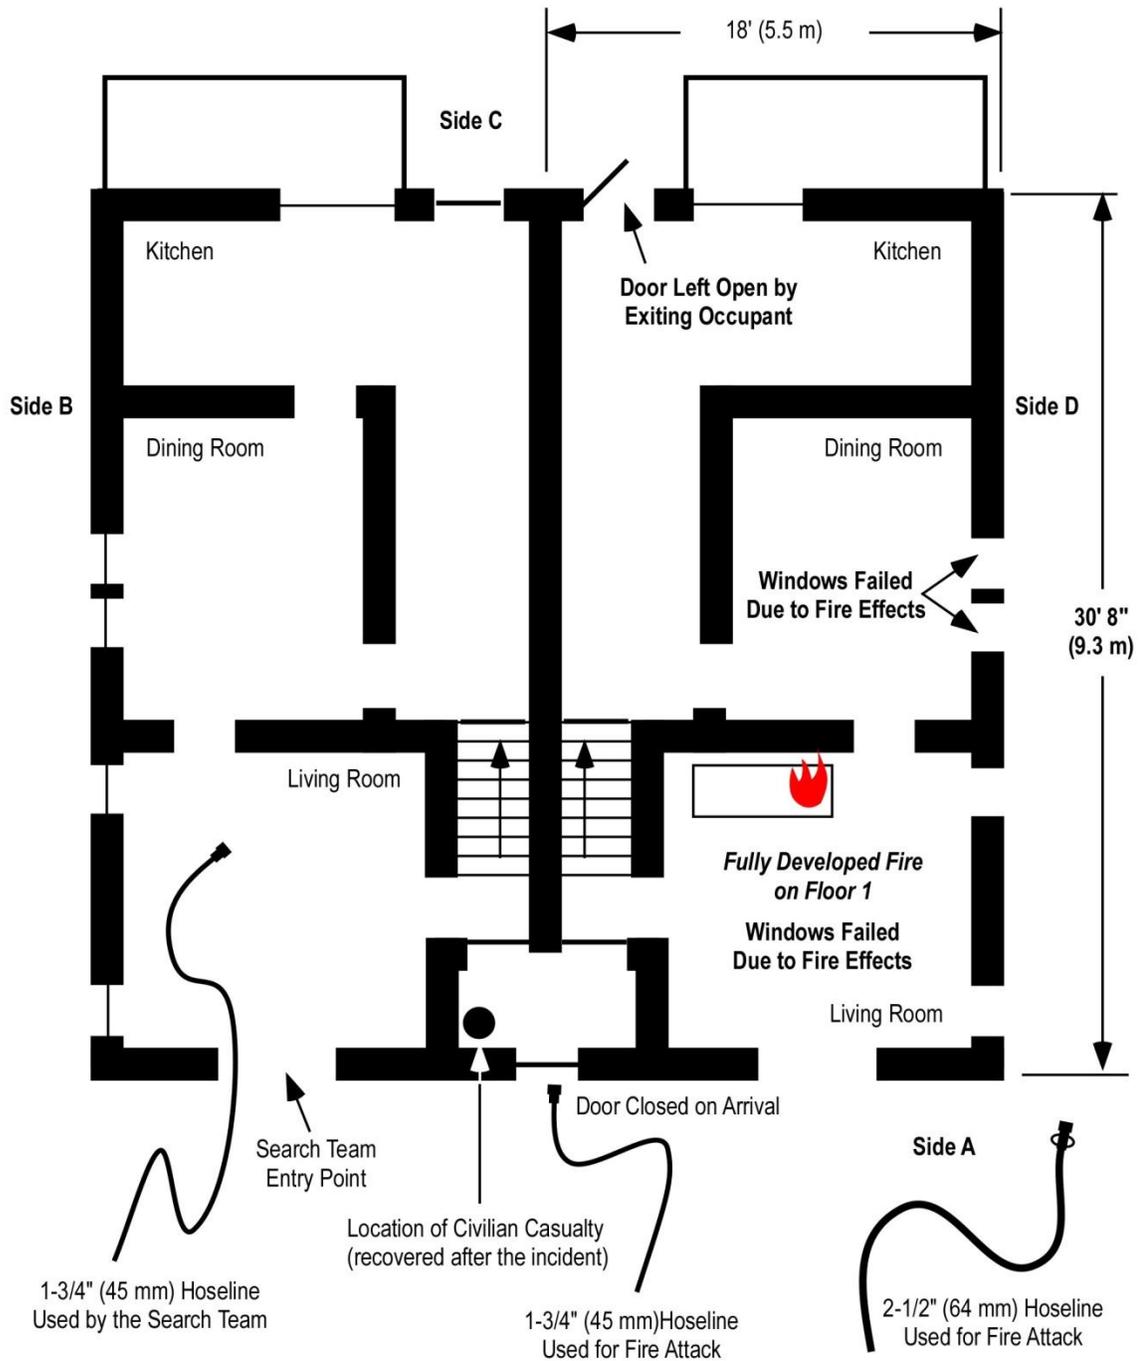
Figure 2. Fire Unit and Exposure Bravo Floor 1

As illustrated in Figures 2 and 3, the floor plan of each unit was a mirror image of the other. The first floor had a living room, dining room and kitchen and a deck on Side C. The units shared a common entry on Side A. The second floors had two bedrooms and a bathroom.

The Officer of Engine 95 vented the window on Floor 1 Side A of Exposure Bravo and observed that the ceiling light was on (indicating that there was limited optical density of the smoke on Floor 1 of the exposure). Firefighter Holmes and Lieutenant King entered through this window (see Figure 2) to conduct primary search of the exposure and observed that the temperature was low and there was limited smoke on Floor 1. Engine 95 passed the search team a 1-3/4" (45 mm) handline through the window and the search team knocked down visible fire extension and completed their search of the first floor. At this point, Firefighter Holmes and Lieutenant King left the hoseline on Floor 1, went up the stairs to Floor 2 and began a left hand search.

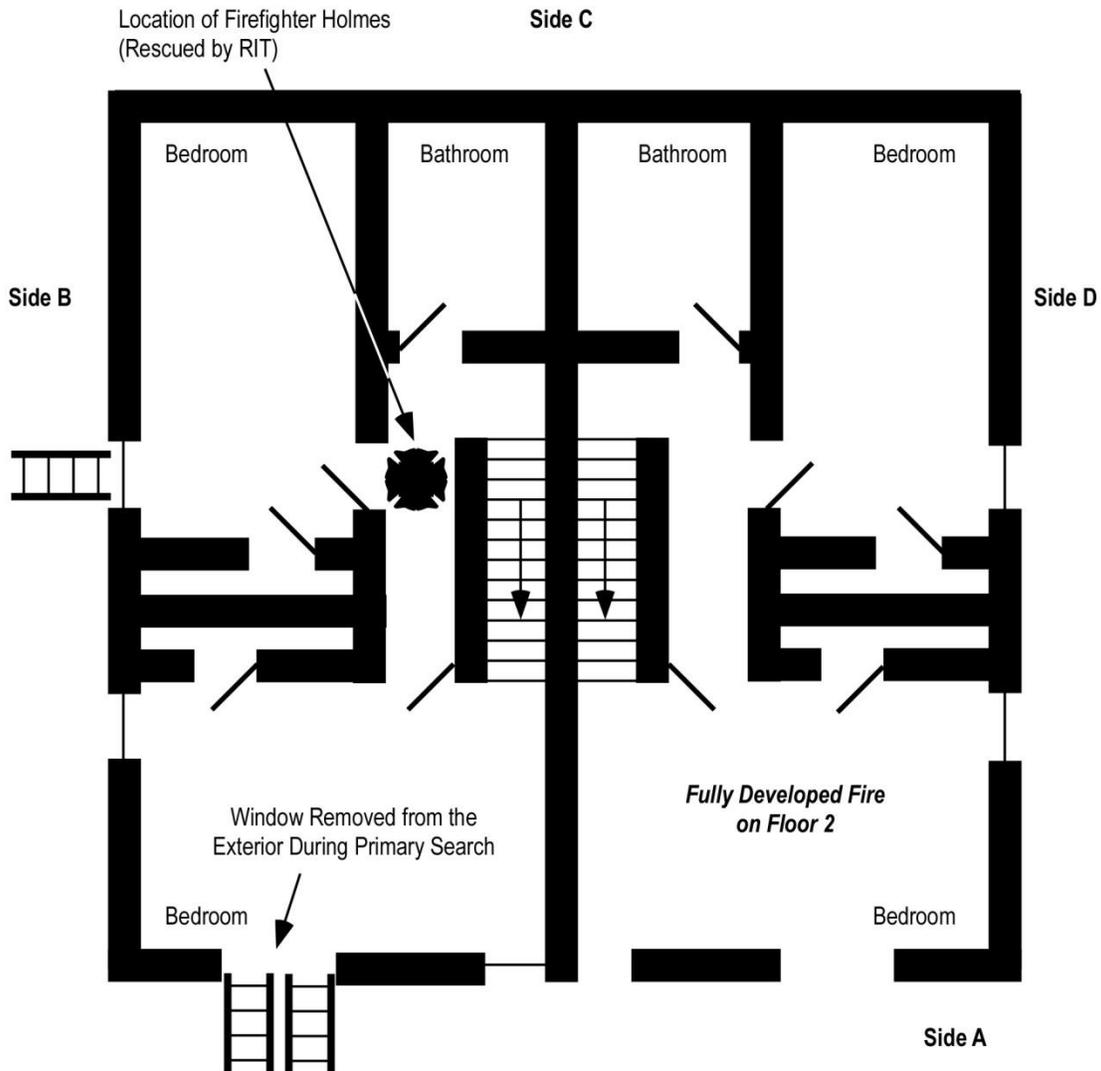
Figure 3. Fire Unit and Exposure Bravo Floor 2

The Officer of Engine 95 noticed that the search crew had finished their search on the first floor and were advancing to the second floor. He placed a ladder and broke the window on Floor 2, Side A (See Figure 3). He stated that there was not much heat on the second floor because the plastic insulation on the window was not melted, but he did notice heavy black smoke beginning to bank down. *NIOSH Report F2008-06 did not specify the depth of the hot gas layer (down from the ceiling) or the air track at the window that was vented or Floor 1 openings (windows and door).*

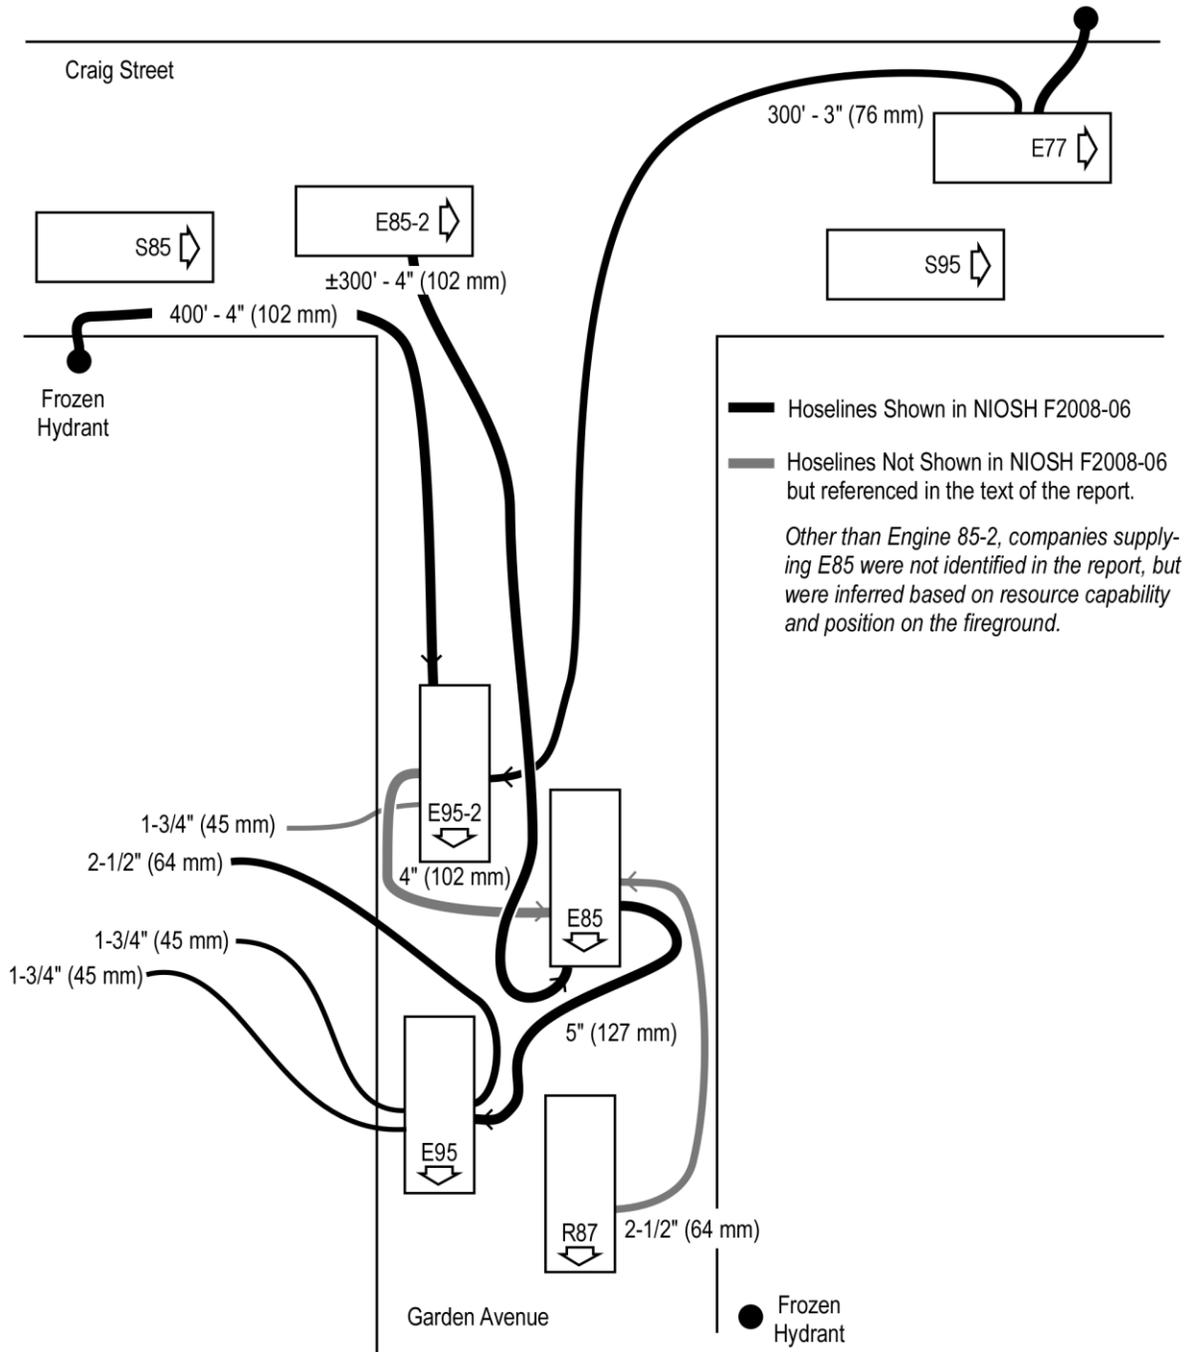
Figure 4. Apparatus Position and Water Supply Operations Prior to 0643 Hours

The hydrant that Engine 95-2 laid in from was frozen as was the closest hydrant on Garden Avenue (several houses beyond the fire building). First alarm companies used tank water to support initial firefighting operations. The crew from Engine 95-2 began to hand stretch a 3" line to a hydrant on Craig Street, east of Garden Avenue. *Due to the complexity of water supply operations, additional detail is provided in a subsequent section of this case.*

As the two closest hydrants to the fire were frozen, water supply was a critical factor in this incident. In an effort to sustain firefighting operations while trying to establish a continuous water supply, tank water from multiple apparatus was transferred to the engines supplying handlines. Figure 5 illustrates the hose layout and water supply operations at the incident prior to the Incident Commander's shift to a strictly defensive strategy. Table 1 illustrates the pump, tank, and supply hose capacities of the apparatus used at this incident.
