Fire Behavior Case Study

On February 22, 2008 at approximately 1340 hours, the Durango Fire and Rescue Authority responded to a commercial fire in downtown Durango, Colorado. Before this incident was concluded, nine firefighters and officers were transported to the hospital following an explosion. Several of the injured had serious injuries and were admitted and the others were treated for minor injuries and released.

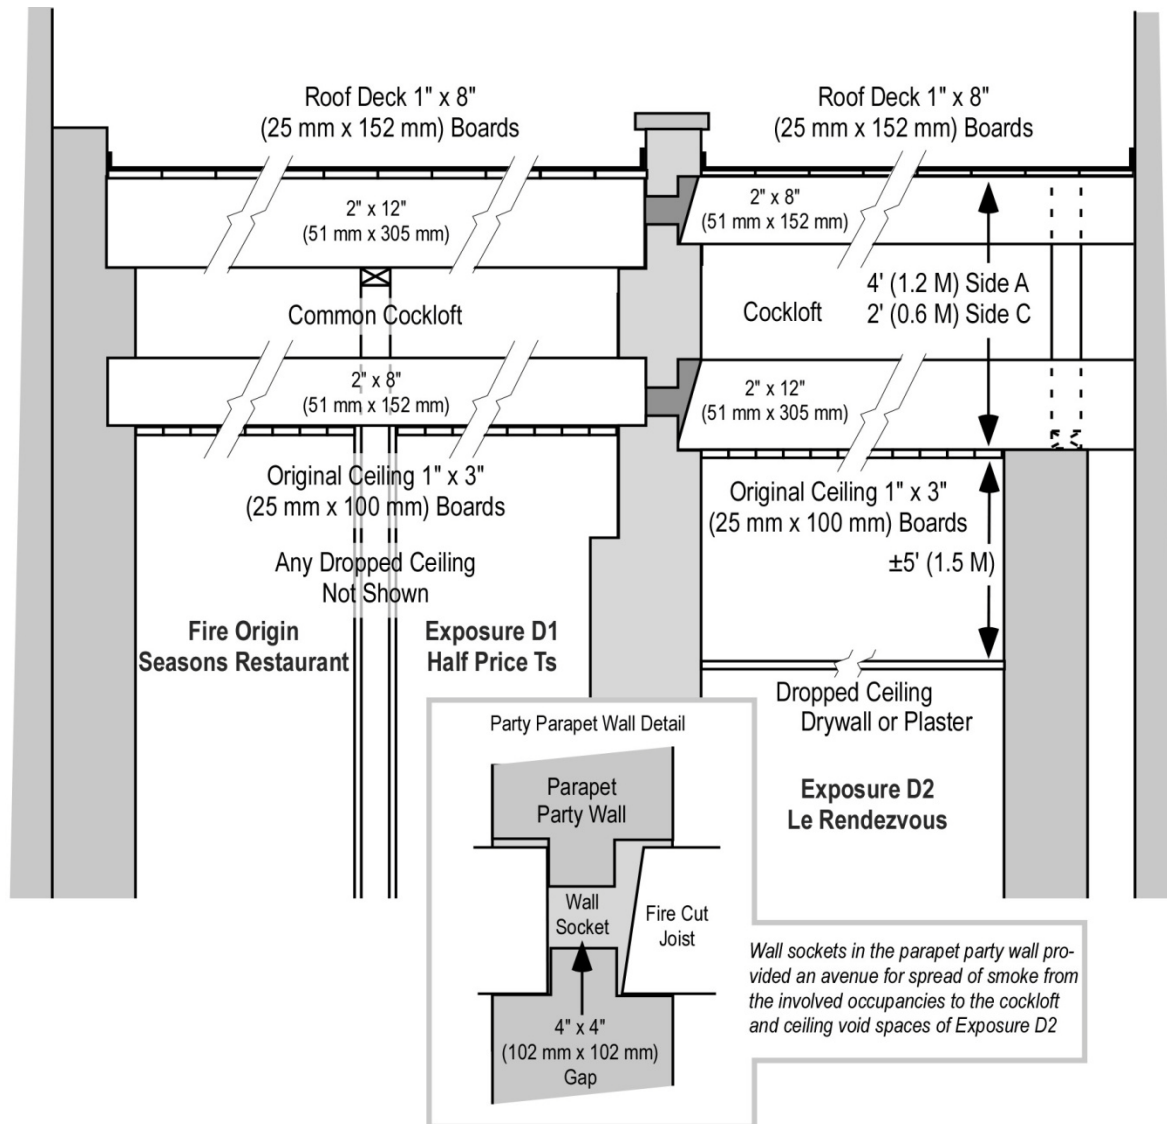
Figure 3. Cockloft, Ceiling Voids, & Party Wall Detail

Exposures D1 and D2 were separated by a party wall. Roof joists and ceiling joists supporting the original ceiling were supported in common wall sockets (see Figure 3). Fire investigators discovered that there was a 4" x 4" (102 mm x 102 mm) opening in the wall behind the joists. This wall was also constructed using sand lime mortar which can degrade over time due to contact with water. Loss of mortar between bricks can result in loss of stability and gaps that permit passage of smoke and heat transfer through convection.

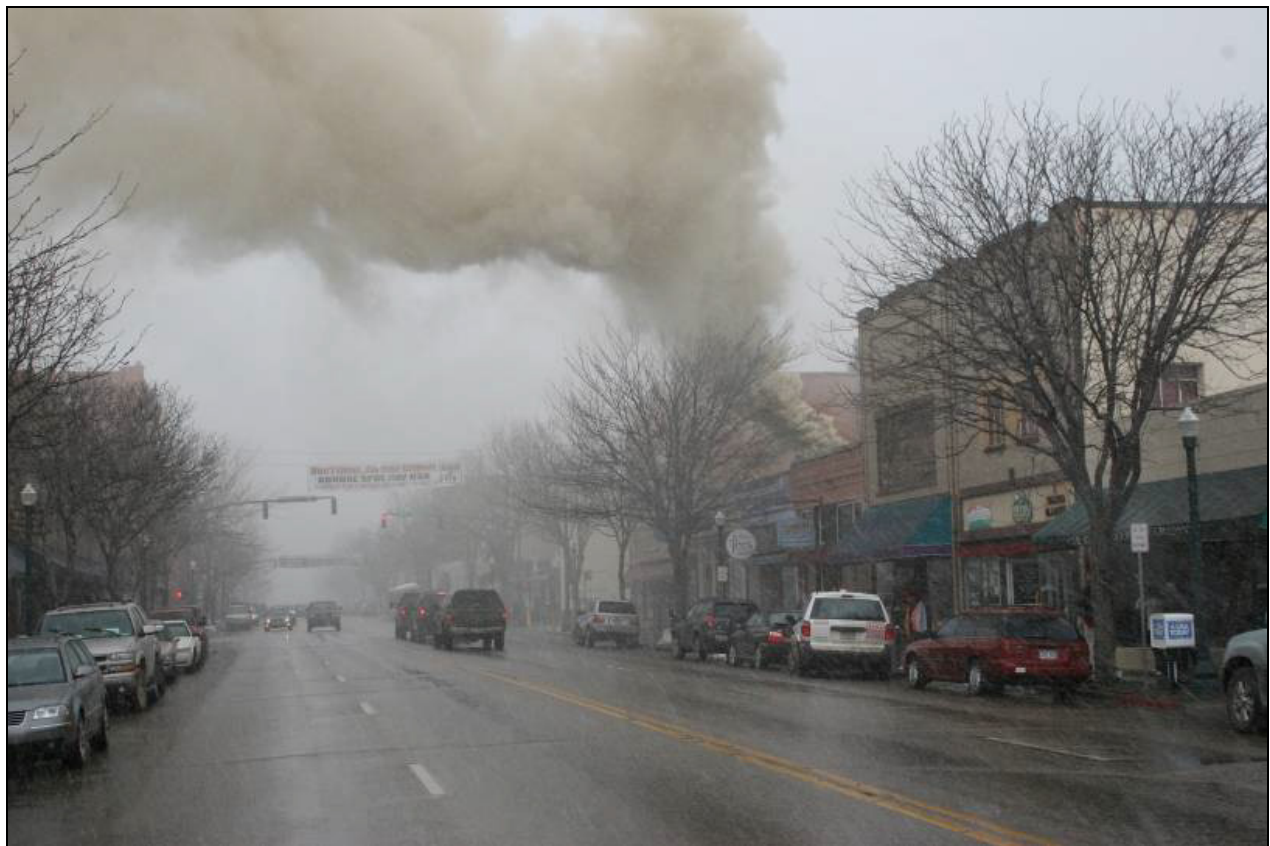
Figure 4. Smoke Conditions at 1340 hours.

At 1340 hours on February 22, 2008, Central Dispatch received multiple calls for a fire at Seasons Restaurant at 764 Main Avenue. Callers reported smoke showing from the building and a thick column of smoke extending to the west, across Main Avenue. The first alarm assignment included three engine companies (Engines 2, 1, and 9), two truck companies (Ladders 2 and 1), advanced life support (ALS) ambulance (Medic 2), non-transport medic unit (EMS 1), and battalion chief (BC 1). The Fire Marshal (Fire 4) and several other staff also responded on the initial alarm.

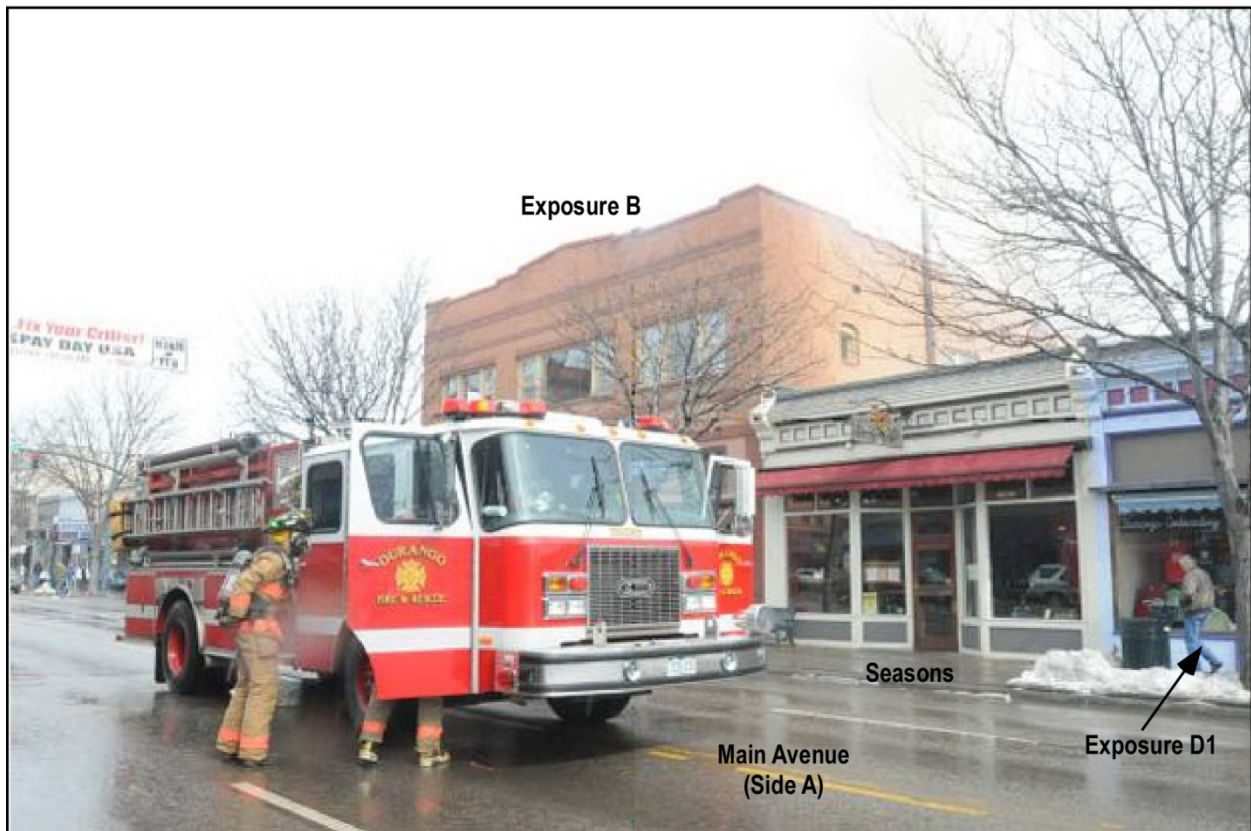
Figure 5. Commercial Fire at 764 Main Avenue, Durango, Colorado

Engine 2 arrived at 1346 and observed light smoke from the Seasons Restaurant (see Figure 5). The Fire Marshal conferred with occupants of Seasons Restaurant and Half Price Ts (Exposure D1) to determine if all occupants had exited the building. While in Exposure D1, he observed a light haze of smoke with some smoke coming from the basement.

The Fire Marshal observed smoke from various areas of the roof above Seasons and Exposure D1, with a larger volume of thicker (optically dense) smoke near the parapet wall separating Exposure D1 and D2. He also observed flames near the base of a roof mounted ventilation fan above Seasons.

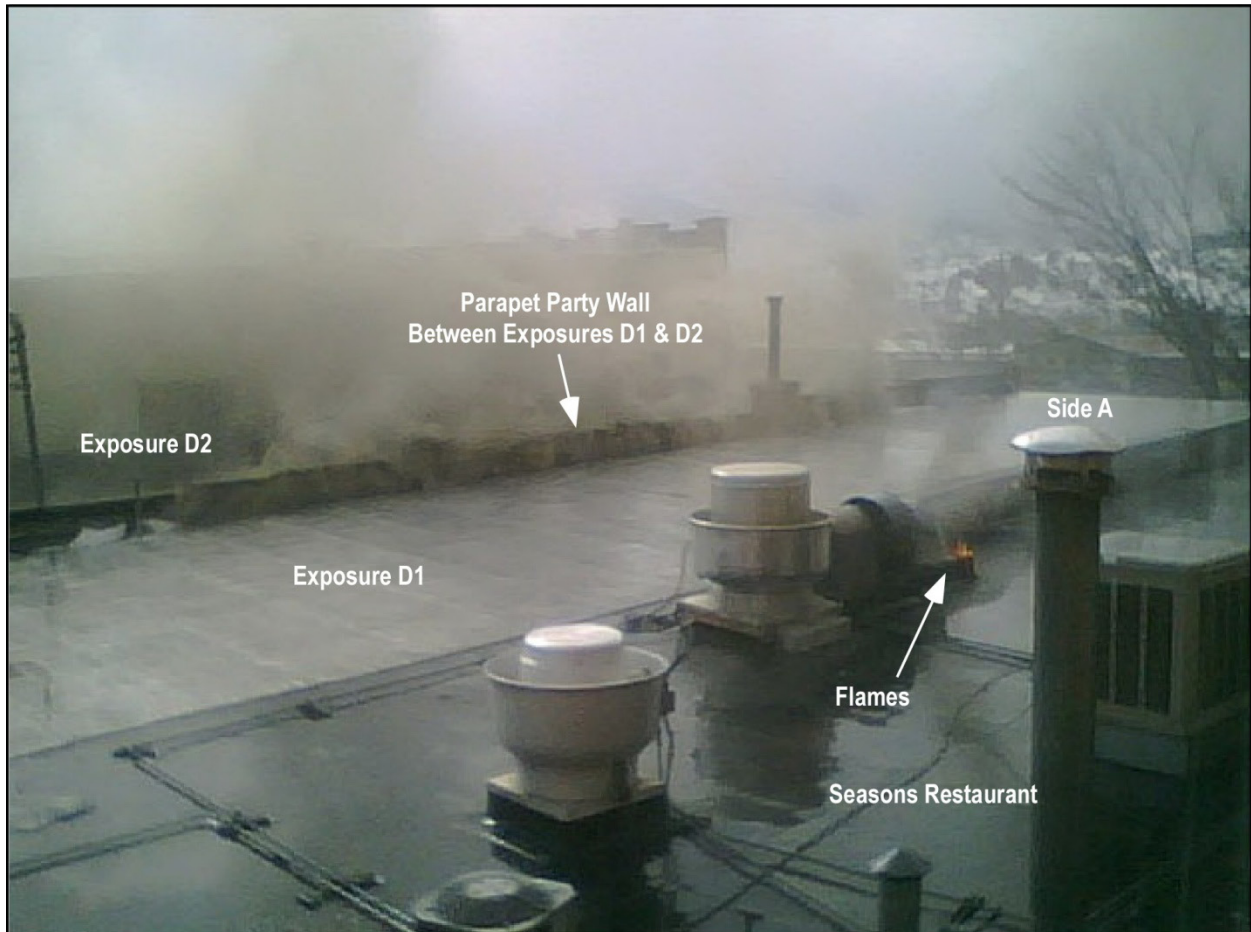
Figure 6. Conditions on the Roof Prior to 1345 Hours

Early in the incident, a civilian photographer (identified as Ms. Ellis) took a photograph (Figure 6) of the roofs of Seasons Restaurant and Exposures D1 and D2 from a bathroom window on Side D of Exposure

B. Figure 6 shows conditions on the roof prior to 1345 as seen from Exposure B. These conditions would be similar to those observed by Fire Marshal Kaufman (simply from a different angle and elevation).

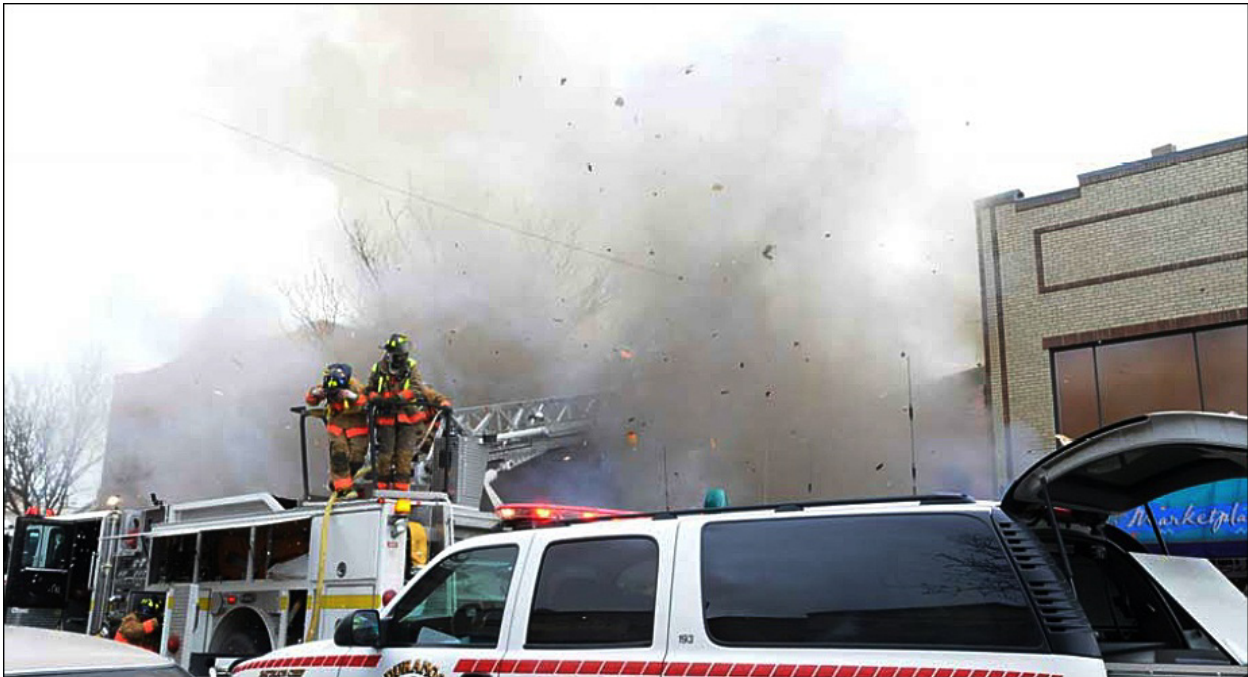
Figure 11. Explosion

openings) into the cockloft and void space between the original and newer dropped ceiling. Approximately 50 minutes after the arrival of the first company, an explosion occurred in Exposure D2, which caused significant structural damage to the wall on Side A and roof of this occupancy. The explosion injured seven firefighters working on the roof and on Side A in front of Exposure D2

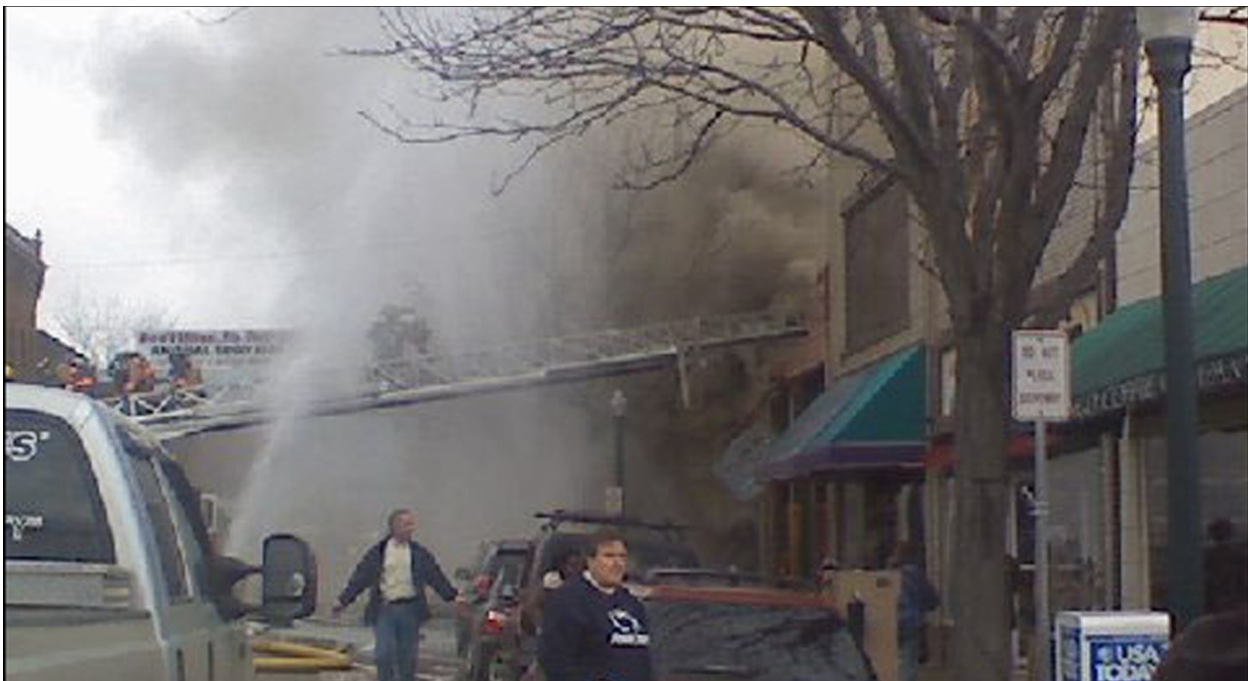
Figure 12. Conditions on Side A Immediately Following the Explosion.

Ladder 2's aerial was repositioned to reach the firefighters on the roof. The firefighter from Ladder 2 was rescued and the members of Engine 2 were able to self-extricate and egress the roof over the aerial ladder.

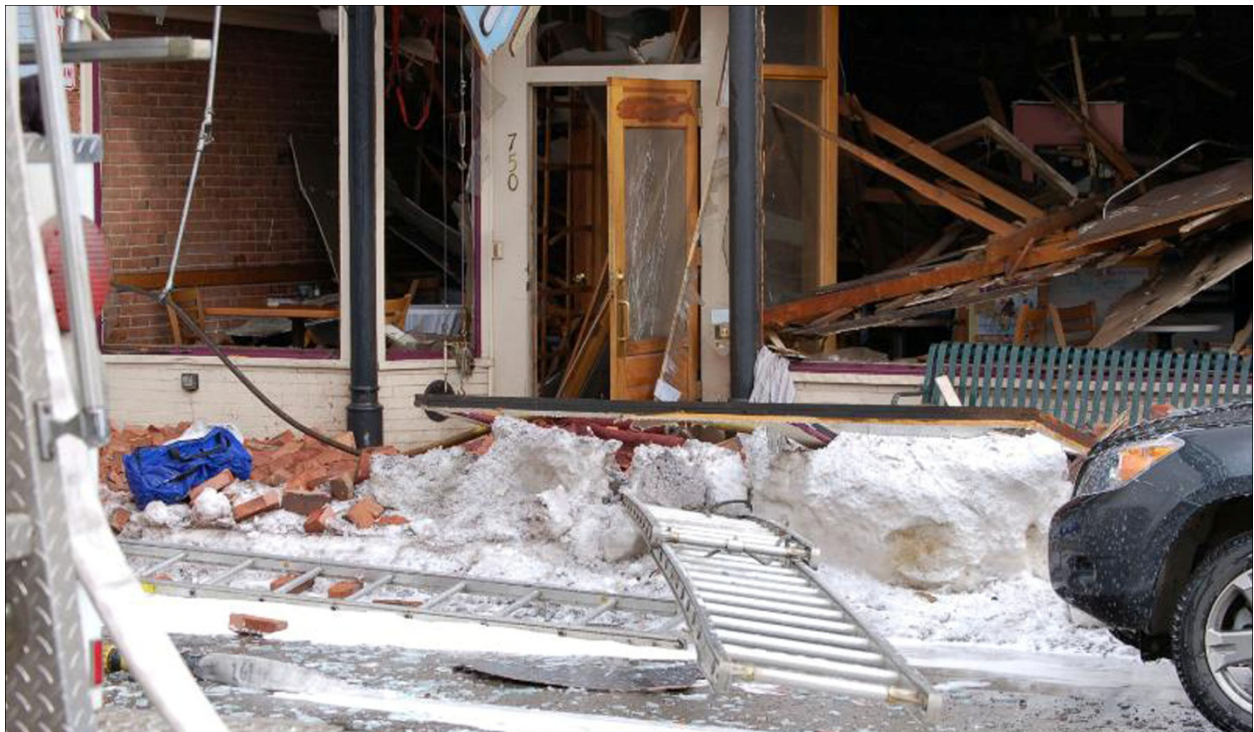
Figure 13. Side A in Front of Exposure D2

As illustrated in Figures 13-15, the force of the explosion resulted in significant damage, but fire development within Exposure D2 was limited to some involvement of the roof (likely due to extension from Exposure D1 after the explosion).

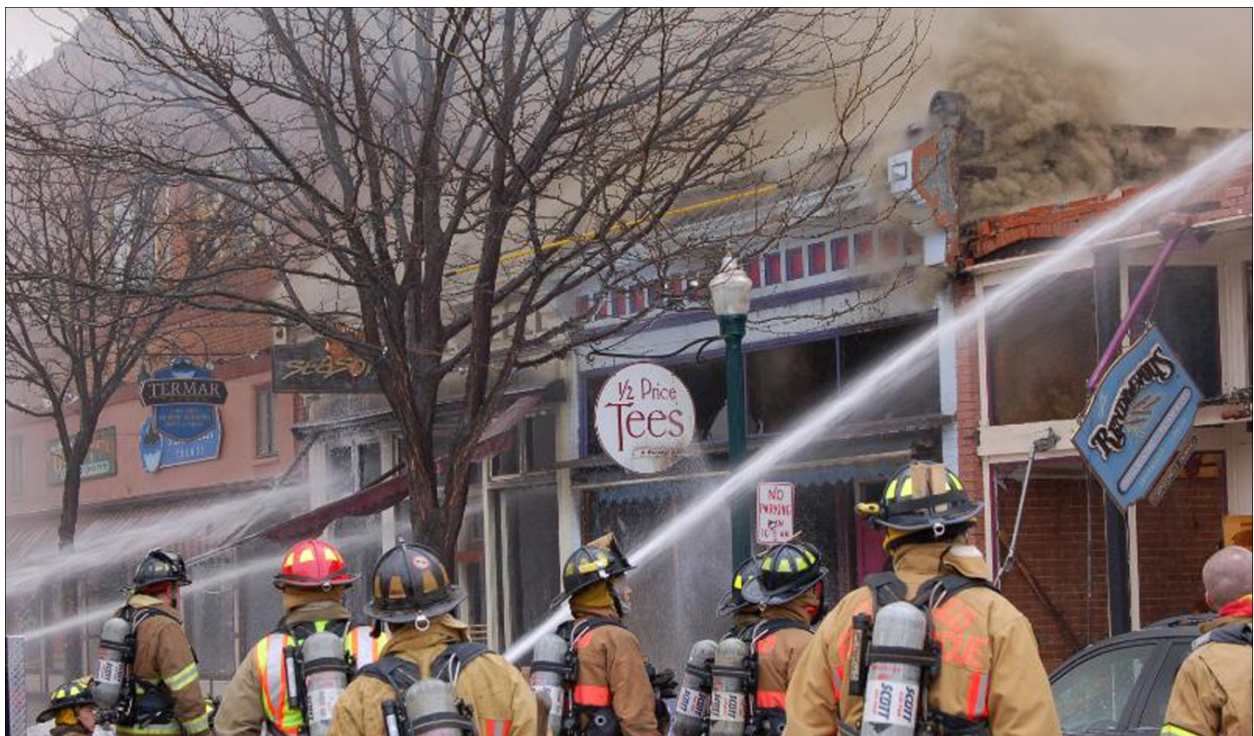
Figure 15. Side A Exposure D1 and Seasons Restaurant.

As showing in Figure 15, the fire burning in the void spaces between the ceiling and roof of Seasons Restaurant and Exposure D 1, continued to produce a large volume of thick (optically dense) smoke after the explosion occurred in the void spaces between the ceiling and roof of Exposure D2.
