Fire Behavior Case Study

The Case

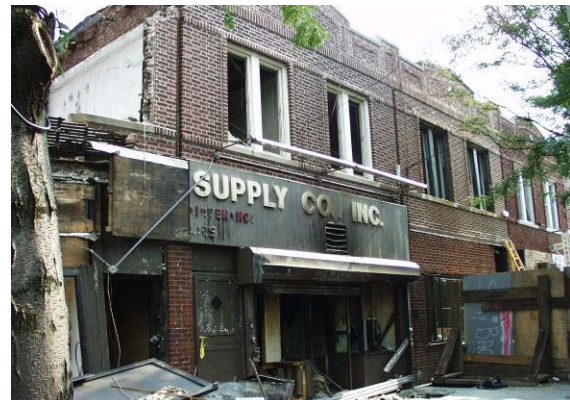
Figure 1. Side Alpha-Post Fire

At approximately 1448 an explosion occurred in the basement. The force of this explosion displaced the first floor and caused collapse of the exterior wall on Side Bravo. One firefighter operating on the interior fell into the interior stairwell in Building 1. The collapse on Side Bravo trapped three firefighters who had be conducting ventilation operations.

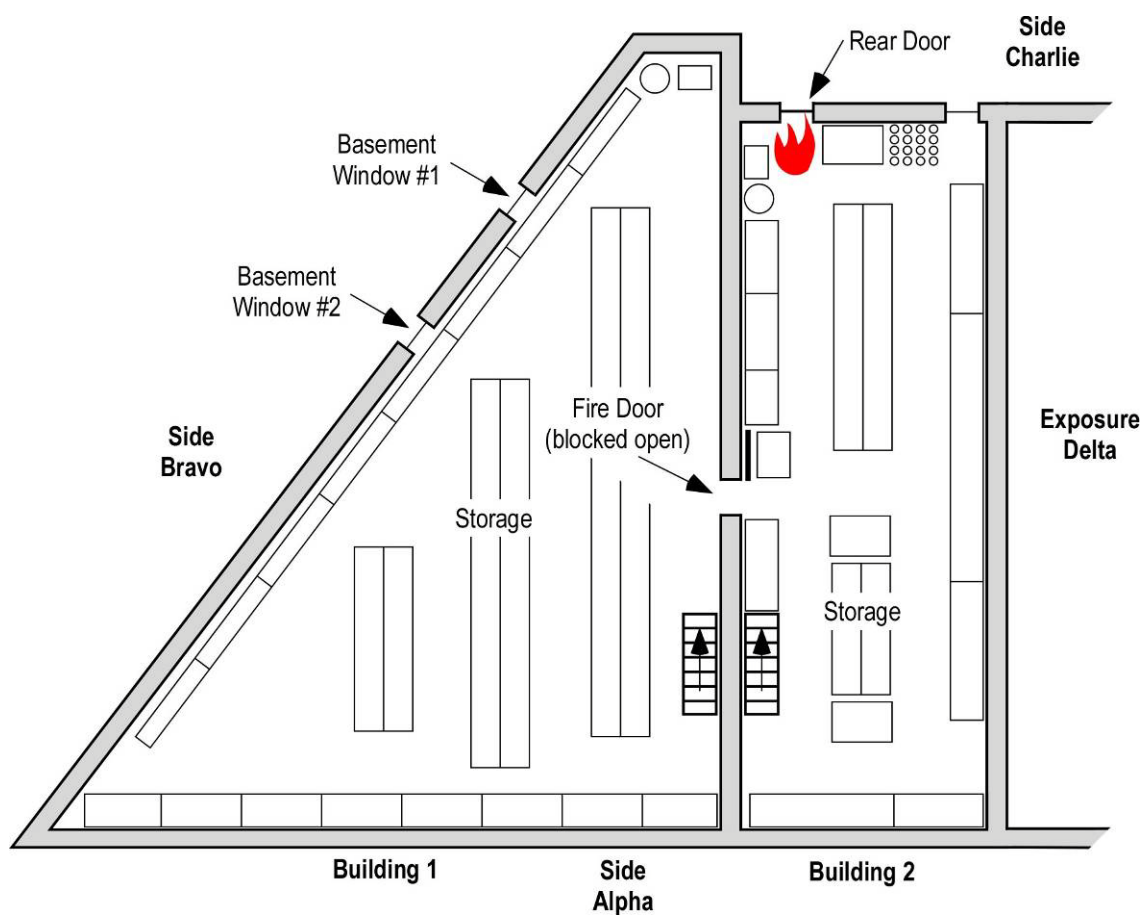
Figure 2. Basement Floor Plan

The fire involved two, two-story buildings with a basement. Both structures (and Exposure Delta) were of ordinary construction. These structures shared a party wall and were interconnected on both floor 1 and in the basement (see Figure 2). The first floor and basement contained a hardware store (retail on floor one and storage and repair/assembly in the basement). Building one had apartments on floor two while building two contained office and storage space on floor two.

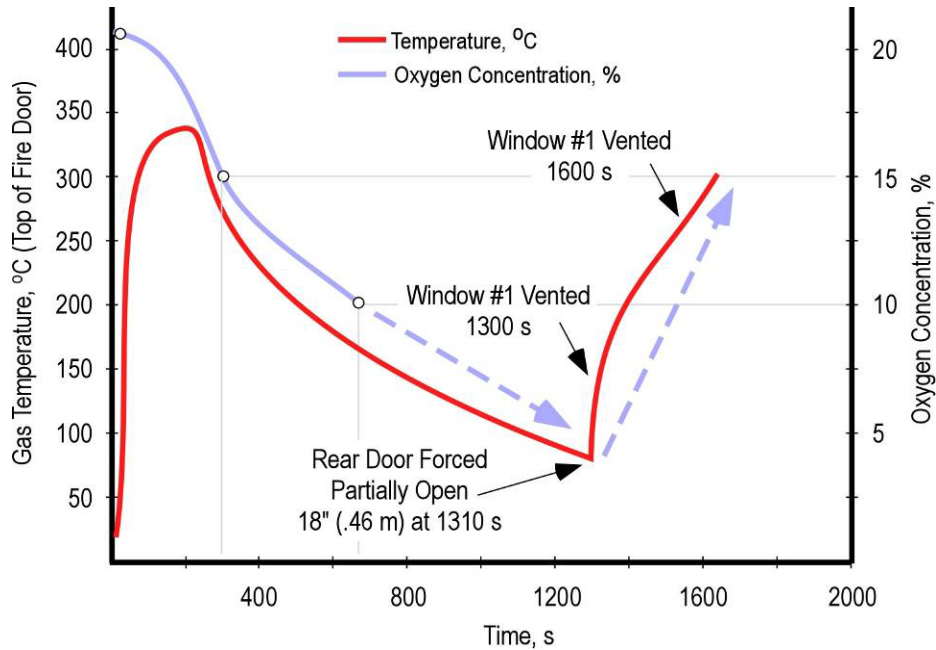
Figure 5. Temperature and Oxygen Concentration

These simulations examined fire growth after ignition and up to the point at which the explosion occurred. The software used for this computer simulation cannot model an explosion. NIST researchers used multiple scenarios based on the fire door in the basement being open or closed, and initial heat release rates from 500 kW to 2000 kW. Selection of this range of heat release rates considered solvents stored in the basement and combustible structural materials (but did not include other building contents). The example used in this Training Bulletin (see Figure 5) uses the scenario with a 2000 kW initial heat release rate and inoperative fire door.
