Fire Behavior Case Study

The Case

Figure 1. Cross Section of 3146 Cherry Road NE

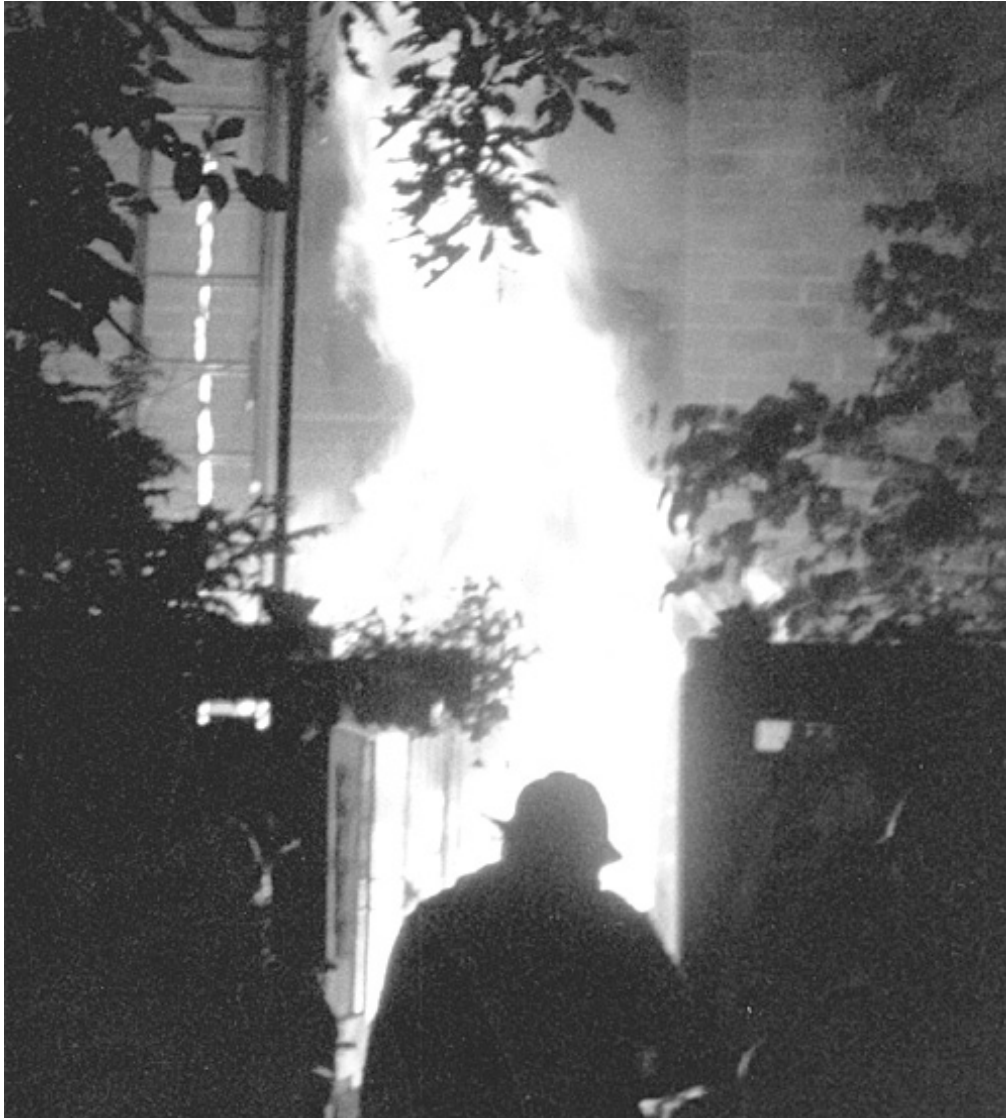
Figure 8. Conditions on Side C at Aproximately 00:28

At this point crews from Engine 26 and 10 are operating on Floor 1 and conditions begin to deteriorate. Firefighter Morgan (Engine 26) observed flames at the basement door (Figure 8 illustrates conditions visible from Side C at approximately the same time). Firefighter Phillips (Engine 10) knocked down visible flames at the doorway, but conditions continued to deteriorate. Temperature increased rapidly while visibility dropped to zero.

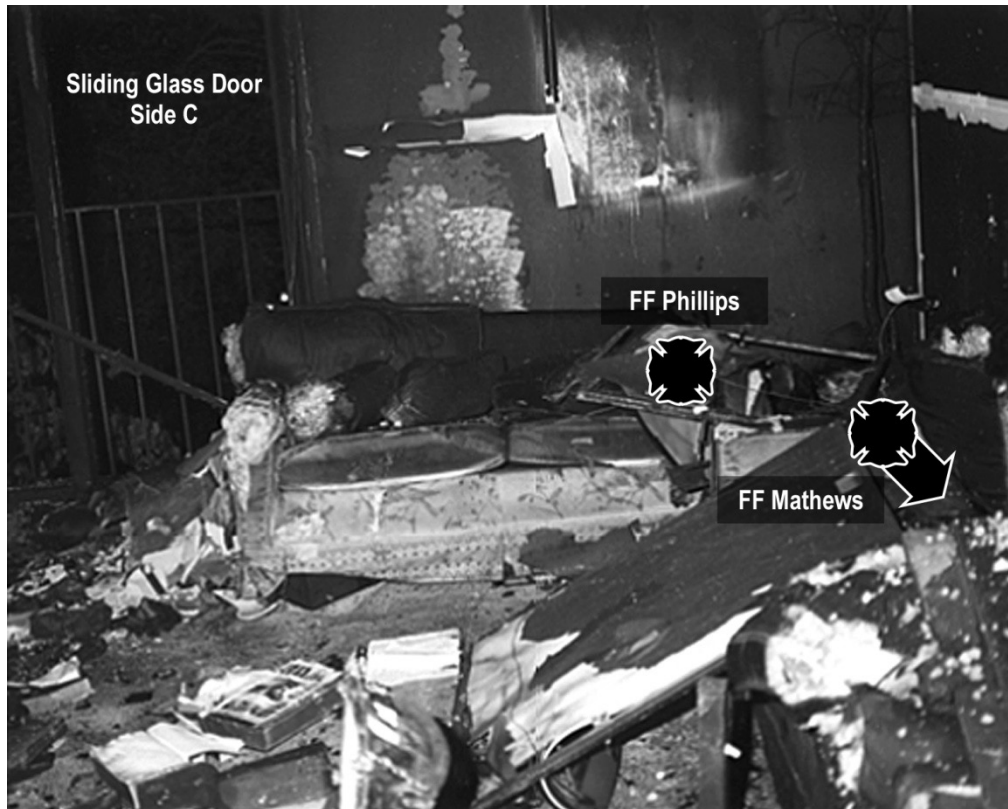
Figure 11. Post-Fire Conditions on Floor 1

The basement had severe fire damage from floor to ceiling, indicating a well-mixed, post-flashover fire. The stairway from the basement to the first floor showed evidence of flame impingement on the ceiling and walls. The door at the top of the basement stairs was open during the fire and was partially burned through (NIST, 1999)

The living room had significant deposits of soot, with limited thermal damage. Most of the paper on the gypsum board walls and ceiling remained intact and sofas in the room only showed signs of pyrolyzation or limited burning on upper surfaces of back cushions and top surfaces of seat cushions. Areas of the living room distant from the basement door opening had less thermal damage (NIST, 1999).

Figure 11 illustrates post fire conditions on Floor 1 and the approximate locations of Firefighters Phillips and Mathews.

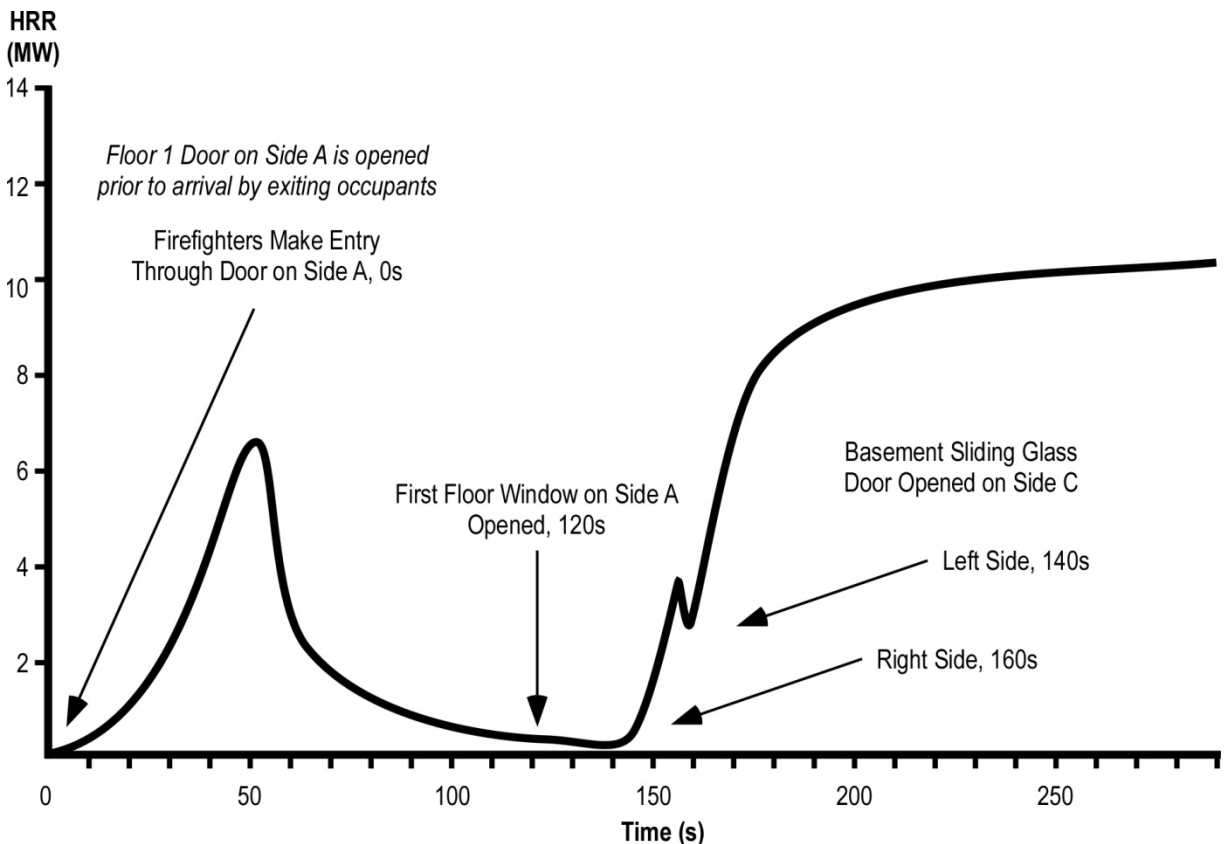
Figure 12. FDS Heat Release Rate Curve

simulation and incident conditions began at 100 seconds into the simulation which corresponds to approximately 00:25 during the incident.

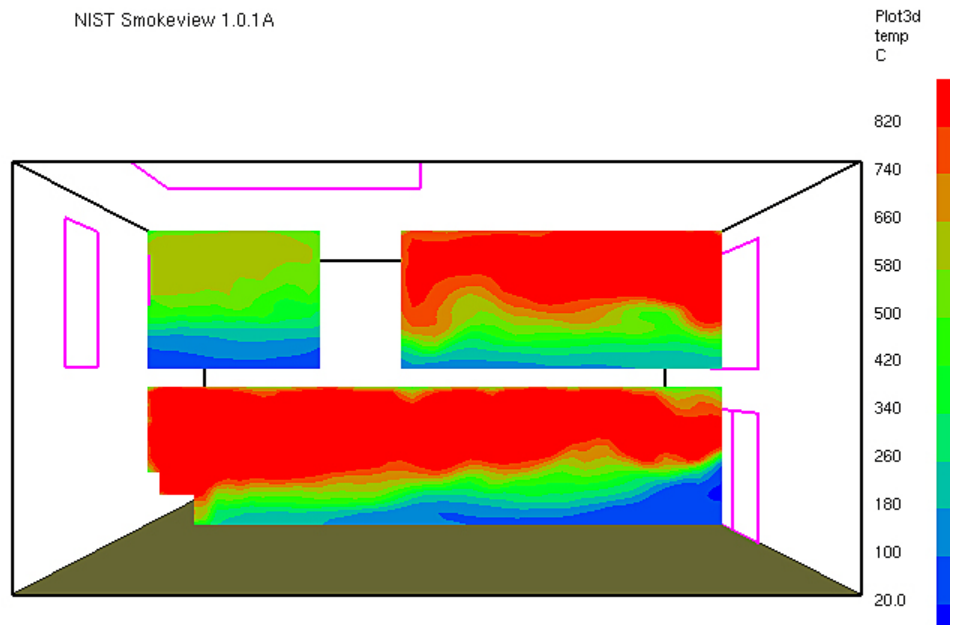
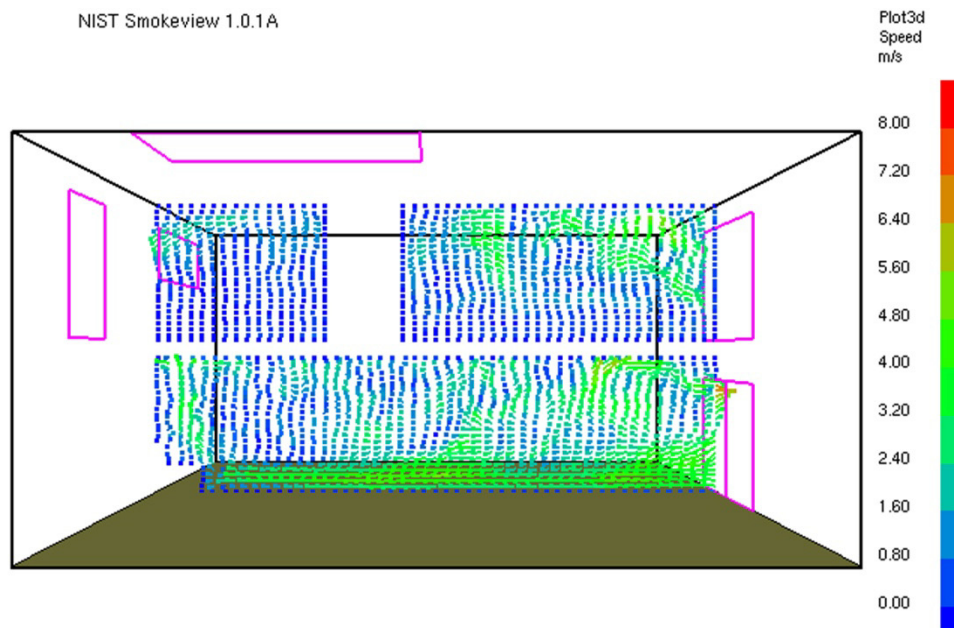
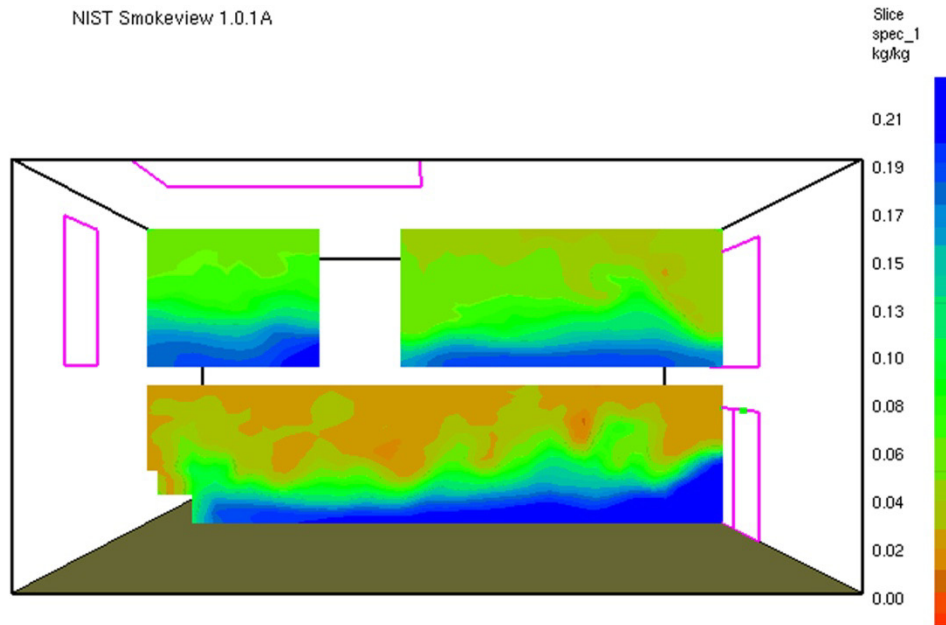
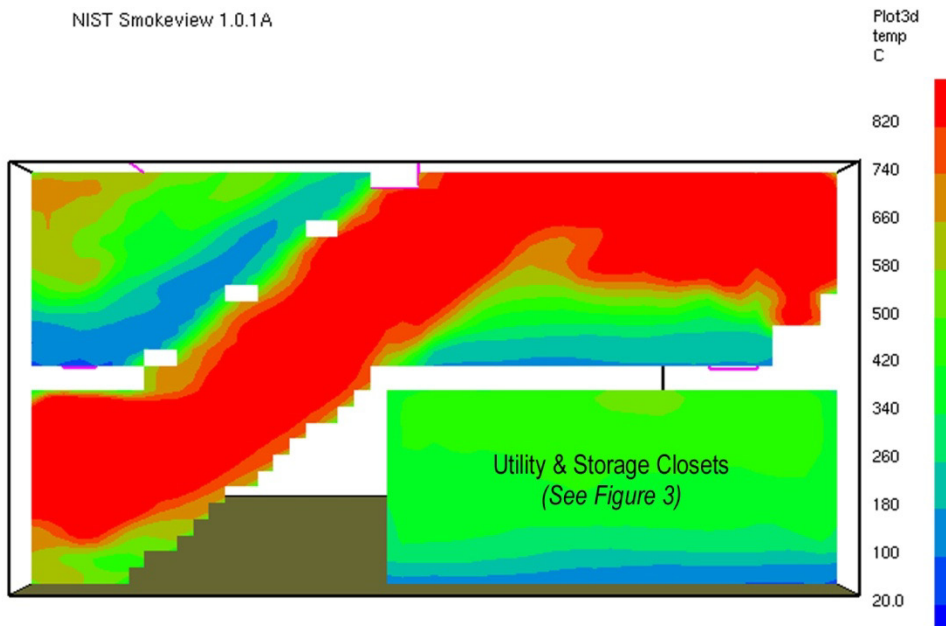
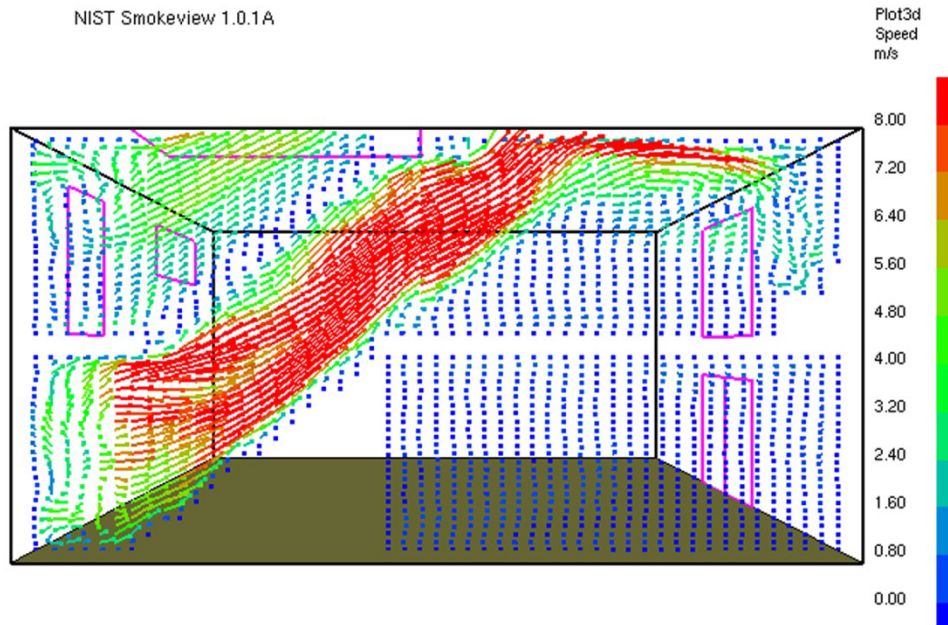
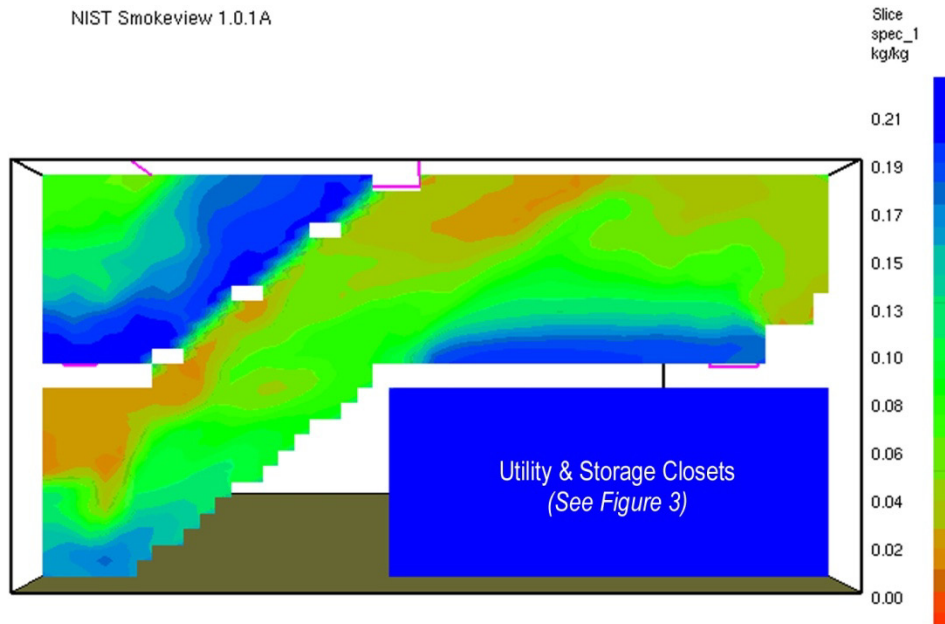
Figures 14-21 illustrate conditions at 200 seconds into the simulation, which relates to approximately 00:27 during the incident, the time at which the fire in the basement transitioned to a fully developed stage and rapidly extended up the basement stairway to Floor 1. Data is presented as a snapshot within a specific slice. Temperature and velocity data are provided for each slice (S1, S2, & S3 as illustrated in Figure 13). Oxygen (O₂) concentration data is provided for the basement (S1) and stairwell (S2).

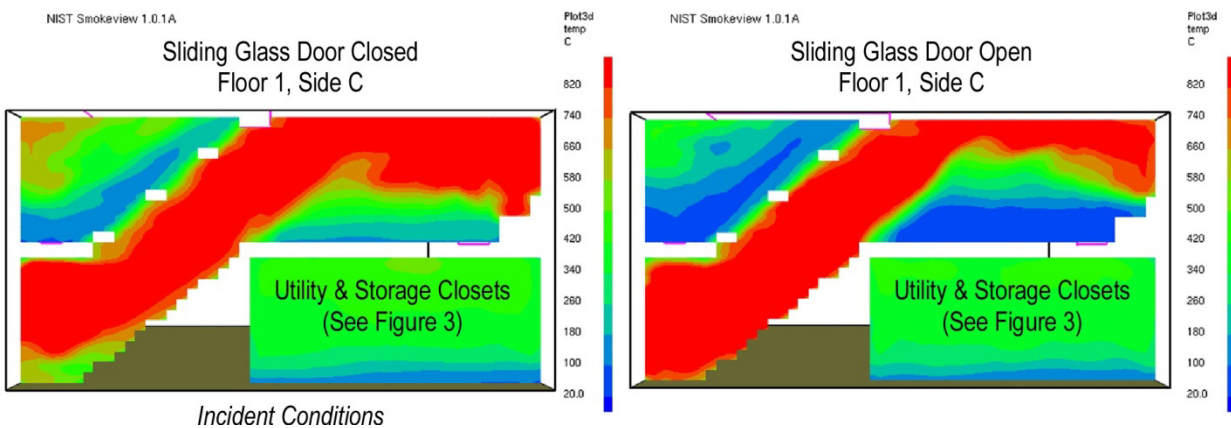
Figure 24. Comparison of Temperature Gradients Along Centerline of Basement Stairwell (S2) at 200 s

The basic input for the alternate simulation was the same as the simulation of actual incident conditions. Ventilation openings and timing was the same, with one exception; the sliding glass door on Floor 1, Side C was opened at 120 s into the simulation. Conditions in the basement during the alternative simulation were similar to the first. However, on Floor 1, the increase in ventilation provided by the sliding glass door on Side C resulted in a shallower hot gas layer and cooler conditions at floor level. A side-by-side comparison of the temperature gradients in these two simulations is provided in Figure 24.

The NIST Report (Madrzykowski & Vettori, 2000) identified that the significant difference between these two simulations is in the region close to the floor. In the alternative simulation (Floor 1, Side C Sliding Glass Door Open) between the doorway to the basement and the sofa, the temperatures from approximately 0.6 m (2 ft) above the floor, to floor level are in the range of 20 °C to 100 °C (68°F to 212 °F), providing at least an 80 °C (176 °F) temperature reduction.
