Fire Behavior Case Study

The deaths of Captain Matthew Burton and Engineer Scott Desmond in a residential fire were the result of a complex web of circumstances, actions, and events. This case study focuses on the fire behavior and related tactical operations involved in this incident. Readers are encouraged to read the Contra Costa County Fire Protection District Report and National Institute for Occupational Safety and Health (NIOSH) Death in the Line of Duty Report F2007-28 for additional information.

Figure 1. 149 Michele Drive-Alpha/Delta Corner

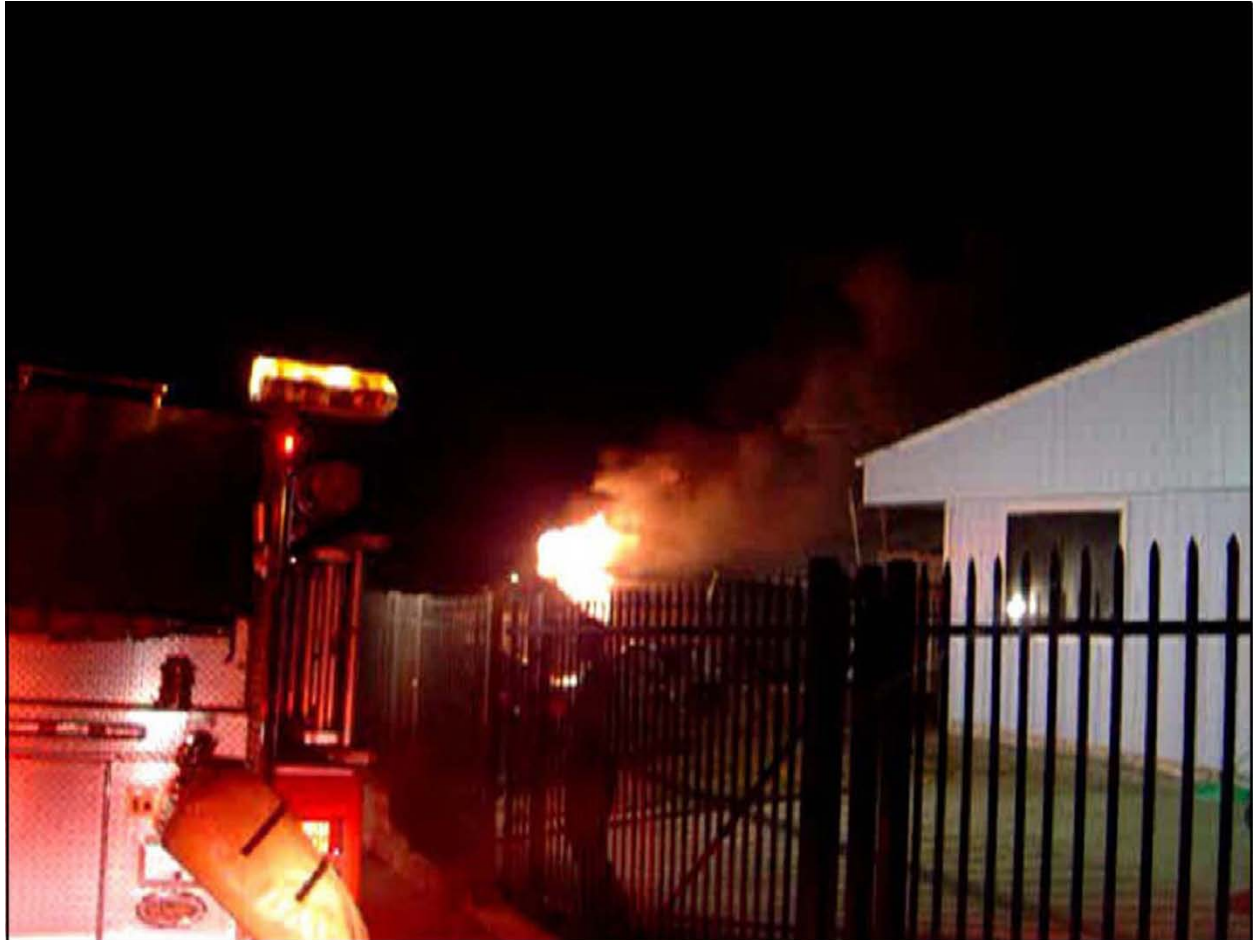
Note: Contra Costa Fire Protection District (Firefighter Q76) Photo, Investigation Report: Michele Drive Line of Duty Deaths. This photo illustrates conditions shortly after 0159 (Q76 time of arrival).

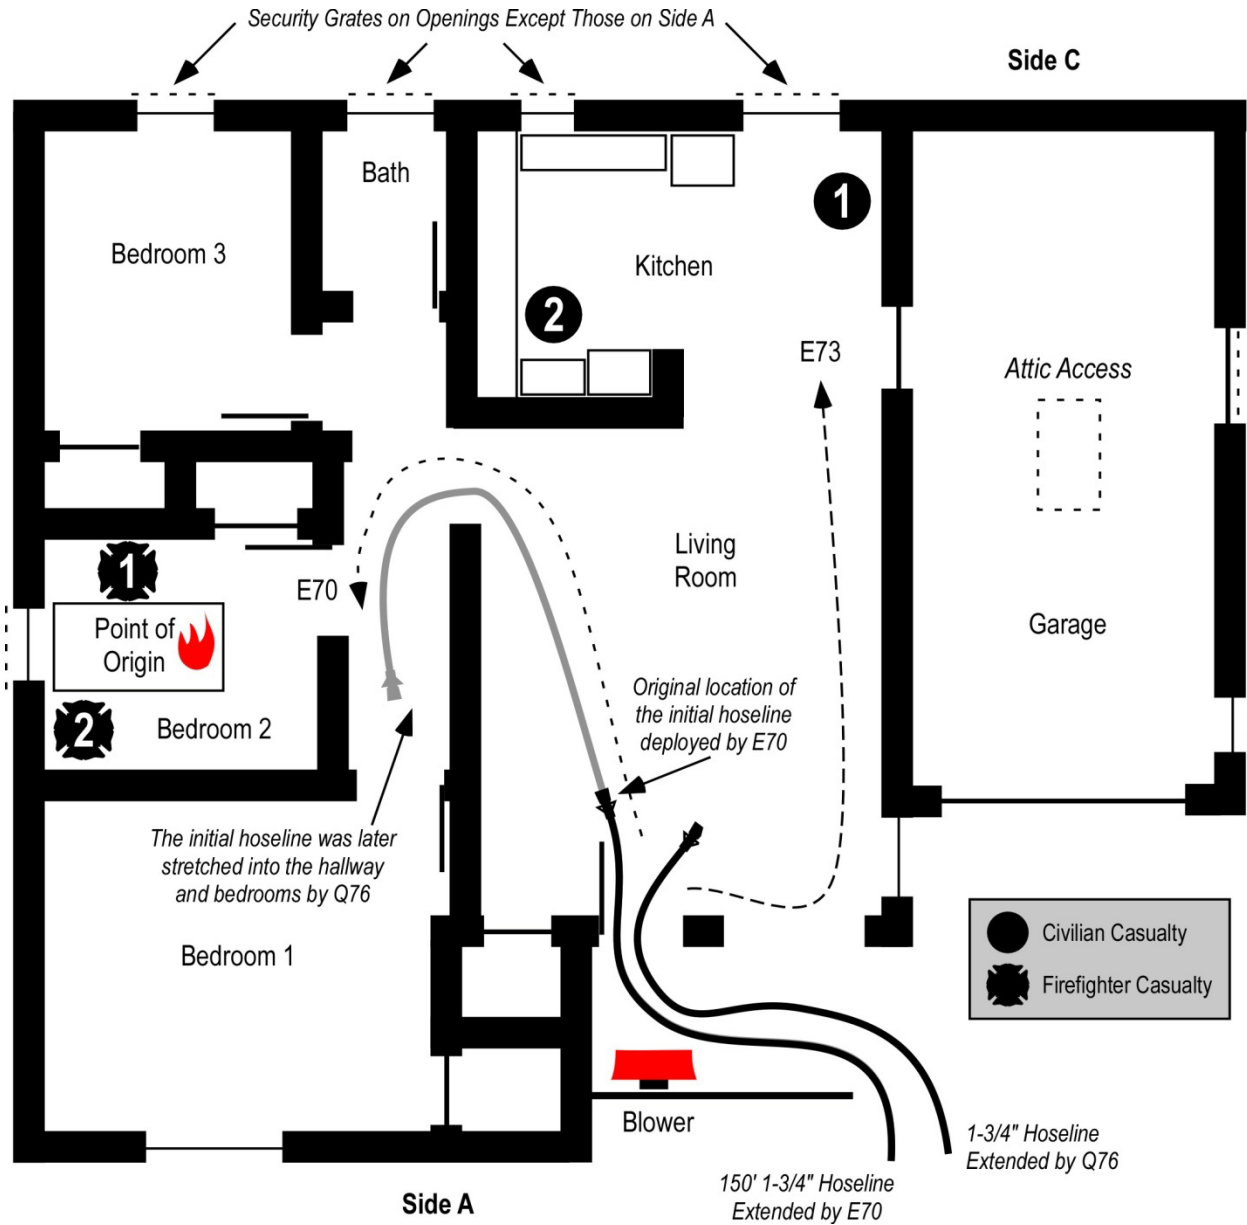
Figure 2. Floor Plan-149 Michelle Drive

Note: This floor plan is based on data provided in the Contra Costa Fire Protection District Investigation Report and is not drawn to scale. The position of exterior doors and condition of windows as illustrated is based on the narrative or photographic evidence. Interior doors are shown as open as illustrated in the report. Fire service casualties are designated as follows: 1) Captain Burton, 2) Engineer Desmond.

All windows with the exception of the Living Room and Bedroom 1 (see Figure 2) were fitted with security bars (see Figure 3). The front door was the primary exit. In addition, an additional exit was

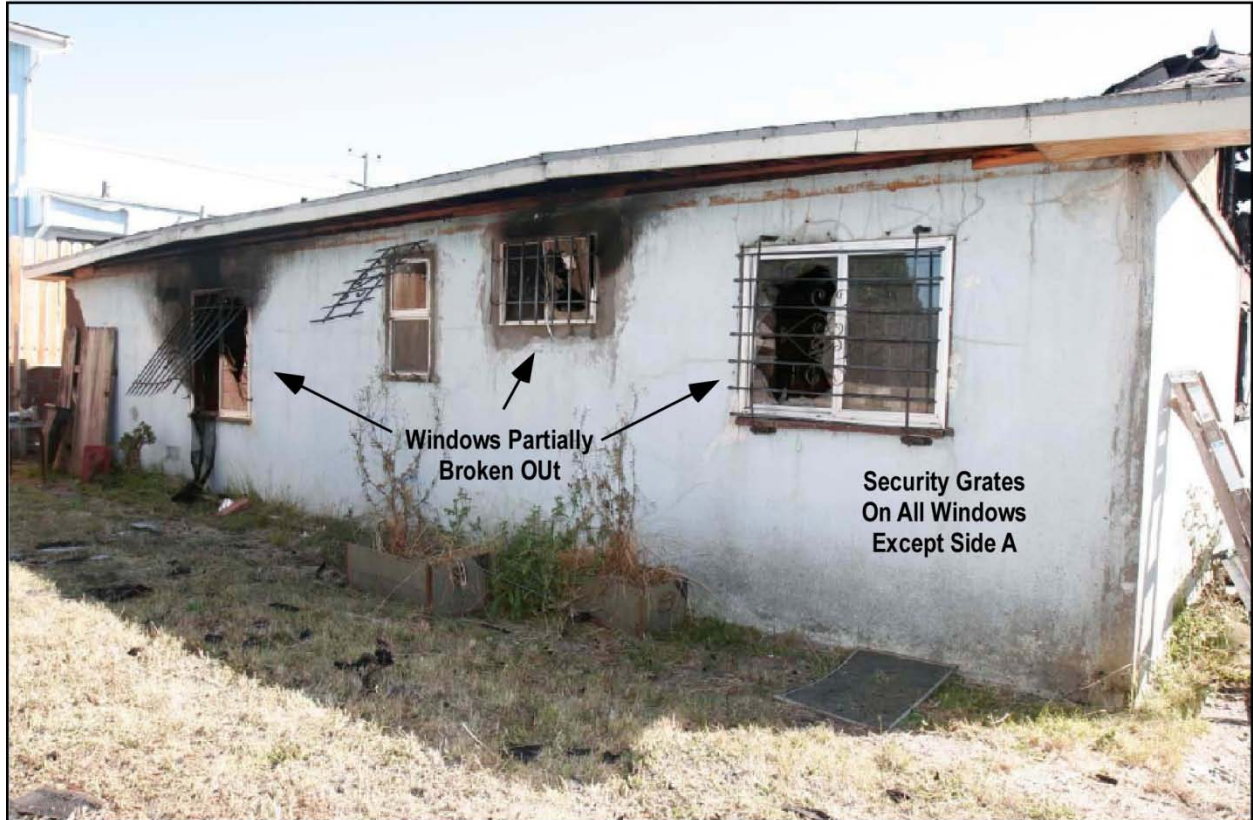
Figure 3. View of Side C from the B/C Corner

Investigators determined that the fire likely originated on or near the east end of the bed in Bedroom 2 (see Figures 2 & 3). The likely source of ignition was improper discard of smoking materials. Developing into growth stage, the fire progressed from Bedroom 2 into the hallway (see Figures 2 & 4) leading to the living room, dining area, and kitchen (see Figures 2 & 5). It is likely that the door on Side A was closed at the time of ignition, but was opened by an occupant exiting some time after discovery of the fire.

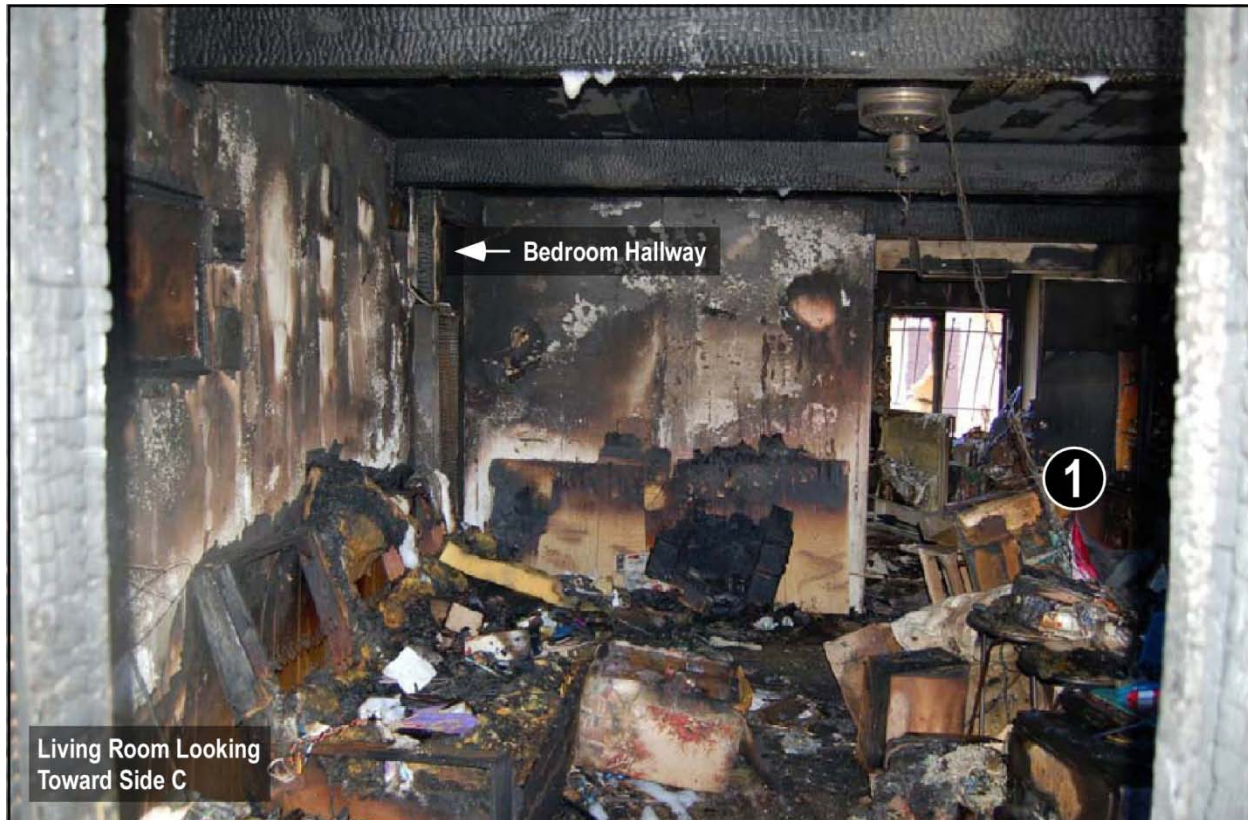
Figure 5. Living Room

Interior walls were gypsum board with wood veneer paneling on some of the walls (e.g., living room). All ceilings with the exception of the kitchen were exposed 2" x 6" (51 mm x 152 mm) tongue and groove planking (see Figure 4). The kitchen ceiling was covered with gypsum board. Ceiling height was 8' (2.4 M).

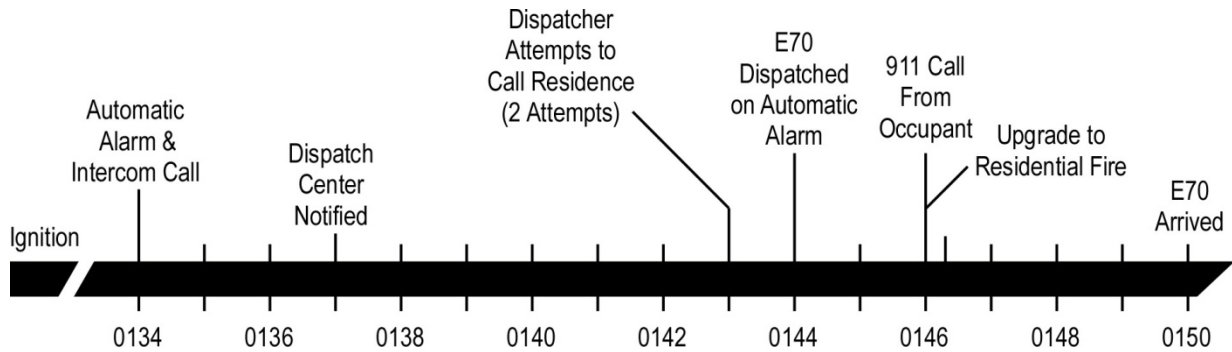
Figure 6. Timeline from Ignition to Arrival

living room window on Side A), and established Command. As illustrated in Figure 6, there was a significant delay from discovery of the fire until arrival of E70 which resulted in significant fire development prior to intervention.

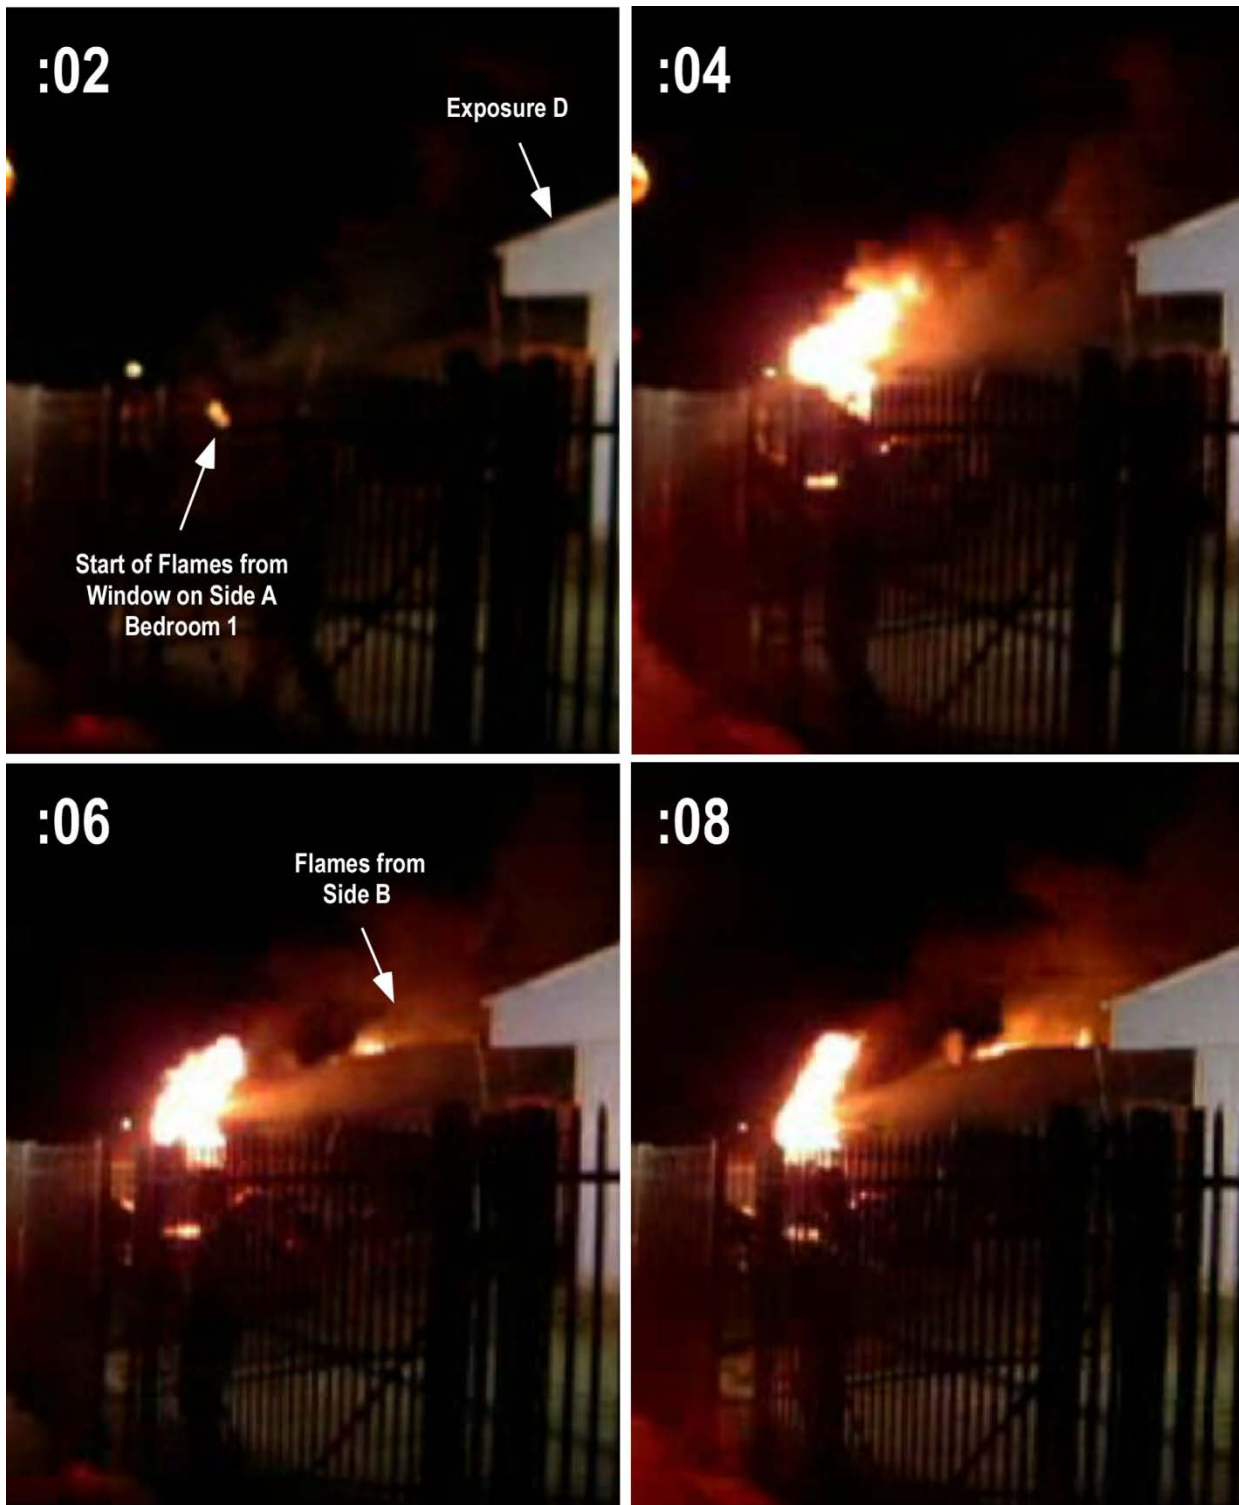
Figure 6. Extreme Fire Behavior

The firefighter from E73 who was providing emergency medical care to the civilian fire victim observed that the window in Bedroom 1 which had been cracked with some discharge of smoke, failed violently with glass blowing out onto the lawn and a large volume of flames venting from the window for a period of 10 to 15 seconds.

Note: Adapted from eight seconds of video was shot by Q76 firefighter from in front of Exposure D, looking towards the A/D corner of the fire building.

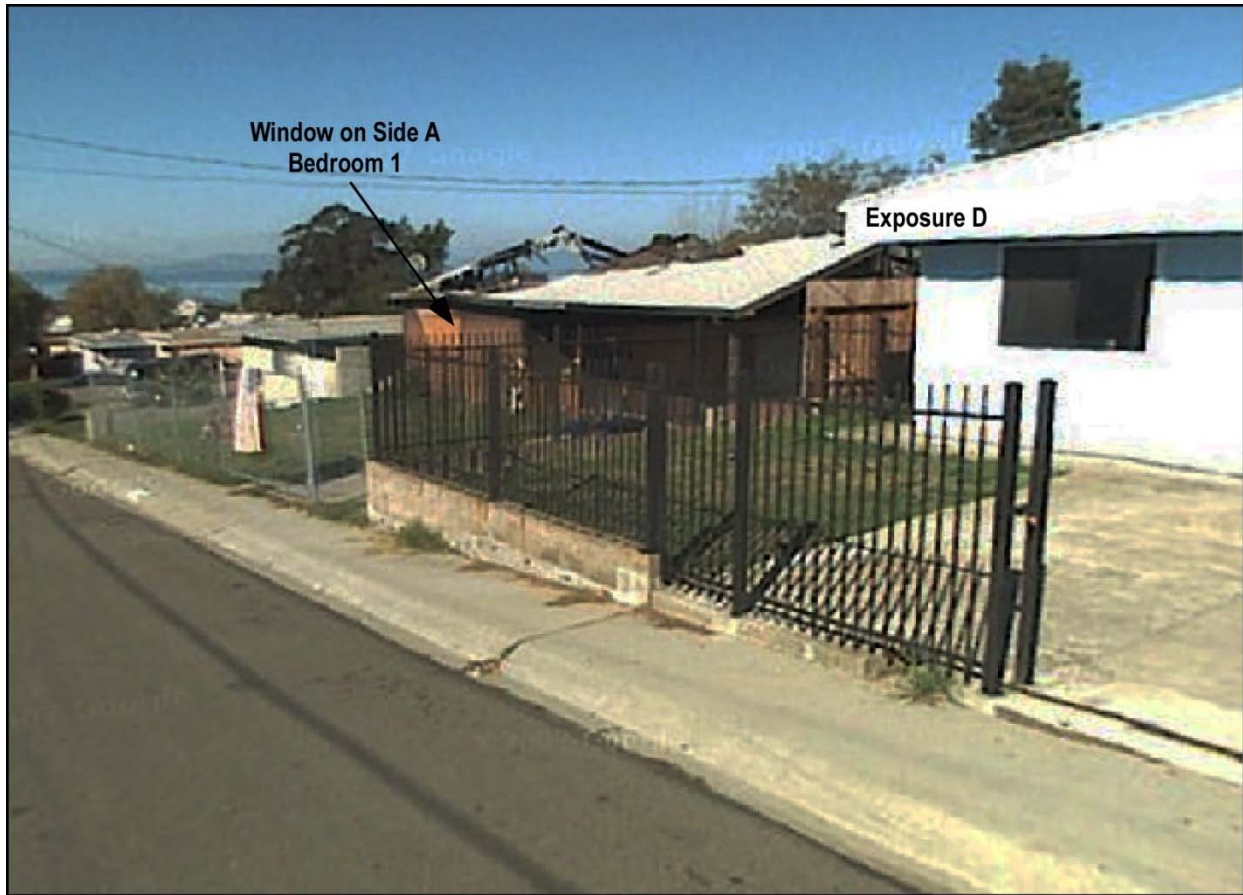
Figure 7. Post Fire Photo from in Front of Exposure D

Note: This screenshot from Google Maps Street View is from a similar angle as the video taken by Q76 firefighter and is provided to provide a point of reference and perspective for the video.

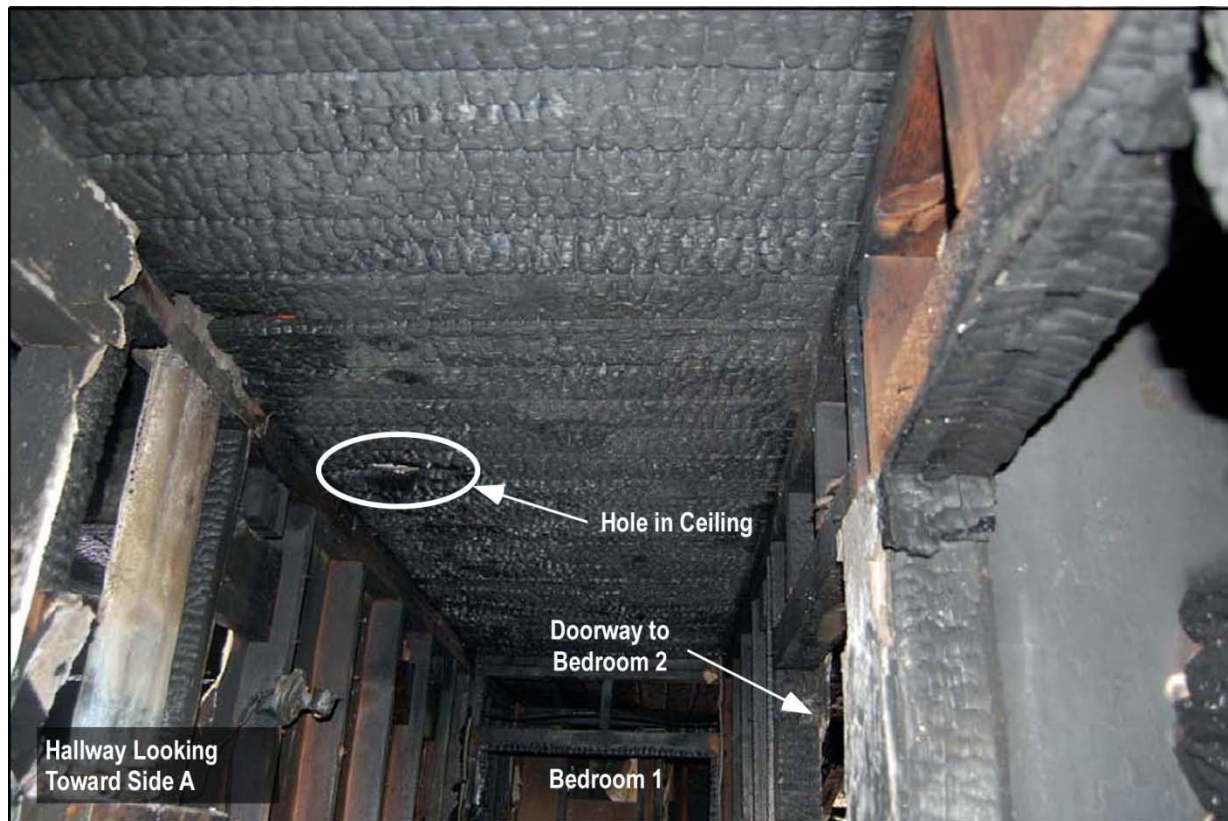
Figure 8. Hallway Ceiling.

While at the doorway of Bedroom 2, Q76 observed a substantial volume of fire in the attic through a small hole in the hallway ceiling (see Figure 7) and attempted to apply water into the attic. However, their stream was ineffective.
