In-Service Training

IS 22-43 Farmington Propane Incident

Author: Chief Ed Hartin

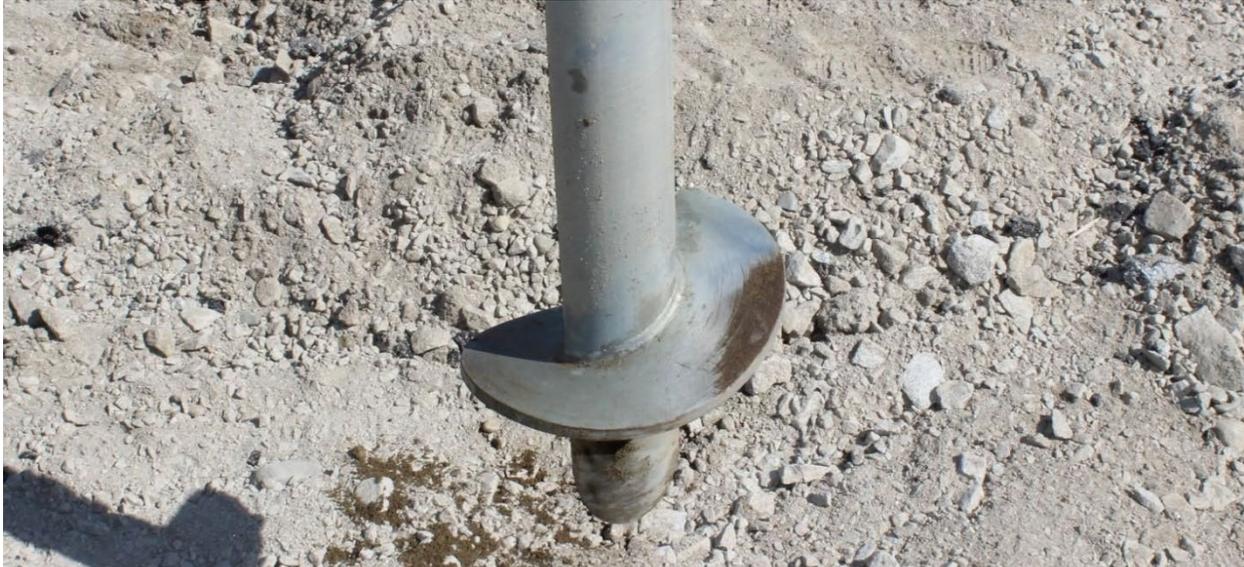
Figure 7. Bollard Auger

On September 10, 2019, four bollards were drilled into the ground to protect air conditioning units installed on Side Bravo. The installer did not call Maine Dig Safe to locate underground utilities prior to installing the bollards. These bollards were designed with an auger on one end to allow them to be drilled into the ground (NIOSH, 2022 & ME OFSM, 2019)

This incident involved underground release of propane from the gas line between the 500-gallon tank and the new addition to the LEAP building and migration of propane from the point of release to the interior of the building’s basement. Notice of this release was hampered by odor fade as ethyl mercaptan was scrubbed from the odorized propane absorbed by dirt or concrete. Breach of the propane gas line was due to installation of bollards without use of utility locate (811) to identify the presence and location of underground utilities. There were multiple errors and points of failure before the Farmington Fire Department was called to the LEAP office building. The pre-incident errors and points of failure provide a basis to prevent reoccurrence on a proactive basis. However, this case study focuses on fire department response to and mitigation of gas leaks occurring inside buildings.

- States should ensure anyone (including homeowners) using power tools or other digging equipment that will penetrate the ground call “811 or 811 Dig Safe” three business days (72 hours) prior to digging to identify if any buried utilities are present and mark their location(s).
- Local and state enforcement agencies should ensure that a leak test of the piping system is conducted in accordance with the requirements of NFPA 54, National Fuel Gas Code, and NFPA 58, Liquefied Petroleum Gas Code, whenever propane service is initiated or restored.

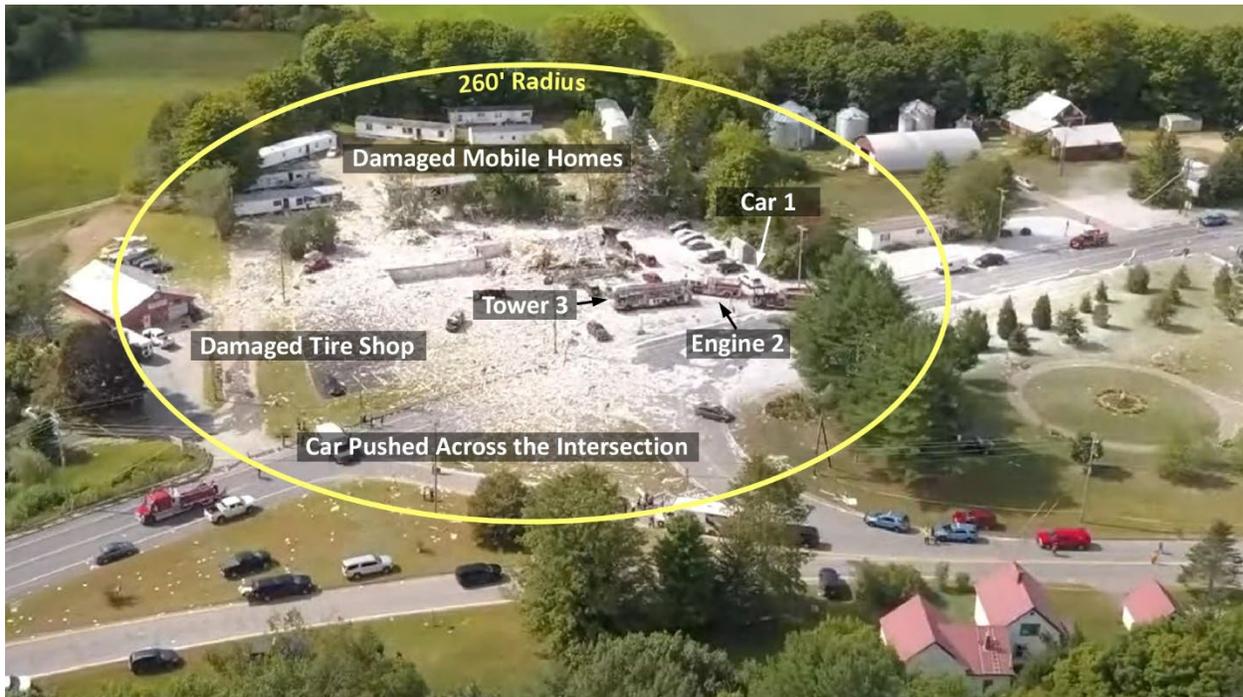
Figure 8. Post-Blast Aerial View

A flammable mixture of propane and air inside the basement of the LEAP building ignited, resulting in an explosion, destroying the new addition and original building. The explosion resulted in a fireball and ignition of building debris which continued to burn after the initial blast. Blast effects also severely damaged eleven mobile homes located to the southwest (Abbott, 2019) and a tire shop to the east of the LEAP building. In addition, a vehicle was damaged by the blast and blown across the intersection of Farmington Hills Road and High Street directly in front of the LEAP building.

Watch the [aerial video](#) (News Center Maine, 2019) and examine Figures 8 through 12 to gain perspective on the extent of damage resulting from this explosion.

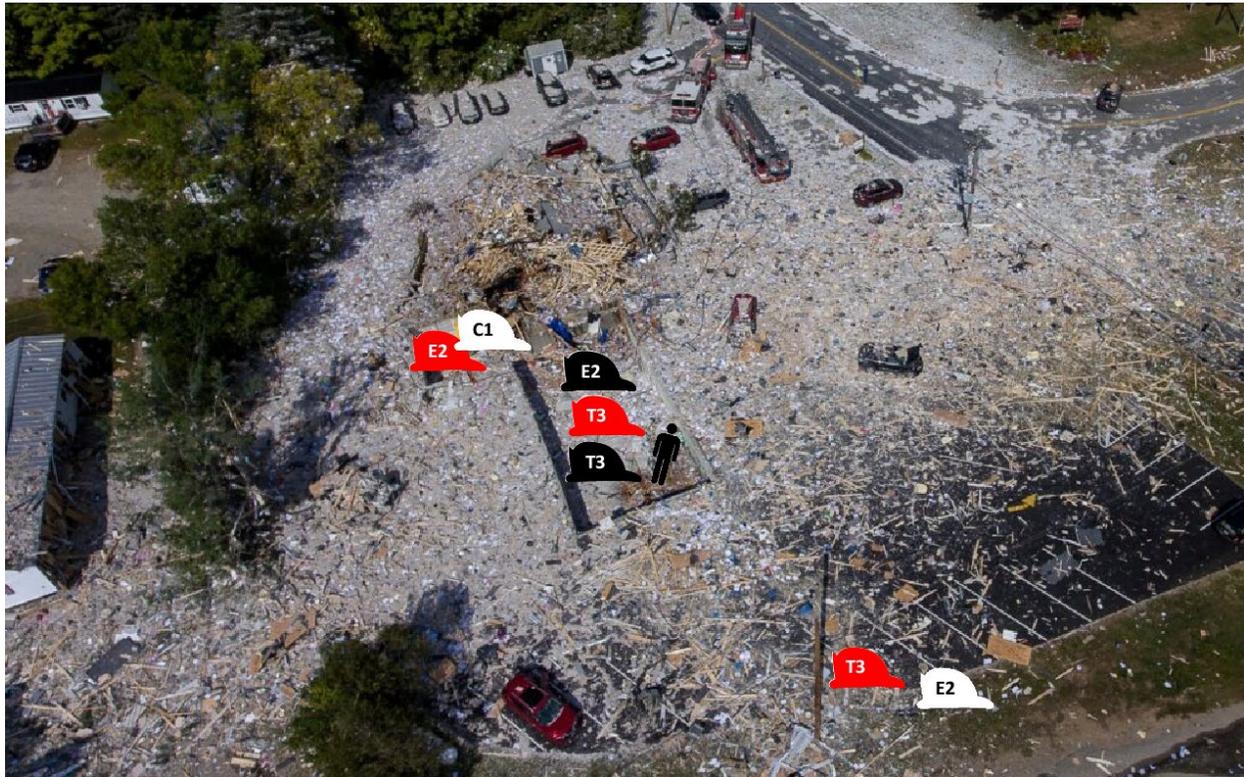
Figure 12. Victim Locations

Prior to the explosion, Captain Tim Hardy and Firefighter Joe Hastings (Tower 3) were in the basement with the maintenance supervisor, along with Firefighter Ted Baxter (Engine 2). Chief Terry Bell (Car 1) and the Captain Mike Bell (Engine 2) were on the 1st floor of the office building on Side Charlie. Deputy Chief Clyde Ross (Engine 2) and Captain Scott Baxter (Tower 3) were in the parking lot on Side Bravo.

Chief Bell and Captain Bell, Captain Hardy, Firefighter Hastings, Firefighter Baxter, and Maintenance Supervisor Larry Lord received thermal burns and traumatic blast injuries in the explosion and were initially trapped in the basement. Deputy Chief Clyde Ross and Captain Scott Baxter were in the parking lot on Side Bravo and were knocked down, suffering traumatic injuries.
