Death in the line of duty...

A summary of a NIOSH fire fighter fatality investigation

A Career Captain and an Engineer Die While Conducting a Primary Search at a Residential Structure Fire – California

Fatality Assessment and Control Evaluation Investigation Report # F2007-28

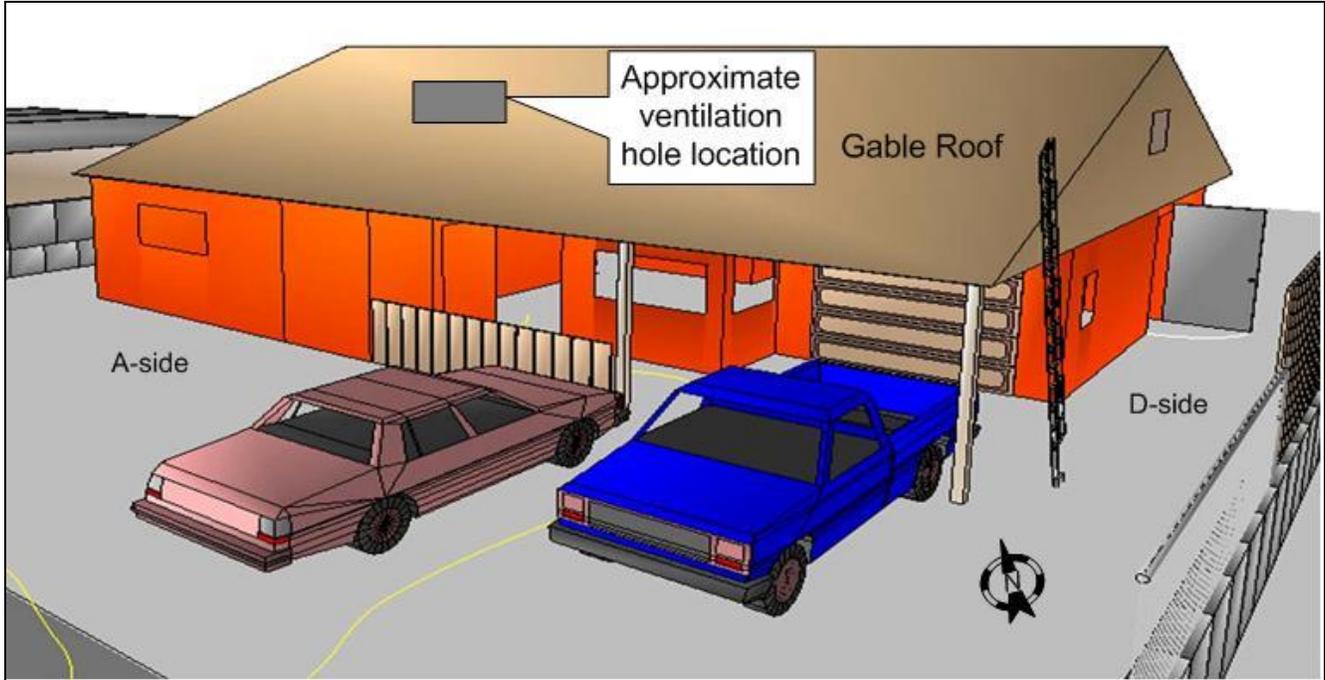
The crew from E69 laddered the D-side towards the front of the structure and then heard that the first civilian was found and was being removed from the structure (Figure 1). The E69 crew immediately went to the front porch to assist with removing the civilian to the front lawn area. *Note: The gas powered PPV fan was running facing the front door. The E69 officer noticed that the smoke conditions in the living room area were negligible at this time.*

Figure 1. Ladder location on D-Side of structure.

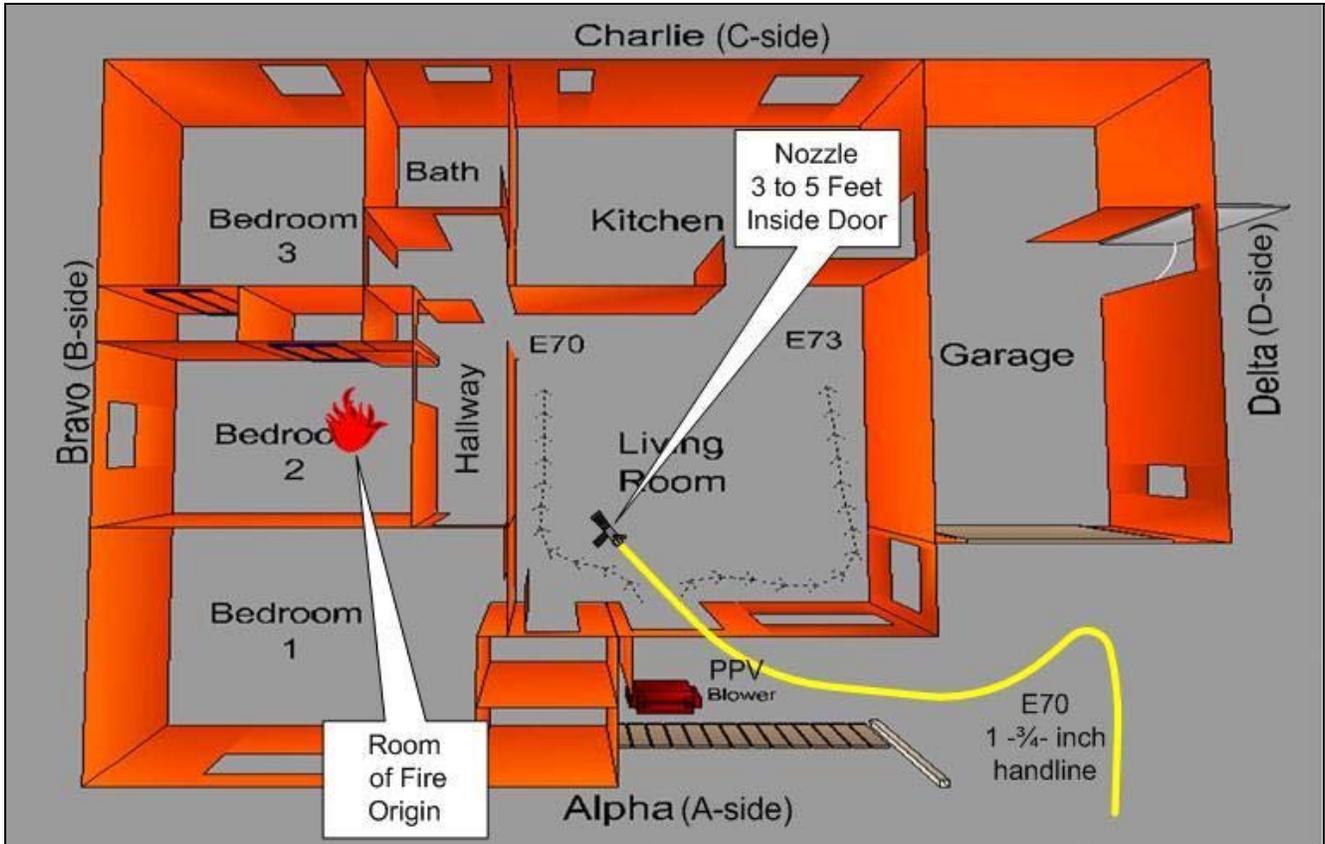
The fire originated in the Bedroom 2 (see Figure 2) where the two victims were found. It is believed to have started from improper disposal of smoking materials by the owners.

to confirm his request with Engine 69 (E69) while they were responding. The fire fighter from E73 went to retrieve the TIC. The E70 engineer told him that he would get it and directed him to help with hooking-up the hydrant. After assisting with the hydrant, the E73 fire fighter returned to make entry. The officer from E73 requested a positive pressure ventilation (PPV) fan from Engineer 70 because visibility was zero. The two victims were standing as they made entry through the smoke and proceeded to the left. The crew from E73 went to the right to search for the victims. The conditions were hot and visibility was near zero. (Figure 2).

In this incident, positive pressure was applied at the door on Side-A with the only exhaust opening being the large window in the living room which had broken out prior to the arrival of the first company. This potentially placed the search teams between the fire (in the bedrooms and hallway) and the exhaust opening (in the living room). In addition, no fire control action was being taken during the search as the hoseline deployed by E70 was unstaffed. Application of positive pressure without an adequate opening (in this case the opening may have been marginally adequate, but in a non optimal location) results in increased air supply to the fire, turbulence, and mixing of hot smoke (fuel) and air which can result in a fire gas ignition or ventilation induced flashover. It is not recommended to initiate positive pressure ventilation after firefighters enter the building⁸. If used post fire control, fire fighters should be withdrawn to a safe (uninvolved) area or out of the building while it is pressurized. If used in positive pressure attack, the building should be pressurized and the effectiveness of ventilation verified by observation prior to entry⁸.

Figure 2. Location of E70 nozzle, positive pressure ventilation, and search patterns of E70 and E73.

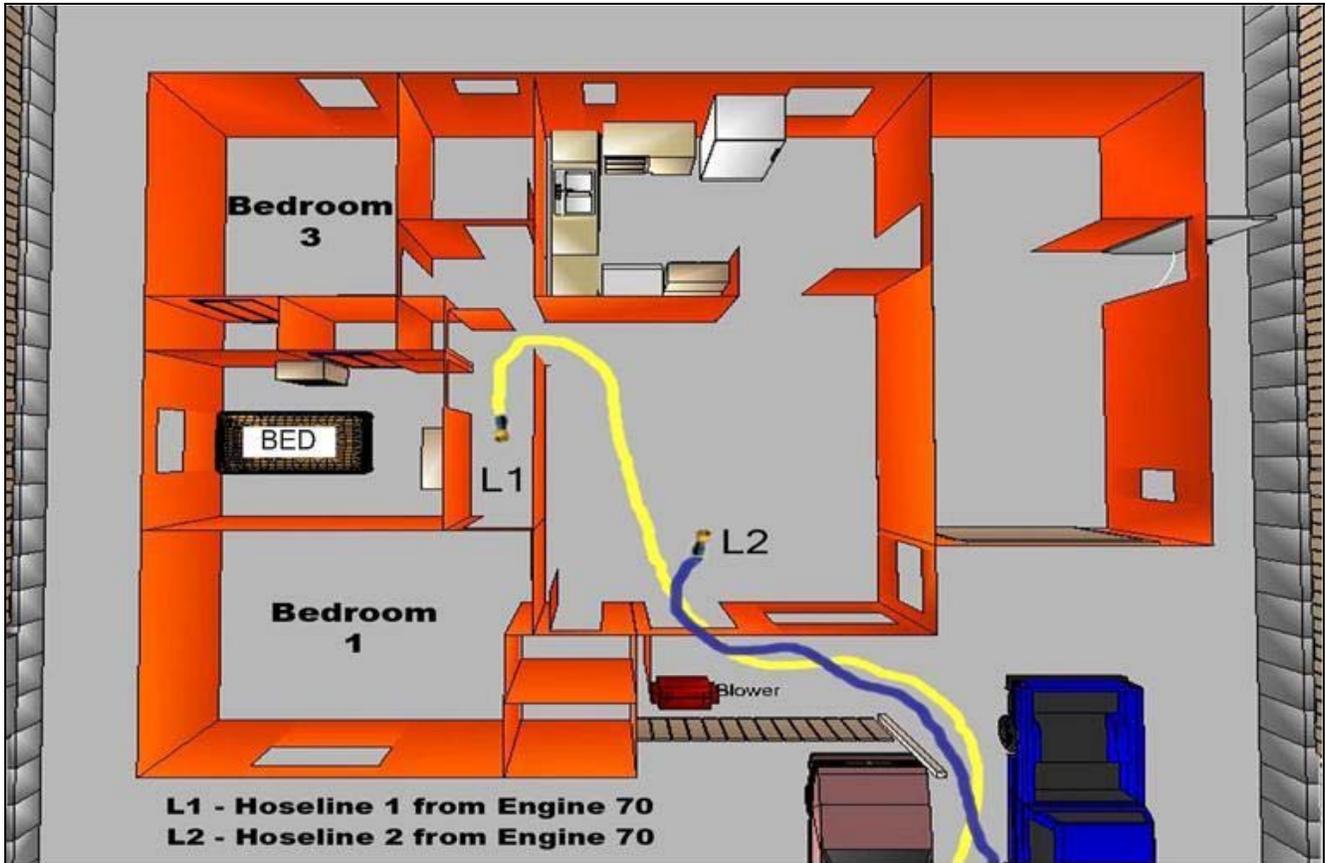
The Q76 officer was backing up his fire fighter on the nozzle as they fought fire around the corner and into the hallway leading into the bedrooms (Figure 3). They darkened down the fire in the middle bedroom and the captain scanned the area with his TIC and did not pick up anything on the screen. *Note: The crew from Q76 did not know that the victims were missing at this point. The crew did not hear any PASS devices.*

Figure 3. Hoseline locations from E70.

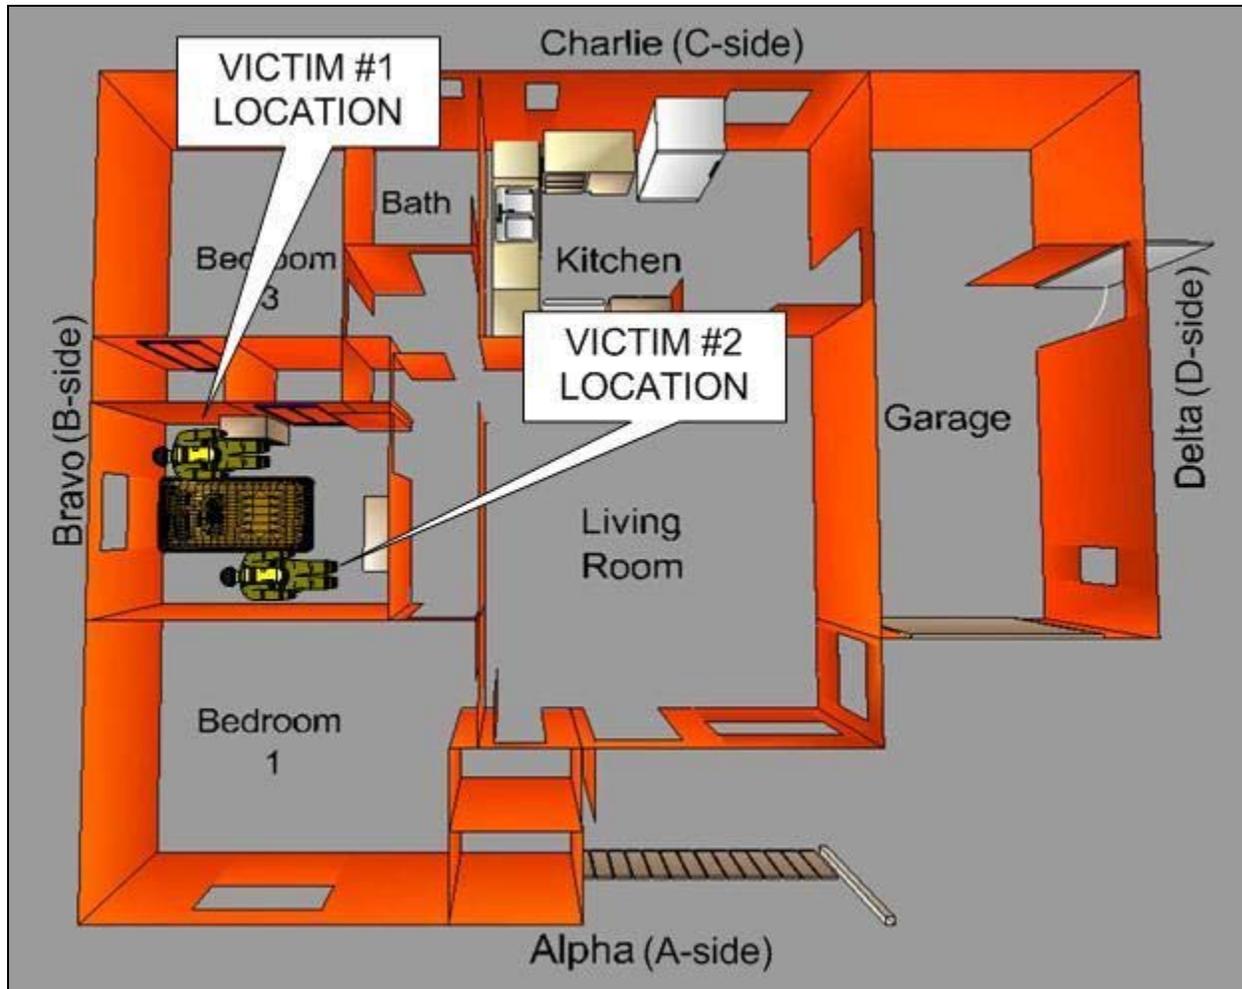
The E69 crew re-entered with a handline, but did not have a TIC with them. They proceeded into the hallway and bedroom areas and extinguished spot fires as they searched for the missing fire fighters and listened for any PASS devices. *Note: It is probable that the PASS devices did not function properly due to the heat and fire impingement.* The smoke was banked down to around neck level with good visibility below that level. The crew visibly searched the small bedrooms, but did not see the victims. The E69 officer exited to confirm his finding with the IC and to make sure the E70 crew was not outside. He went back inside and met-up with his crew in Bedroom #2. The crew was searching when the evacuation horns sounded at approximately 0221 hours. BC7 ordered the evacuation signal to conduct a personnel accountability report (PAR). They began to exit when the E69 engineer noticed Victim #1 in the right rear corner of Bedroom #2. They immediately began to remove Victim #1. FF76 and E68 crew assisted with the removal. BC 64 was on-the-scene at this time and was aware of a fire fighter missing, but not fully aware of the search operations taking place. Victim #2 was located on the left side of Bedroom #2 by the Q76 officer. Additional crews, including an automatic aid crew and BC 64 assisted with recovering the victim from the structure at approximately 0228 hours (Figure #4).

Figure 4. Location of victims in Bedroom #2.

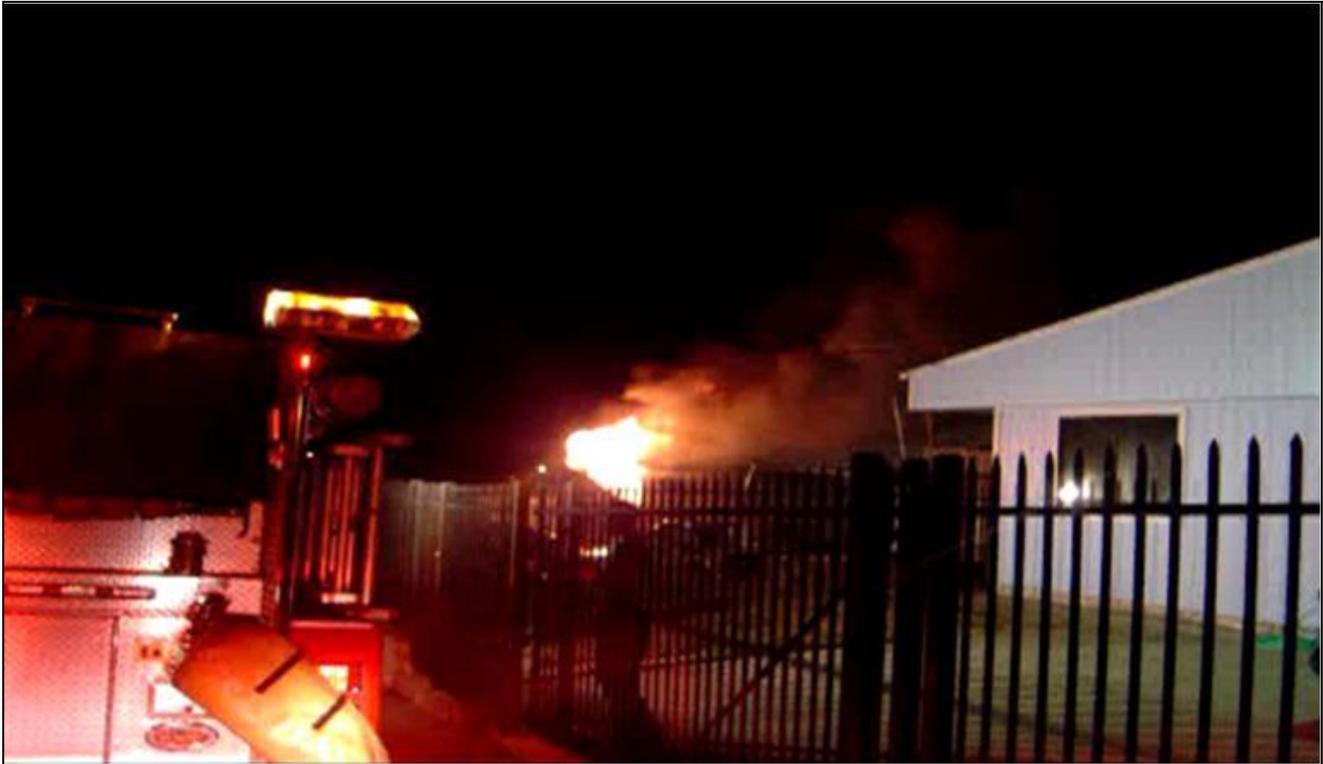
Quint 76 (Q76) arrived on-the-scene at 0159 hours. While the crew was donning their gear, the Q76 fire fighter took a photograph and a short video that showed a rapid fire event venting from the A-side bedroom window (Photo 1). The E73 fire fighter was administering care to the civilian on the front lawn when the rapid fire event occurred and he reported large amounts of fire venting from the front bedroom window for approximately 15 seconds. *Note: Members on the fire ground described the rapid fire progression as a sound resembling a tire exploding, which resulted in heavy flames shooting out from the front bedroom window.*

Photo 1. Flames exiting window on A-Side from rapid fire development.
(Photo courtesy of Fire Department.)

Fire Behavior Indicators & Conditions	Time	Response & Fireground Operations
<p>Bedroom window on Side-A, which had been cracked and venting smoke, failed suddenly (glass blew out onto the lawn) with a large volume of fire pushing from the window for 10-15 seconds. (Observed by E73 FF who was performing patient assessment on Side-A).</p> <p>Sudden increase in flaming combustion from the bedroom windows on Side-A and Side-B (captured on video by Q76 FF).</p> <p>Fire fighters reported that the rapid fire progress sounded like a tire exploding (possibly failure of the window on Side-A).</p>	<p>0200</p>	<p>E73 officer reentered through the door on Side-A to attack the fire in the hallway using the hoseline originally deployed by E70 crew. The E70 engineer pulled a second 150-foot 1 3/4-inch hoseline to the door on Side-A.</p>
	<p>0201</p>	<p>Vertical ventilation being performed by E69 (observed by Q76).</p> <p>Q76 advanced the second 1 3/4-inch hoseline into the building. E73 officer exited with his low air alarm sounding after handing the initial hoseline off to Q76. E73 officer expressed concern to his fire fighter that E70 would be low on air as well.</p>
