Revised on January 4, 2011 to add NPPTL SCBA Evaluation report.

Revised on December 8, 2014 to correct the building construction type (page 9).

Career Probationary Fire Fighter and Captain Die as a Result of Rapid Fire Progression in a Wind-Driven Residential Structure Fire – Texas

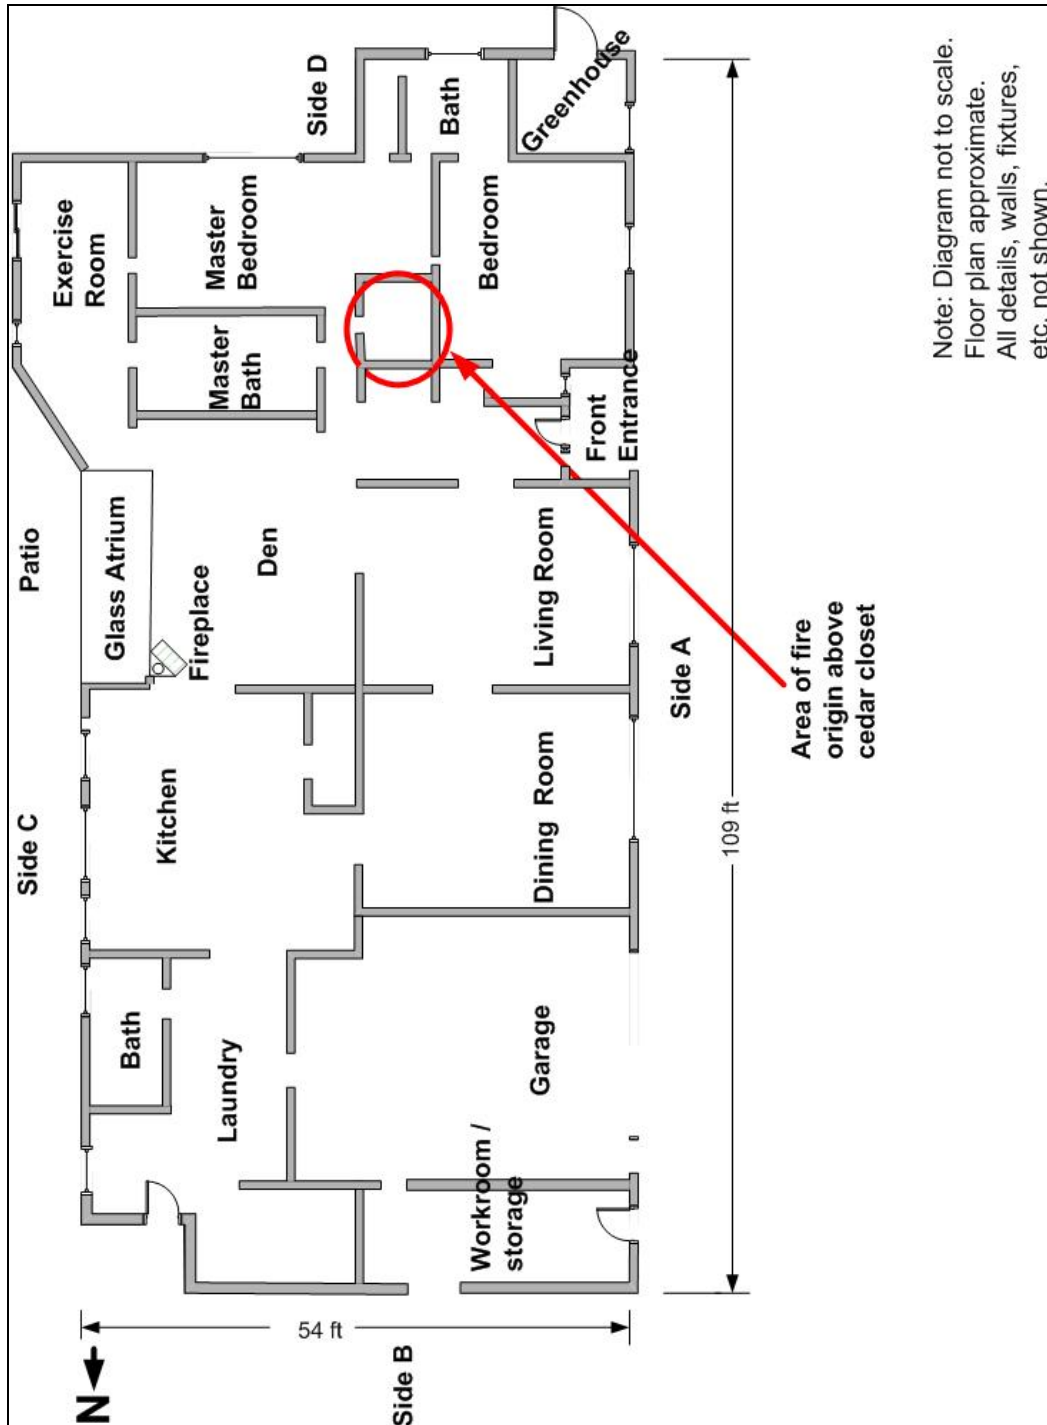
Diagram 2
Layout of residential structure

According to the arson investigator's report, the fire originated in the electrical wiring above a hallway closet near the master bedroom and was accidental in nature (see Diagram 2). It is unknown how long the fire burned before the residents observed fire in the closet and exited the structure.

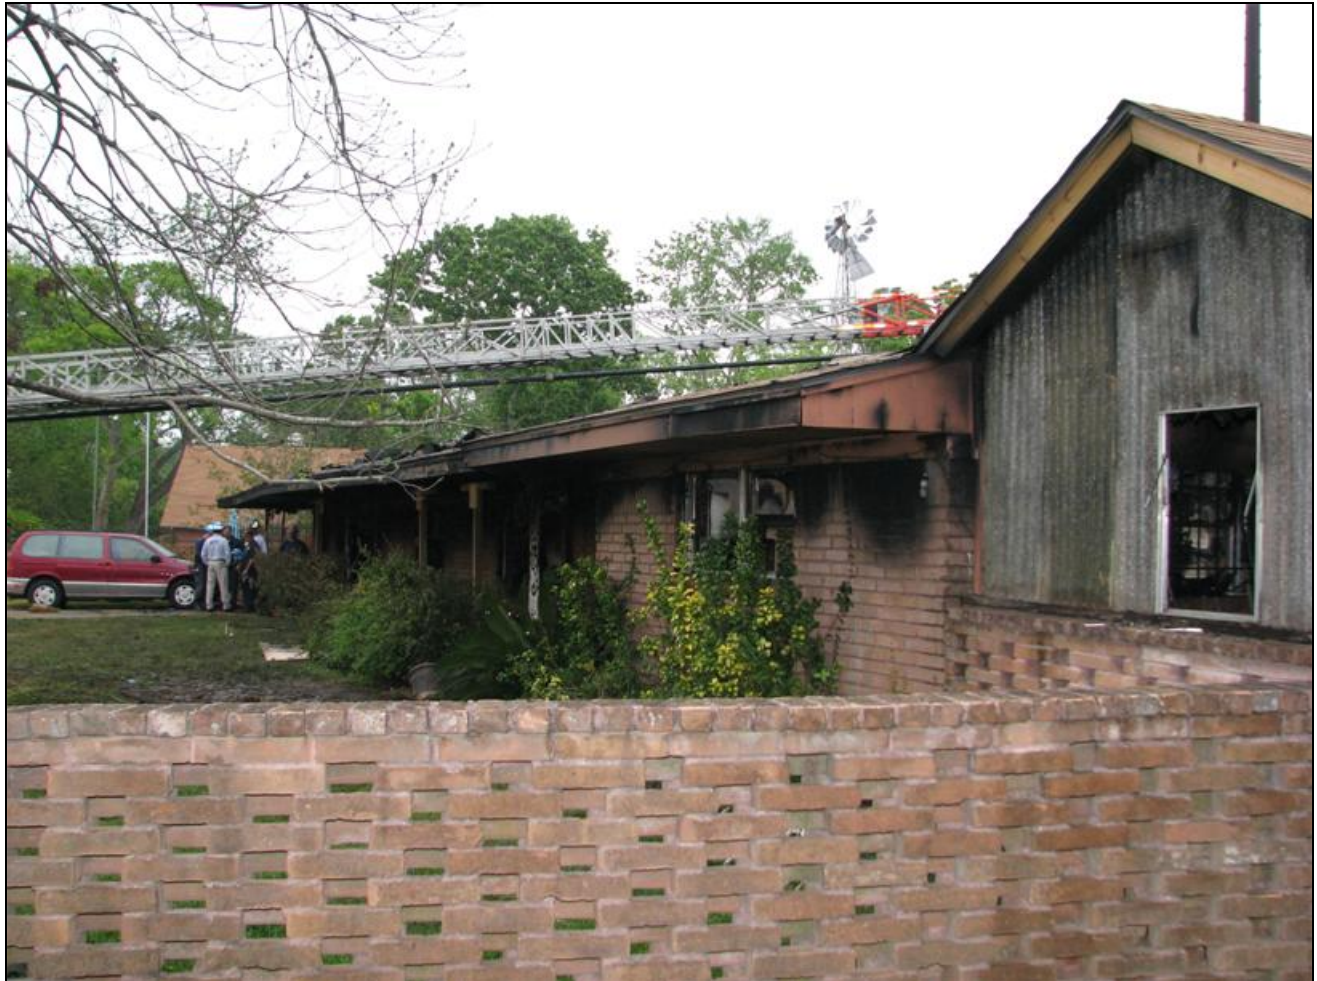
Photo 2:
Photo taken from the A-D corner of the fire structure shows how access to the D-side of the structure was limited by the masonry wall.
Photo provided courtesy of the fire department.

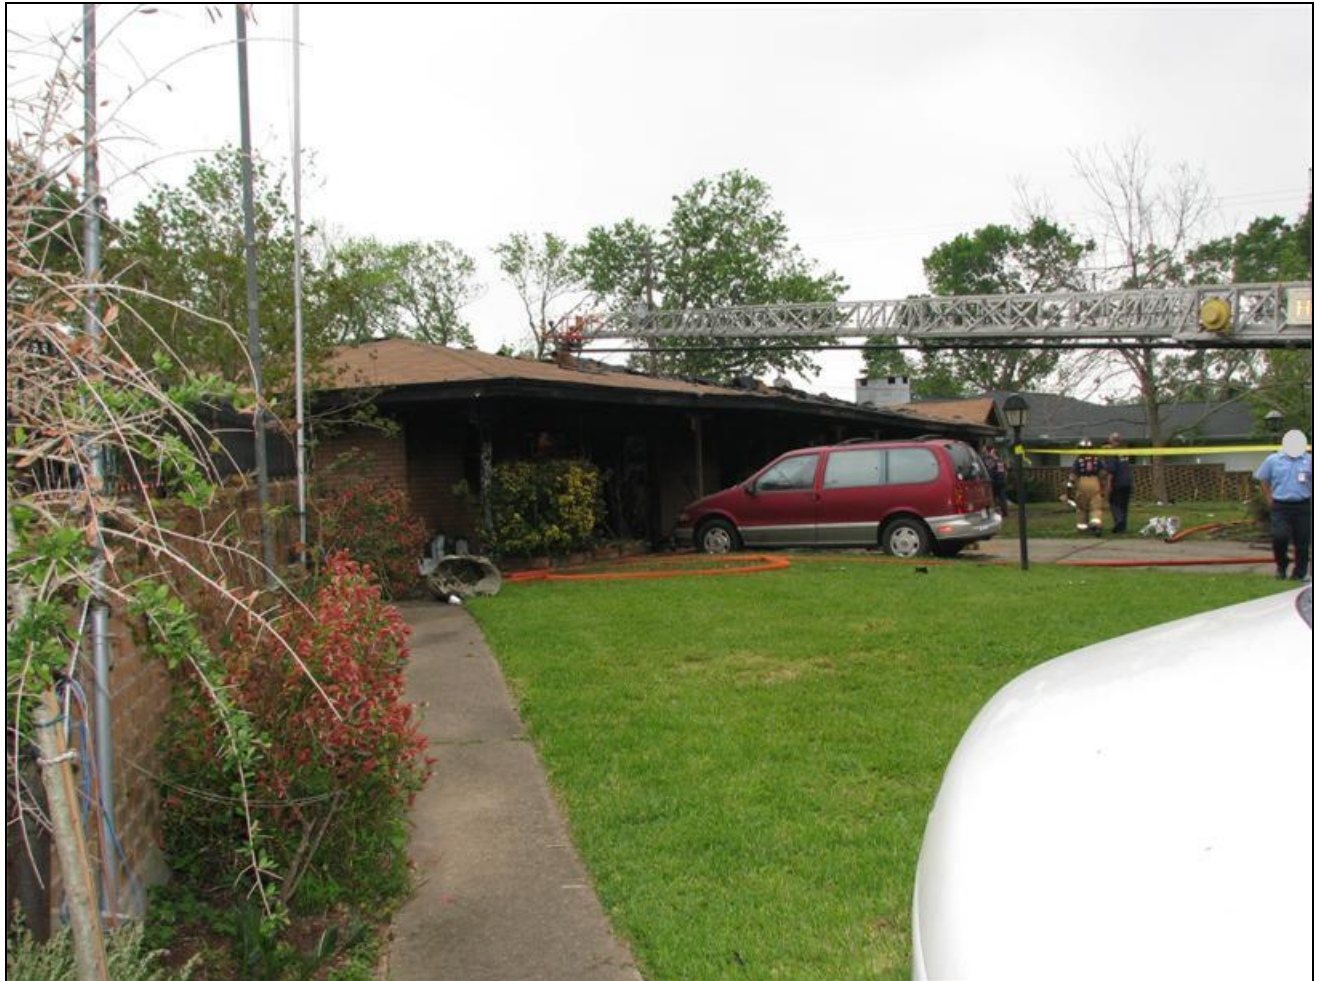
Photo 4:

Photo taken from A-B corner in front of structure shows how access to B-side of structure was limited by the masonry and chain link fences enclosing the rear of the house.

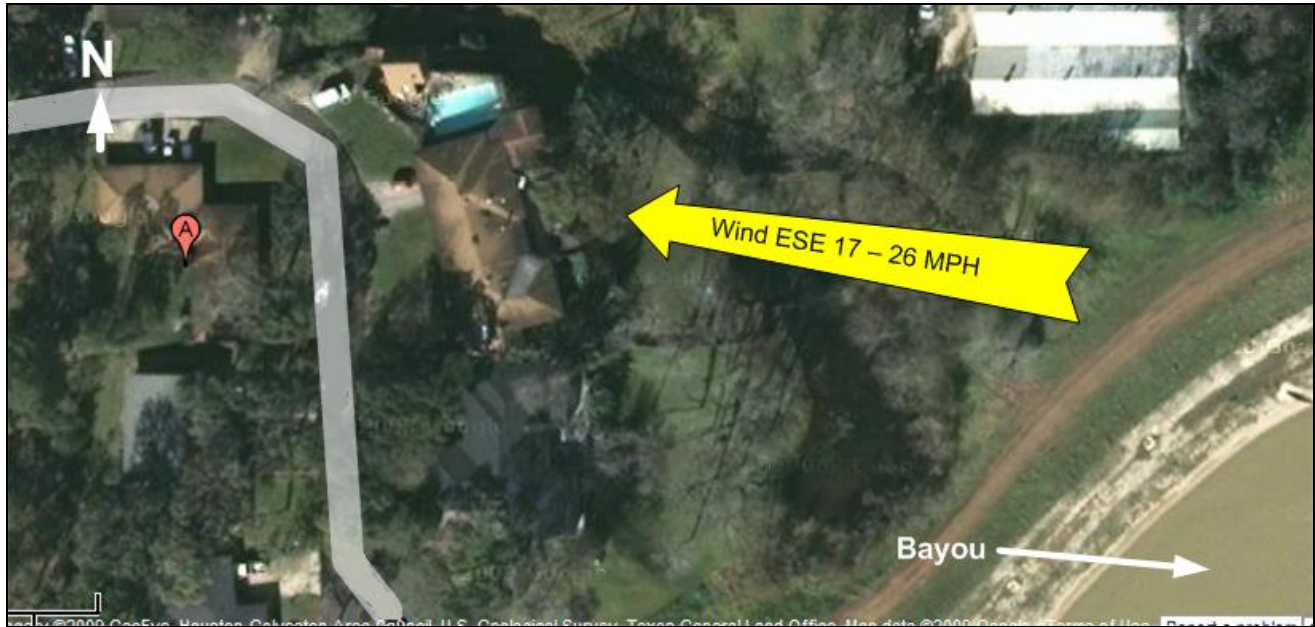
Diagram 3

Satellite view of property showing proximity to bayou and wind direction at time of fire. Wind speeds were recorded at 17 to 26 miles per hour from the east - southeast.¹⁰

High winds may have been a contributing factor in this incident. At the time of the fire, weather conditions in the area included a temperature of 69 degrees Fahrenheit (21 degrees Celsius), 68 to 75 percent relative humidity, with sustained winds from the east / south-east at 17 miles per hour (mph) (27 km/hr) gusting to 26 mph (42 km/hr).¹⁰ Fire fighters interviewed by NIOSH investigators reported changing winds during the incident. At times, smoke blew across the street obstructing vision in front of the fire structure. Wind from the east / southeast was blowing against Side-C of the structure, increasing the air pressure on Side-C in relation to Side-A. After crews opened the front door, any failure of windows or self ventilation on Side C would have provided a flow path for hot gases and flames to be pushed by wind from Side C through the entrance on Side-A (see Photo 1 and Diagram 4). Research by the National Institute of Standards and Technology (NIST) has shown wind speeds on the order of 10 to 20 mph (16 to 32 km/hr) are sufficient to create wind-driven fire conditions in a structure with an uncontrolled flow path.¹¹

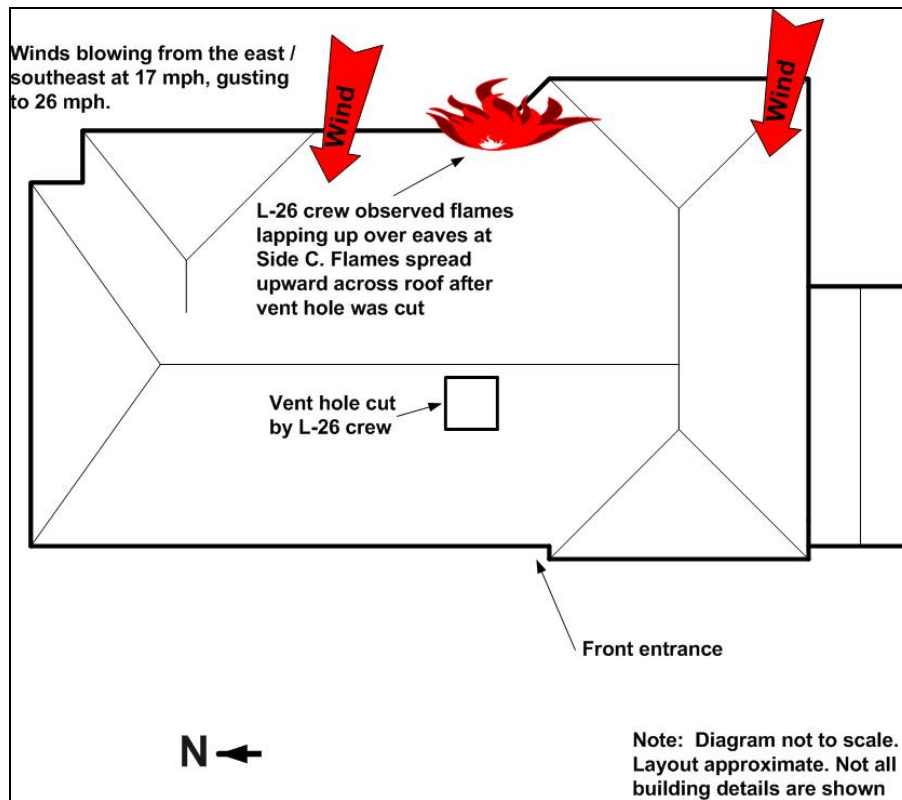
Diagram 4
Approximate location of roof vent hole cut by L-26 crew. Also see Diagram 1.

The L-26 captain observed fire coming from a roof vent that was located on the back side of the roof and near the ridge line between the front door and D-side of the house. *Note: This may have been a vent or skylight over the master bathroom.* The L-26 captain surveyed the roof as an L-26 fire fighter began to cut a ventilation hole on the front side of the roof located above and to left of the front door. Fire was observed coming through the cut just behind the saw. The L-26 captain also observed a small amount of fire (approximately 1-2 feet wide) lapping up over the eave at the back (C-Side) of the roof below him (see Diagram 4). As the ventilation cuts were being finished, the IC radioed the

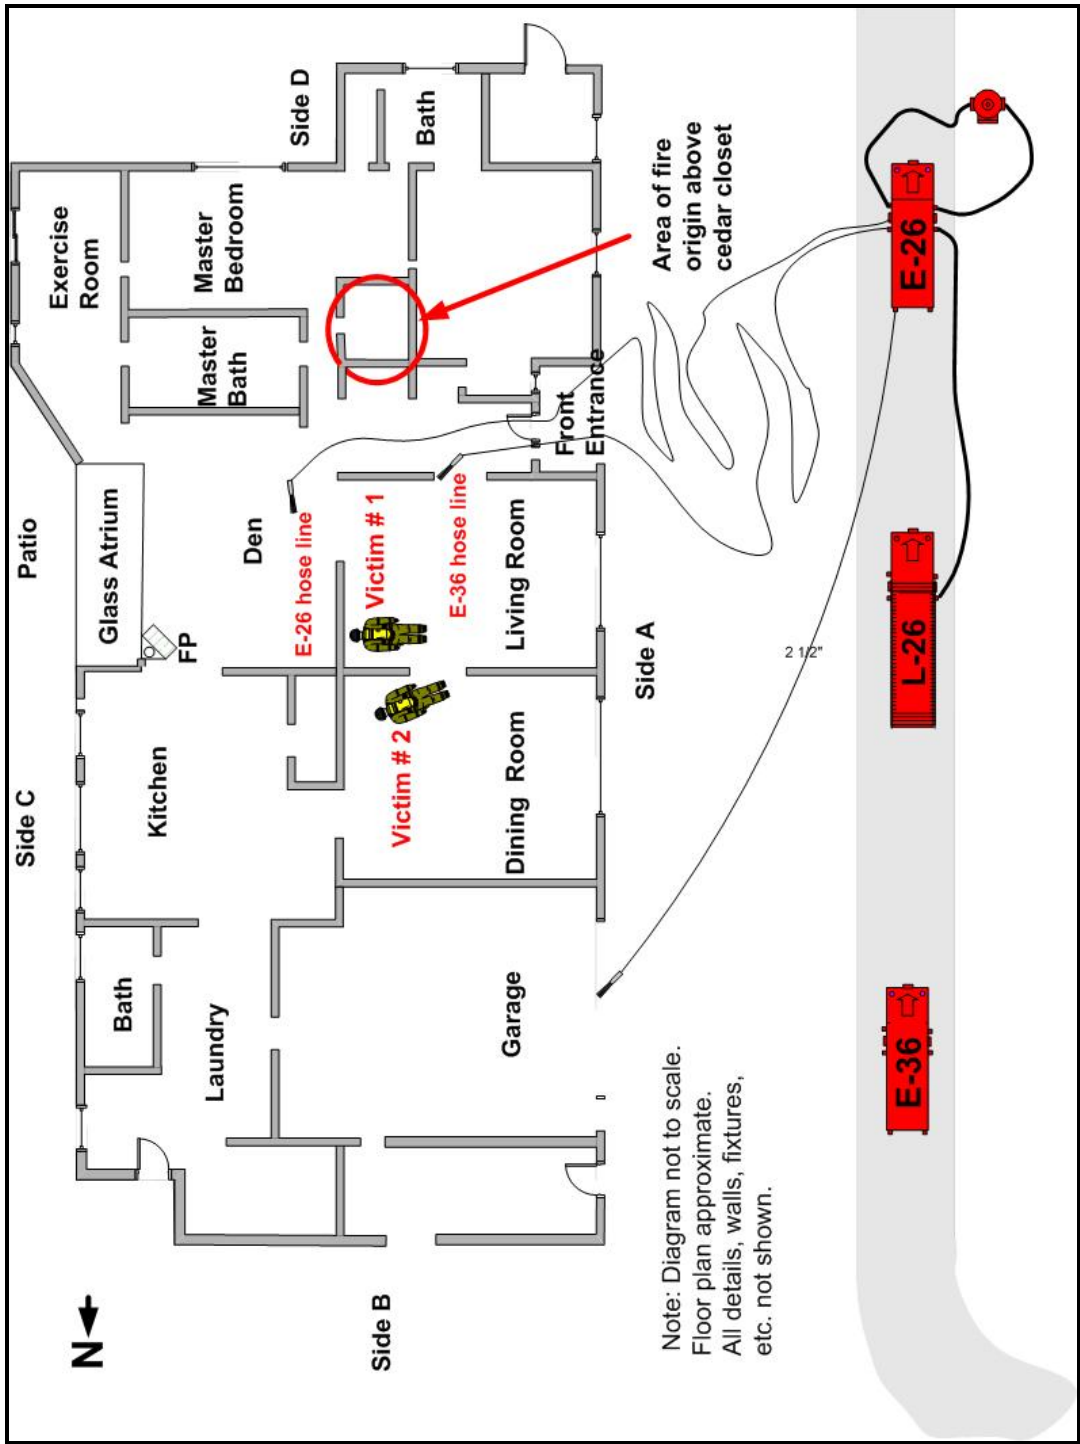
Diagram 5

Diagram shows location of initial attack lines and locations where victims were found.

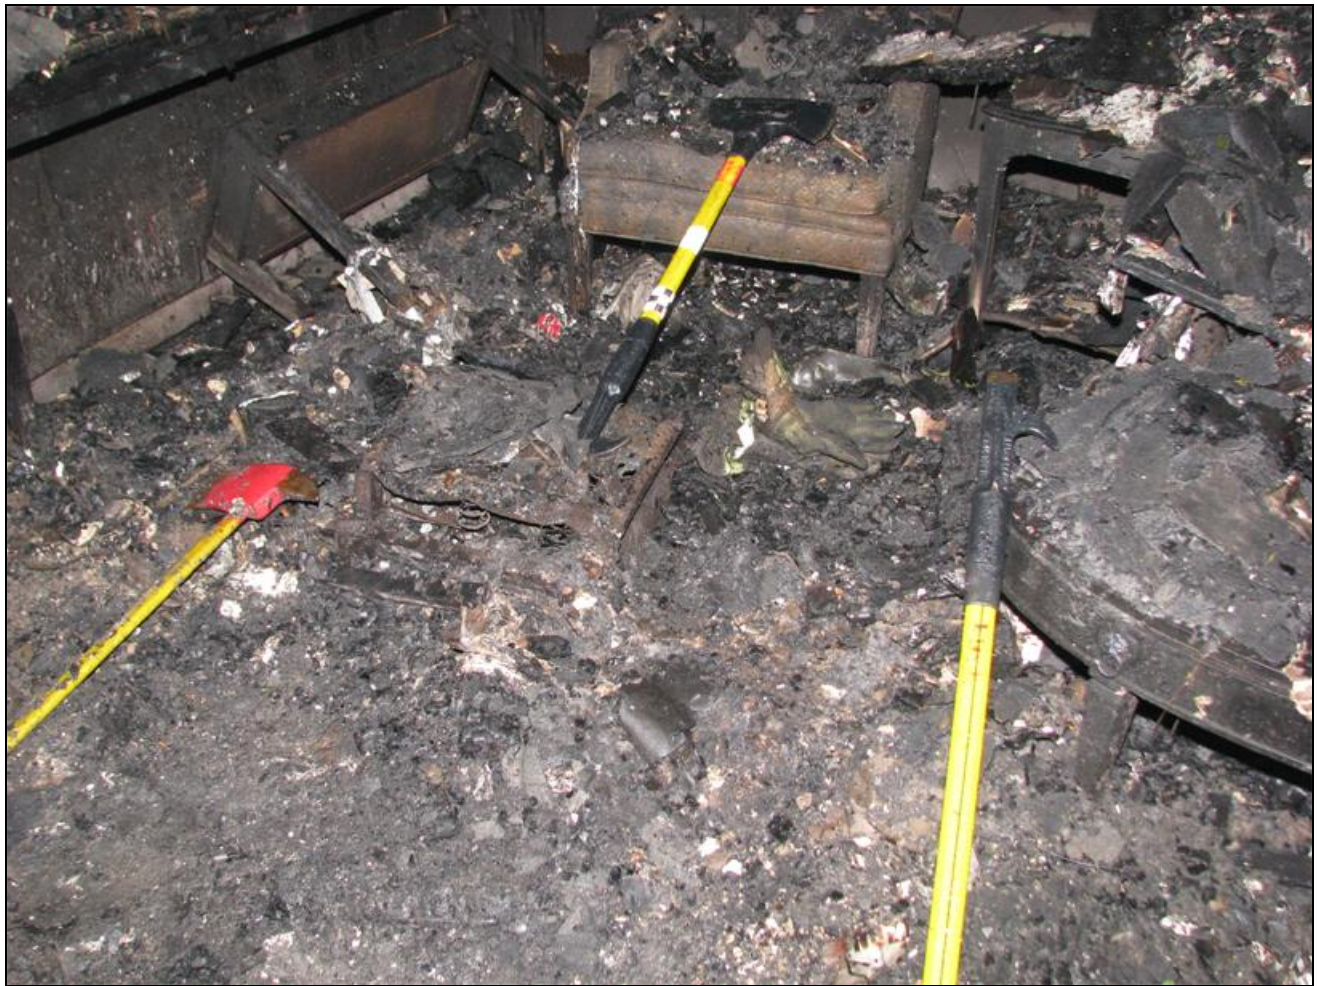
Photo 5:

Photo shows location where Victim # 1 was located in living room. The middle tool marks location where victim was found slumped against the chair at top of photo. Note that the upholstery on the chair is not burned, indicating that a flashover did not occur in this area.

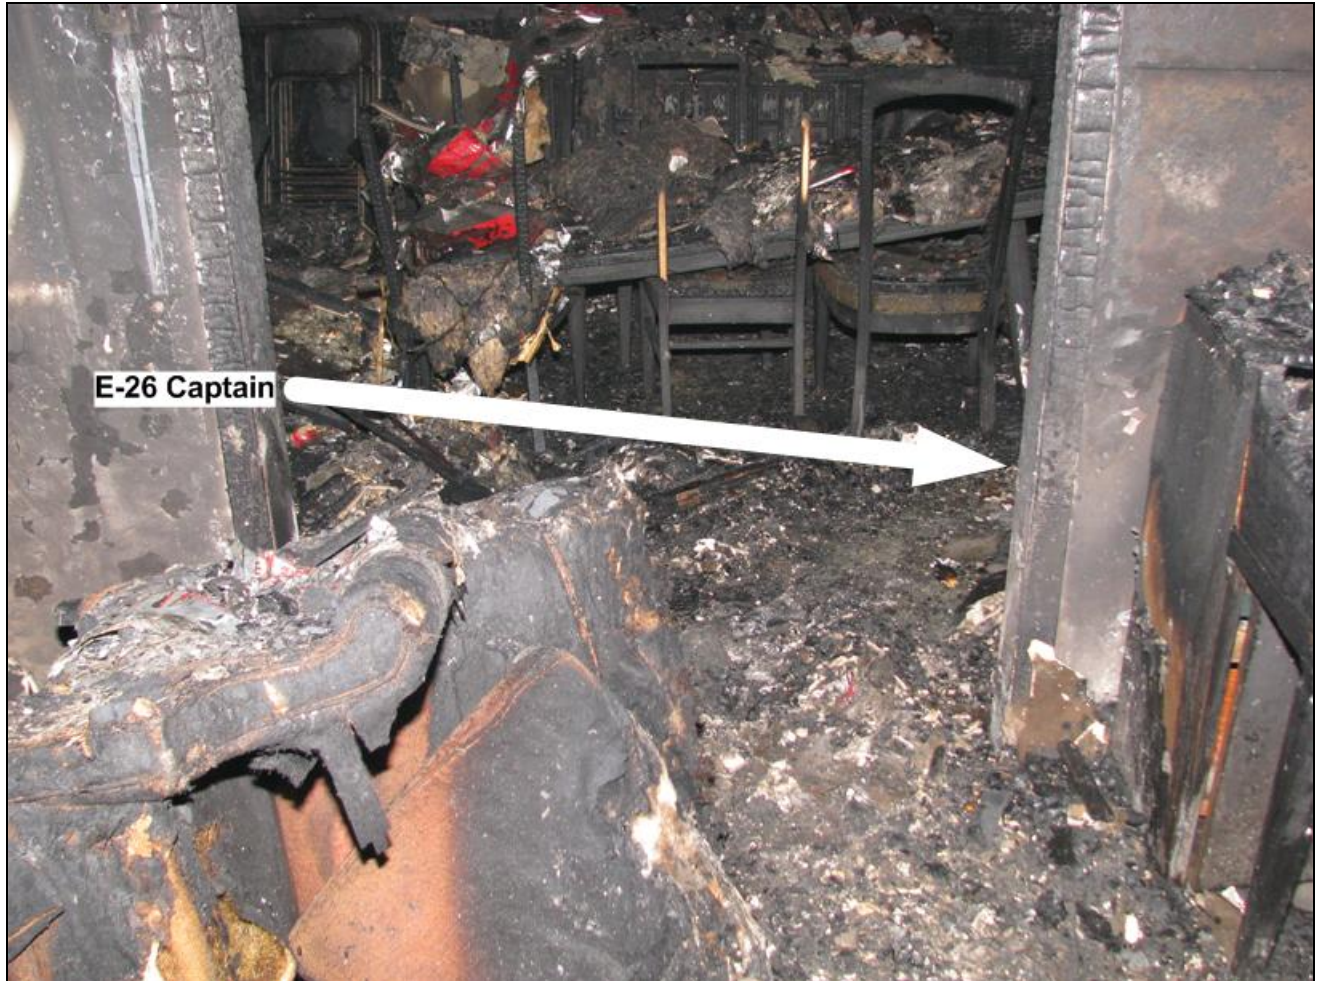
E-26 Captain

Photo 6:
Photo shows location where Victim # 2 was located in dining room just through doorway separating the dining room from the living room.
Photo provided courtesy of the fire department.

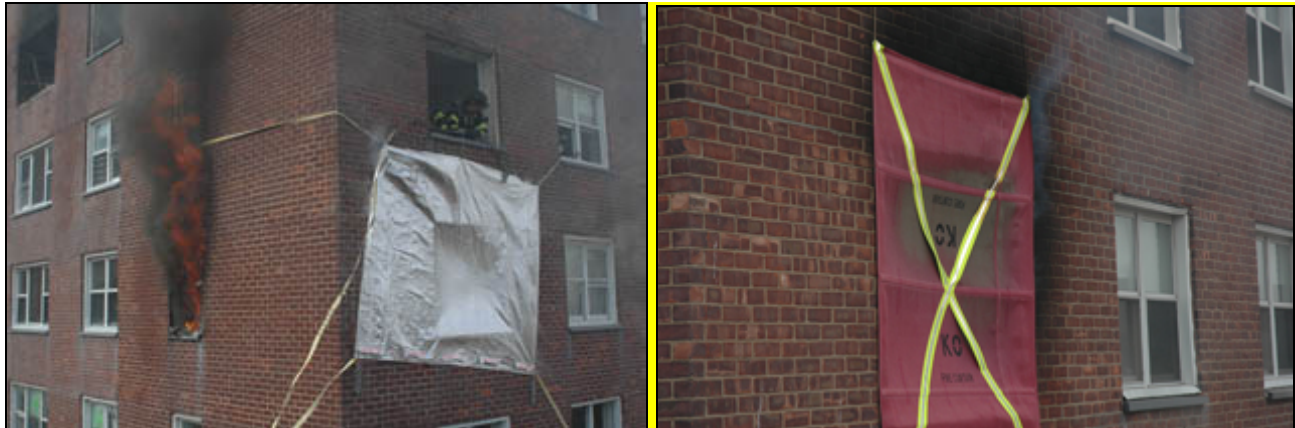
Photo 7

Two different types of Wind Control Devices being used to decrease the wind fed to the fire.
Photos adapted from NIST Report TN 1629¹¹

Incident commanders and company officers should change their strategy when encountering high wind conditions. An SOP should be developed to include obtaining the wind speed and direction, and guidelines established for possible scenarios associated with the wind speed and the possible fuel available, similar to that in wildland fire fighting.²² Under wind-driven conditions an exterior attack from the upwind side of the fire may be necessary to reduce fire intensity to the extent that fire fighters can gain access to the involved compartments. If the fire is on an upper floor, this method may require the use of an aerial or portable ladder. In addition to exterior attack from upwind, use of a wind control device to cover ventilation inlet openings on the upwind side may also aid in reducing wind-driven fire conditions (see Photo 7).¹¹
