In-Station Training

TM 24-39 Chemical Incompatibility

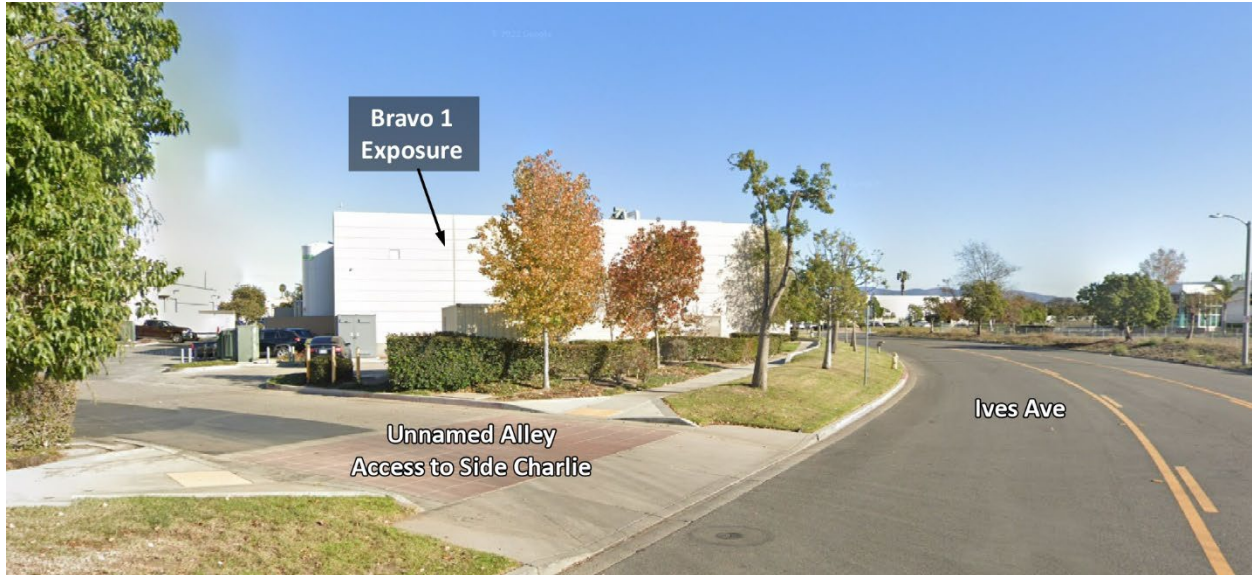
Note: Adapted from Google. (2022d). [Street view, 1721 Ives Avenue in Oxnard, CA]. <https://bit.ly/3XkgYNY>.

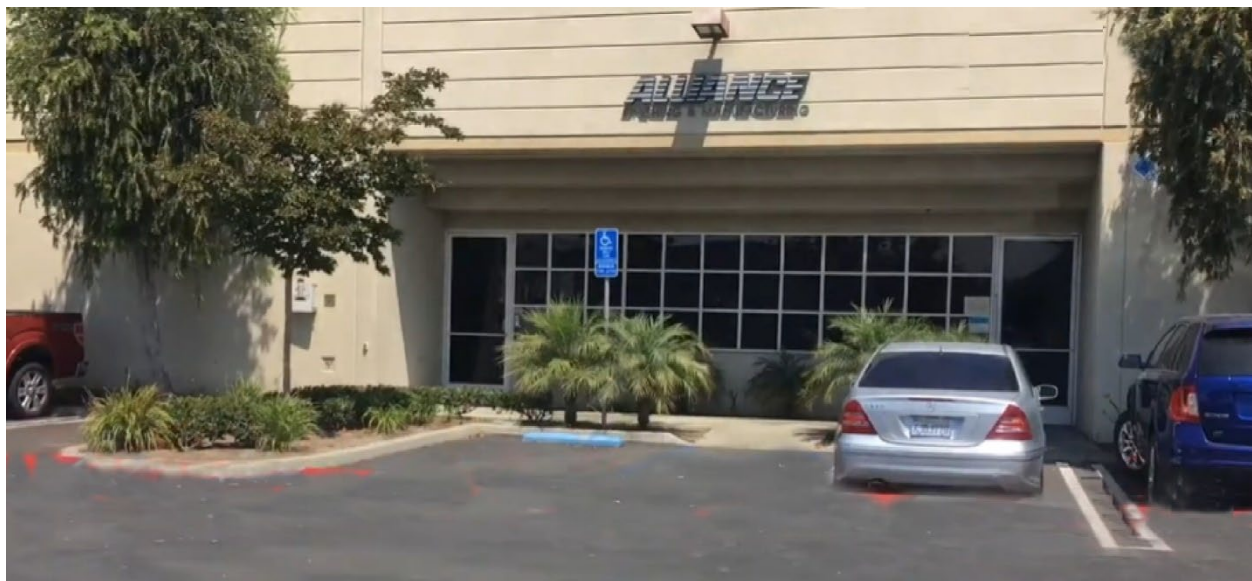
Note: Adapted from Google. (2022e). [Street view, 1721 Ives Avenue in Oxnard, CA]. <https://bit.ly/3StlKFC>.

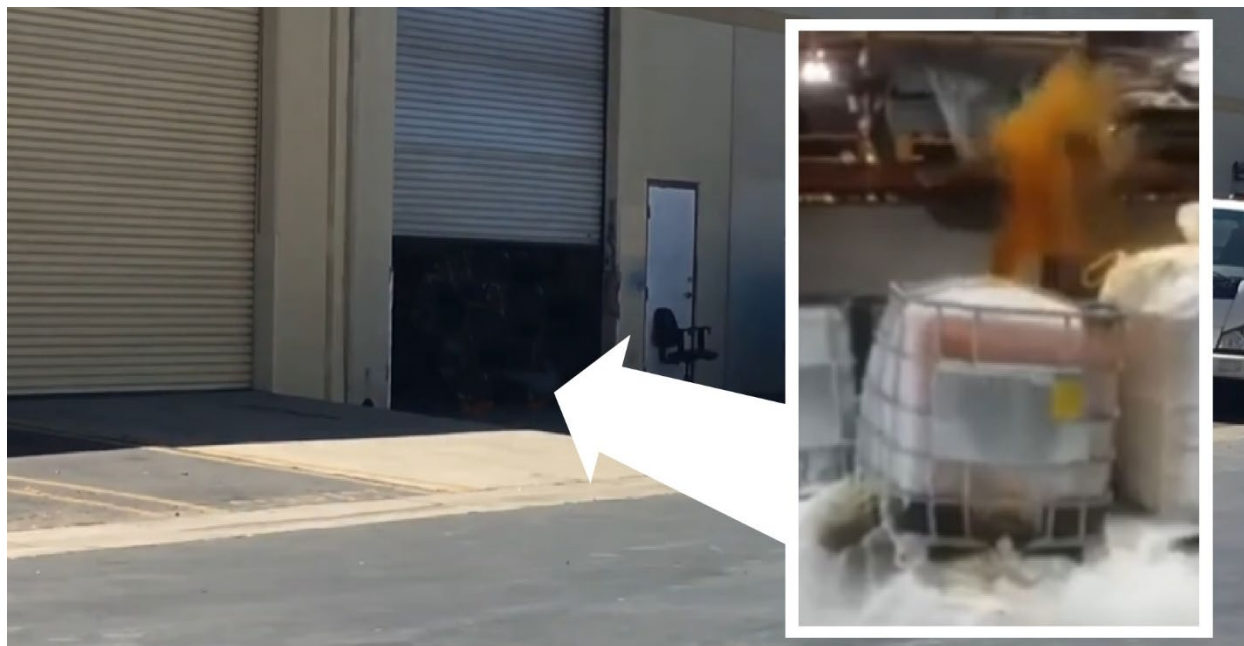
Note: Adapted from Michael M Films. (2019). *Oxnard hazmat incident*. Retrieved August 27, 2024, from <https://bit.ly/3StlKFC>.
