In-Station Training

TM 24-30a Residential Fire with Entrapment

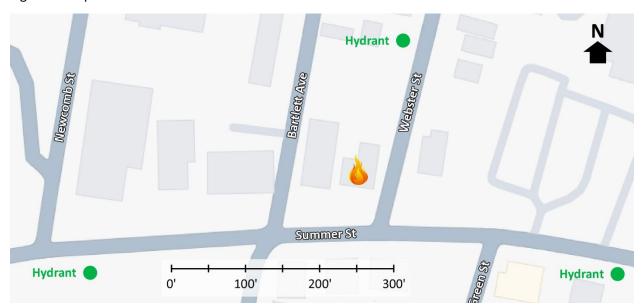
The closest hydrant is north of the incident location on Webster Street. Additional hydrants are east and west of the incident location as illustrated in Figure 1.

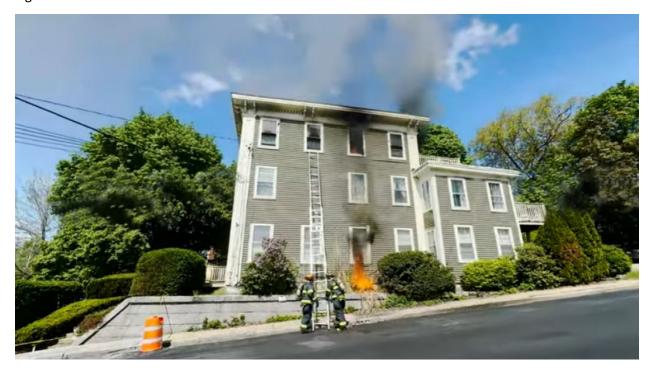
Figure 5. Conditions on Arrival of Chief 1

Watch the first 00:35 of the <u>incident video</u> (Jarvi Productions., 2024) and examine Figure 8 illustrating conditions on your arrival.
