In-Station Training

TM 24-42a Residential Attic Fire

Attic fires are generally ventilation-limited and present potential for rapidly changing fire conditions as well as ceiling or roof collapse. These fires can be challenging due to building construction characteristics and limited access.

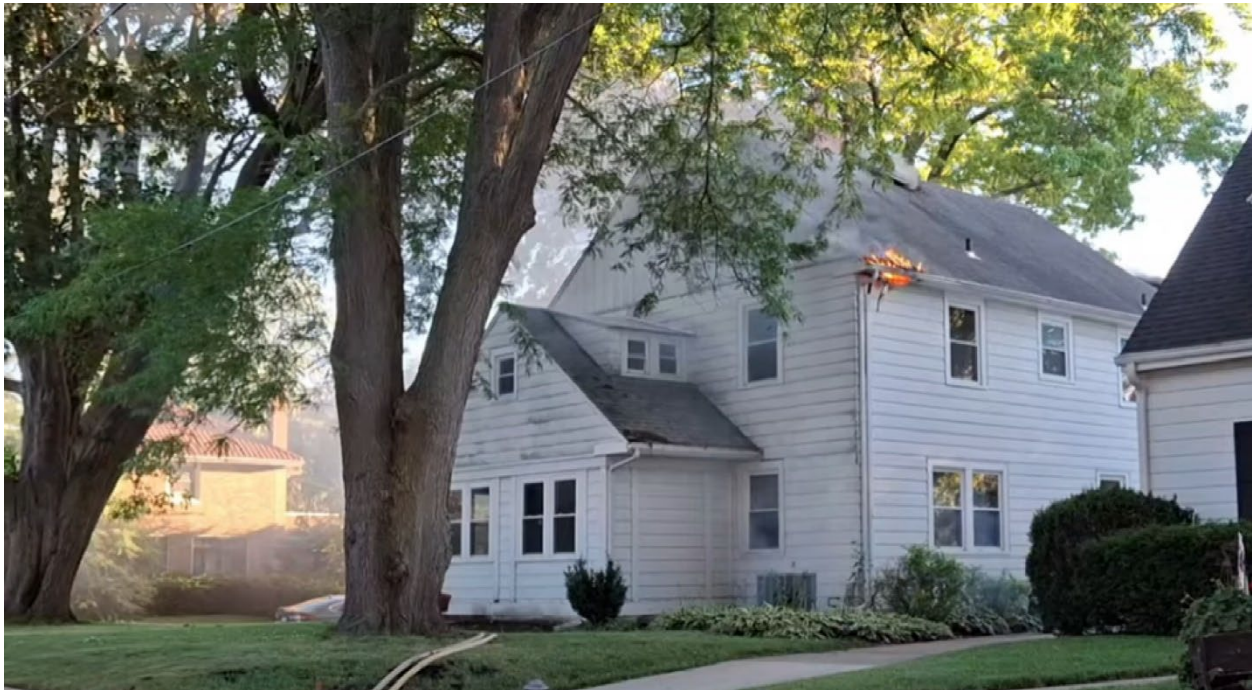
Figure 7. Conditions on Sides Charlie and Delta

Watch the [incident video](#) (Eye on News, 2024) from 00:25 to 01:15 and examine Figure 7 illustrating conditions as you arrive from the north on 1st Avenue.
