In-Station Training

TM 25-12a Residential Fire

Purpose

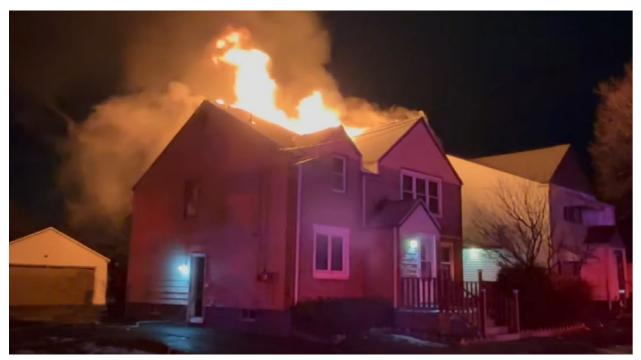
Figure 8. Conditions on Arrival

Watch the <u>incident video</u> from 01:00 to 01:15 and examine Figure 8 illustrating conditions on your arrival.

All clear in the basement with no involvement, the house appears to be vacant with heavy fire on Floor 2 and the attic, applying water with limited effect, if no progress in the next couple of minutes will need to withdraw.

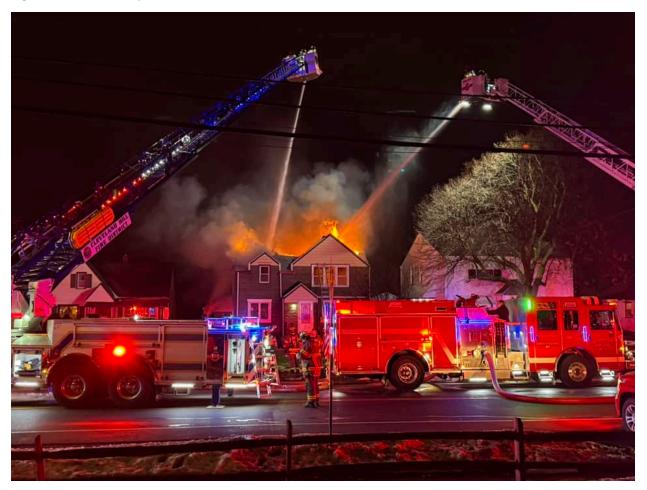
Figure 9. Defensive Operations

Due to structural compromise of the roof and extent of the fire on Floor 2 and in the attic, companies operating at this incident shifted to a defensive strategy. Two elevated master streams were used for defensive fire control as illustrated in Figure 9.

17. In this incident, the incident commander proactively assigned ladder companies to position for ladder pipe operations prior to making a strategic shift to defense. How might this contingency planning have increased the efficiency of the strategic shift from offense to defense?

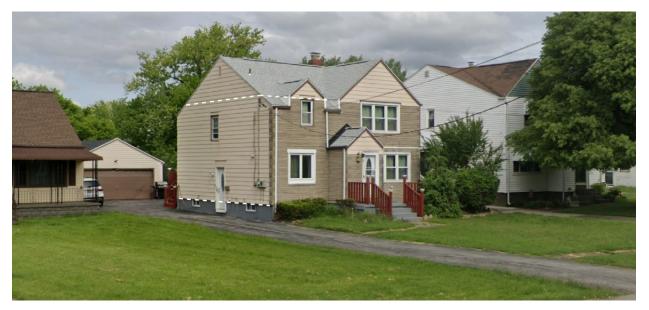
Figure 10. Alpha/Bravo Corner

Additional Learning: Reading the building and anticipating interior layout and configuration are important skills for everyone operating on the fireground. In this incident, the door on Side Bravo had been kicked in prior to the arrival and the first line was stretched through this open door. Examine Figure 10 and give some thought as to what level of the house the door on Side Bravo provided access

to (Basement or Floor 1). What area of the house do you think the window on Side Bravo is in? What factors lead you to these assumptions?

Does this inform your assumptions regarding the exterior door and window on Side Bravo? Where to you think the stairs between the Basement and Floor 1 are located? How would this have impacted the first arriving engine's hose stretch and time to water on the fire?

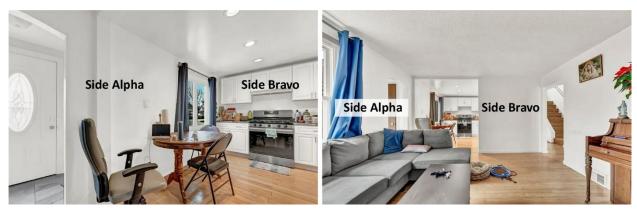
Figure 11. Interior-Livingroom, Kitchen, and Stairway

Examine Figure 11 illustrating the location of the interior stairs from Floor 1 to Floor 2.
