In-Station Training

TM 25-48a Church Fire

Chief Ed Hartin

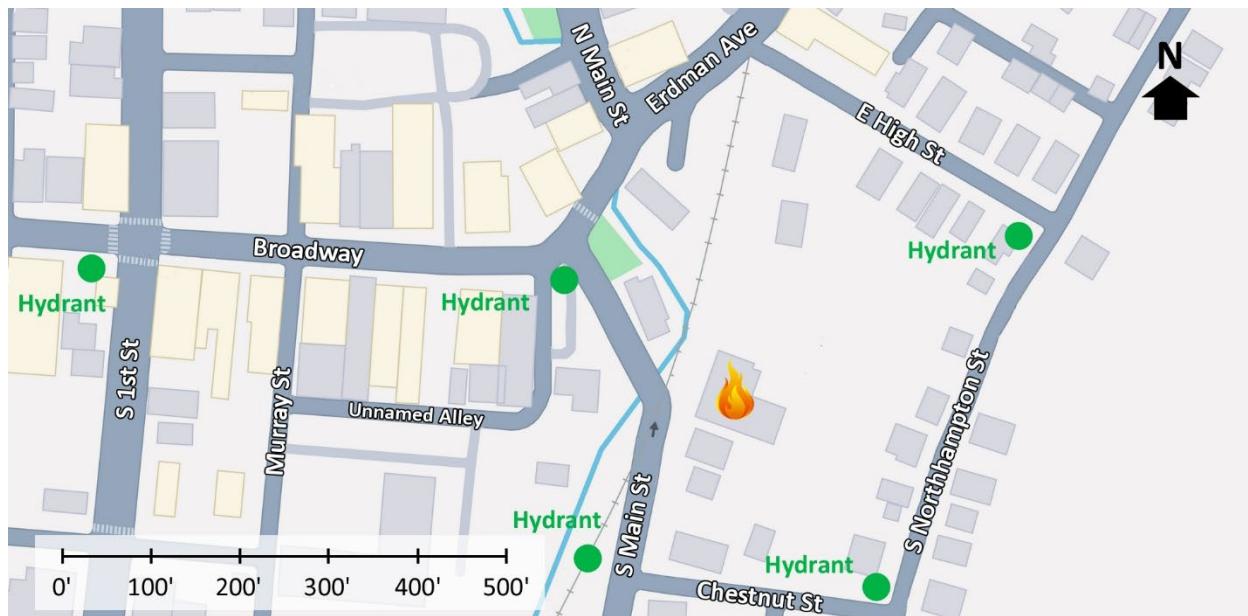
Figure 1. Map of the Incident Area

There are two nearby fire hydrants at the intersections of South Main Street and Chestnut Street and South Main Street and Broadway. Additional hydrants are in the area as illustrated in Figure 1.

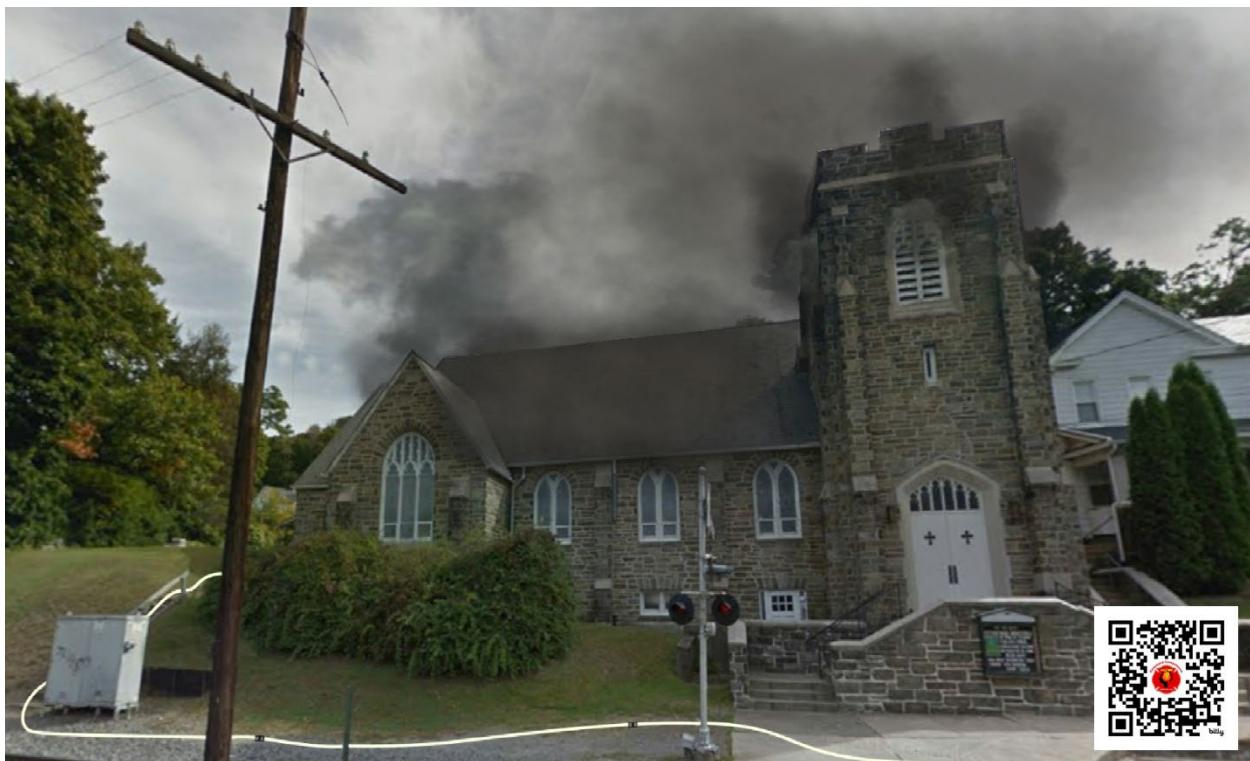
Figure 7. Conditions on Arrival

The fire involves the basement under the rear section of the church applying water from the exterior with good effect. Air status 75%, need to get companies with attack lines into Floor 1 to cut off extension into the sanctuary.

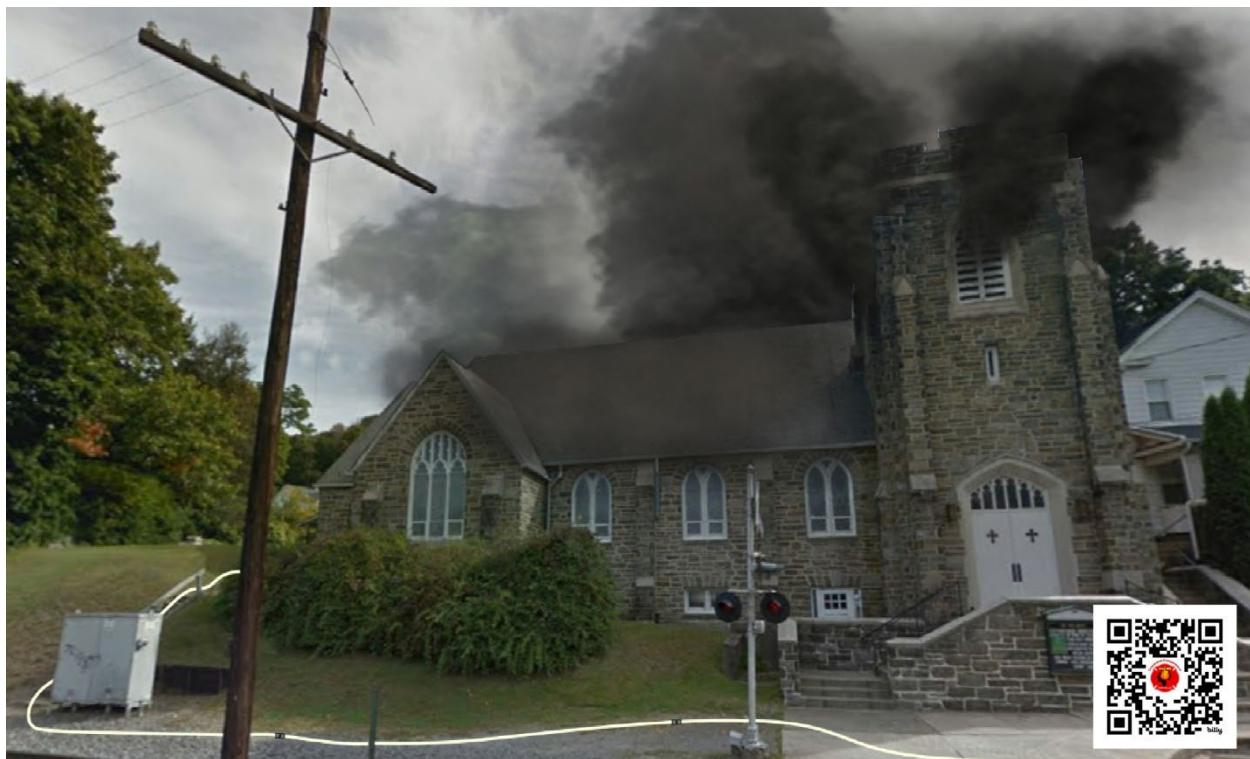
Figure 8. Changing Conditions

Having difficulty accessing the fire, zero visibility, temperature increasing. Need a company with a second attack line to assist with locating the fire and fire control in the basement.
