In-Station Training

TM 25-50 Residential Fire

Garage fires present a wide variety of hazards including vehicle fires inside the garage, storage of flammable liquids and gases. Depending on building configuration, attached garages present a risk of extension to living areas adjacent to or above the garage.

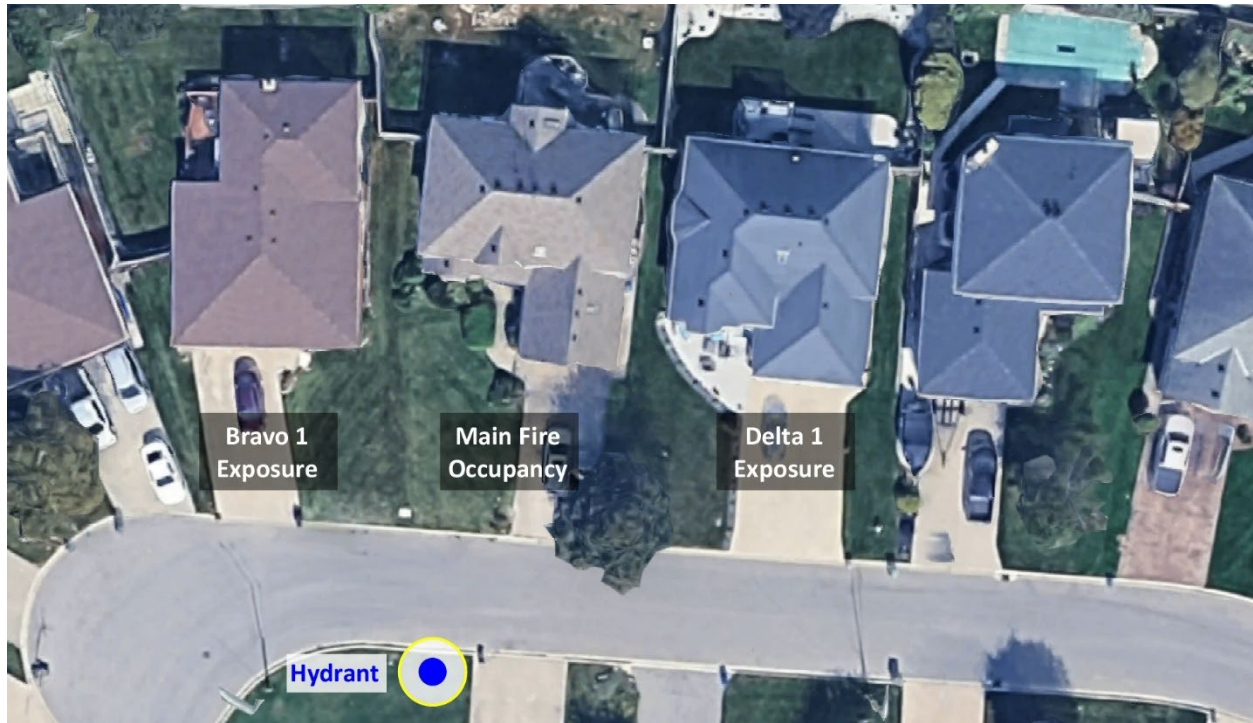
Figure 2. Aerial View

There is a hydrant directly across the street from the incident location and there are additional hydrants in the area as illustrated in Figures 1 and 2.

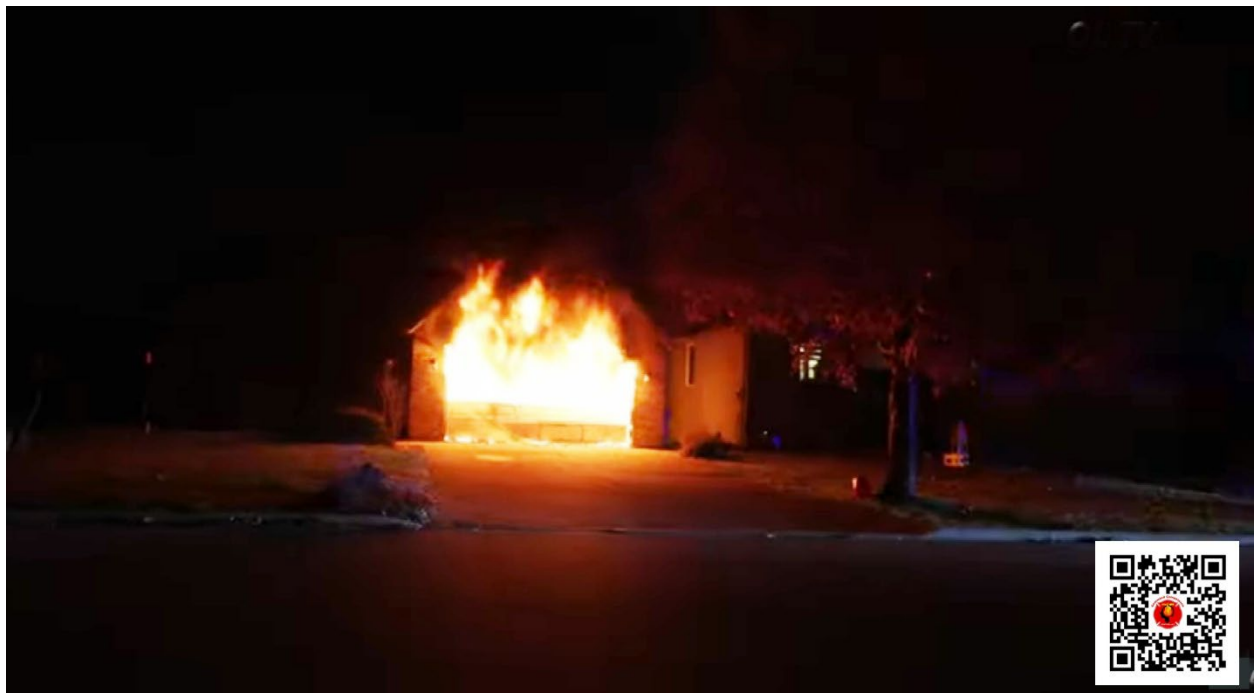
Figure 7. Conditions on Arrival

You anticipate the ladder company will arrive shortly minutes after you, followed by the second arriving engine, and command officer. The third arriving engine will arrive after the command officer. Watch the first 00:40 of the [incident video](#) (OnLocation TV, 2025) and examine Figure 7 illustrating conditions on arrival. Click the link above or scan the QR code to access the video.

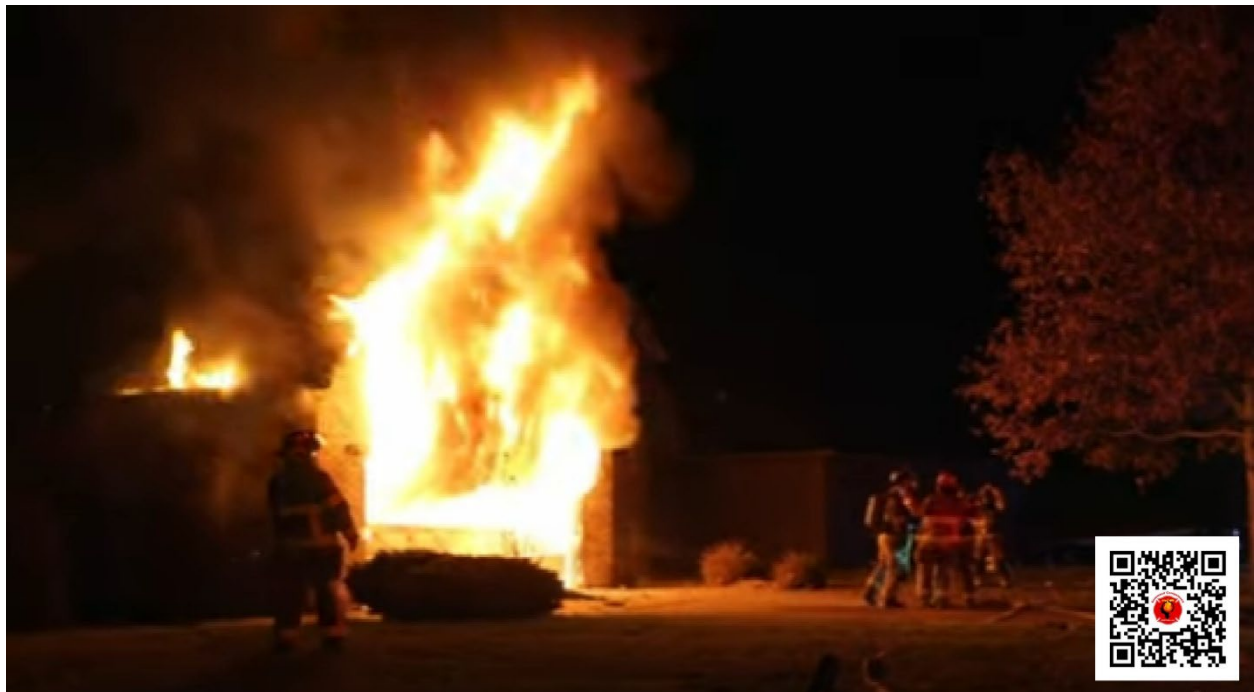
Figure 8. Conditions Post 360-Degree Reconnaissance

Watch the [incident video](#) from 00:40 to 02:00. Conditions on Side Charlie are consistent with those on Side Alpha with a small volume of smoke pushing from the eaves with limited velocity.

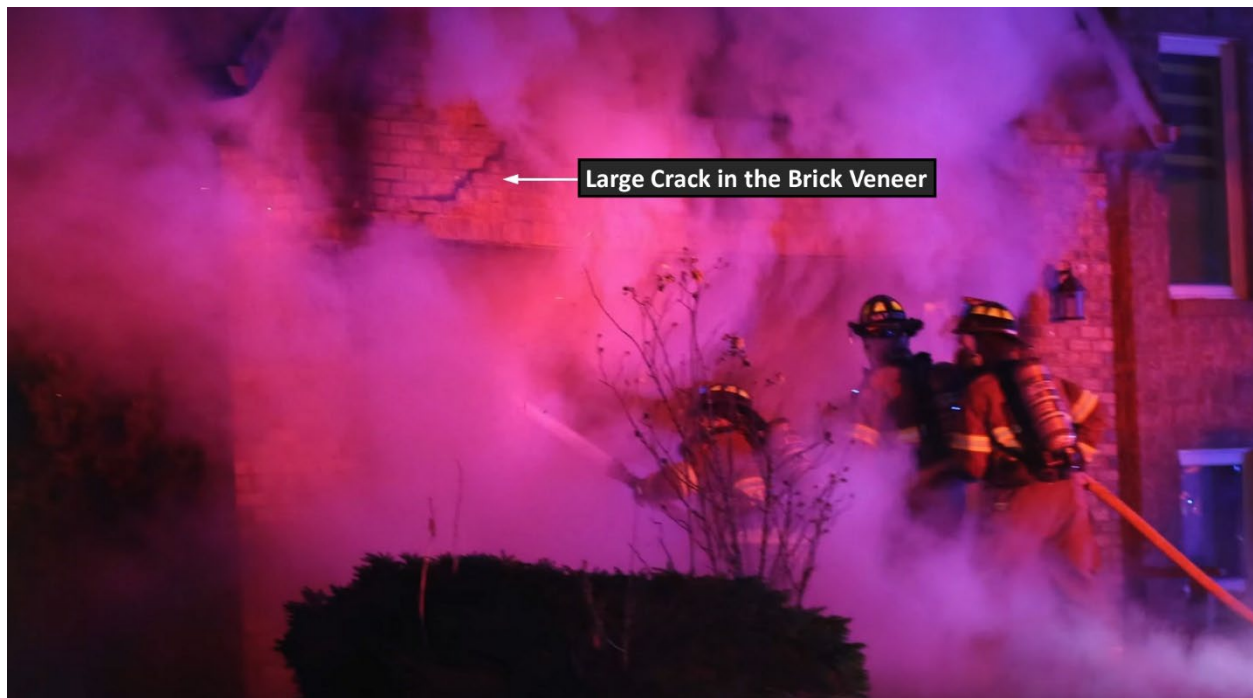
Figure 9. Conditions on Side Alpha of the Garage

Examine Figure 9 before answering the remaining questions.

19. Was the company operating the attack line through the garage door in a safe operating position?
20. If you observed the conditions illustrated in Figure 9, what action would you take. State the face-to-face communications you would have with the crew operating the attack line and radio communications that you would have with IC #2?
