MODELING A BACKDRAFT INCIDENT:
THE 62 WATTS ST. (NY) FIRE

Richard W. Bukowski, P.E.
NIST, Building and Fire Research Laboratory
Gaithersburg, MD, 20899-0001 USA

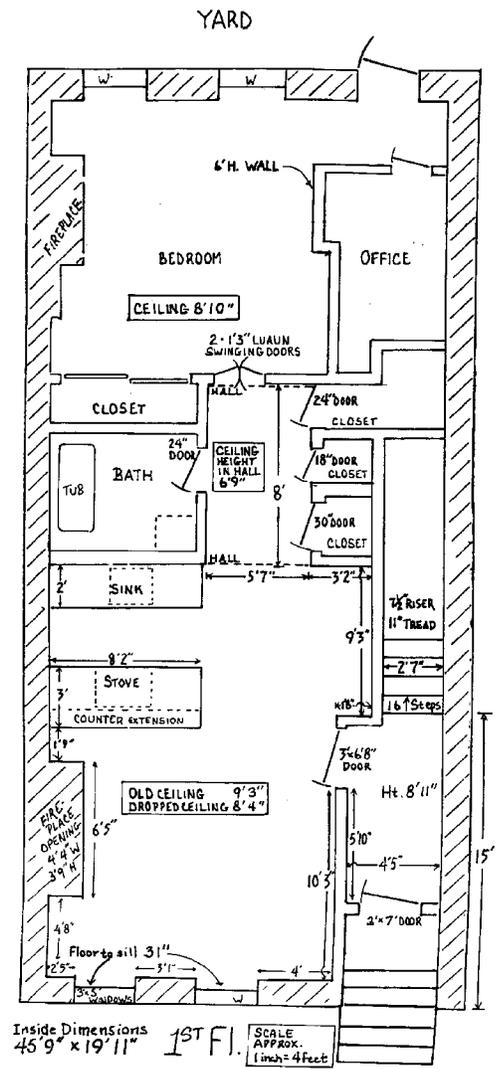
Figure 2 - First floor apartment

Damage to the apartment of origin was limited to the living room, kitchen and hall -- closed doors prevented fire spread to the bedroom, bath, office, and closets. There was no fire extension to the other apartments and no structural damage. The wired glass in the skylight was melted in long "icicles" and

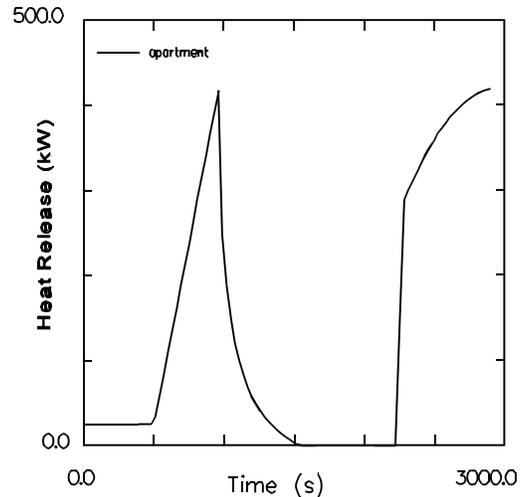
Figure 3 - HRR in apartment

The initial fire was assumed to be a constant heat release rate (HRR) of 25 kW from actual data on burning trash bags[3]. This fire then transitioned into a "medium t^2" fire with a peak heat release rate of 1MW (fig 3); however this was never reached due to limited oxygen. Such "medium t^2" fires are characteristic of most common items of residential contents[4].

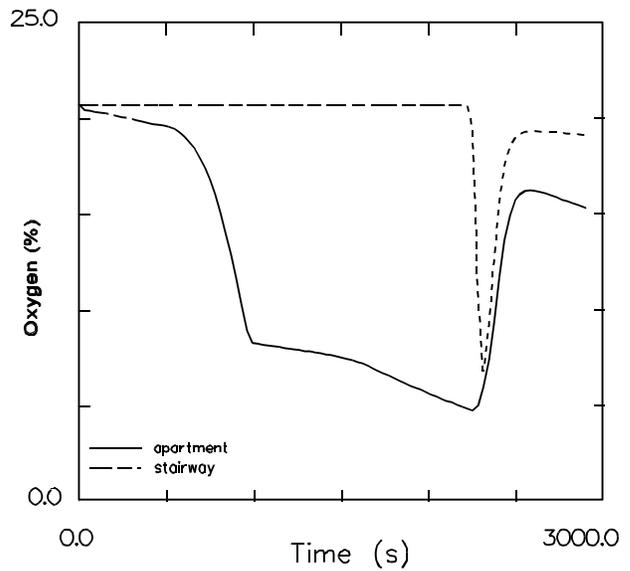
Figure 4 - Oxygen concentrations

The fire grew to about 500 kW over 5 minutes of simulation time, then rapidly throttled back as the oxygen concentration dropped below 10% (fig. 4). Temperatures in the apartment peaked briefly at about 300 ºC (570 ºF) at the time of peak burning, then rapidly dropped below 100 ºC (200 ºF) as the burning rate fell (fig. 5). The concentration of carbon monoxide (CO) rose to about 3000 ppm and unburned fuel accumulated within the apartment volume during this stage of vitiated combustion.

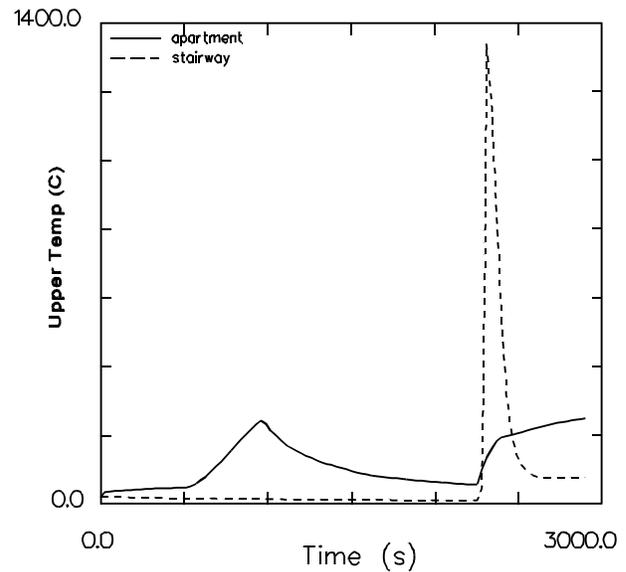
Figure 5 - Upper temperatures

reported by the firefighters. This door flame grew within a few seconds to a peak burning rate of nearly 5 MW (fig. 6), raising the temperature in the stairway to over 1200 ℃ (2200 ℉) (fig. 5) -- sufficient to melt the glass in the skylight, as observed. Most importantly, the quantity of unburned fuel accumulated in the apartment caused the door flame to persist for more than 7 minutes (fig. 6).
