Gresham Fire Department

Serious Injury Incident Investigation

1327 SE 182nd Avenue Duplex Fire
Gresham, Oregon
May 30, 2024

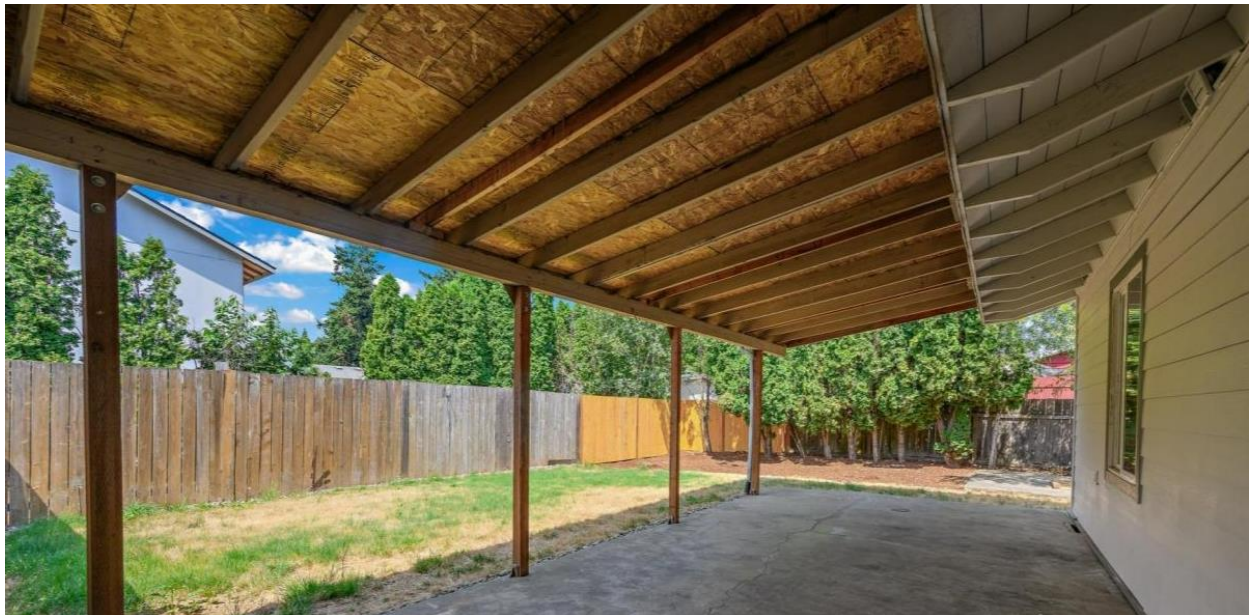
Figure 24. View from the Patio (Side Charlie) to the North

With a wind speed of 10 mph, there is potential for a wind driven structure fire event (Madrzykowski & Kerber, 2009a). However, wind effects may have been mitigated to some extent by the patio roof, fence, and tall vegetation to the northwest of the fire occupancy as illustrated in Figure 24.

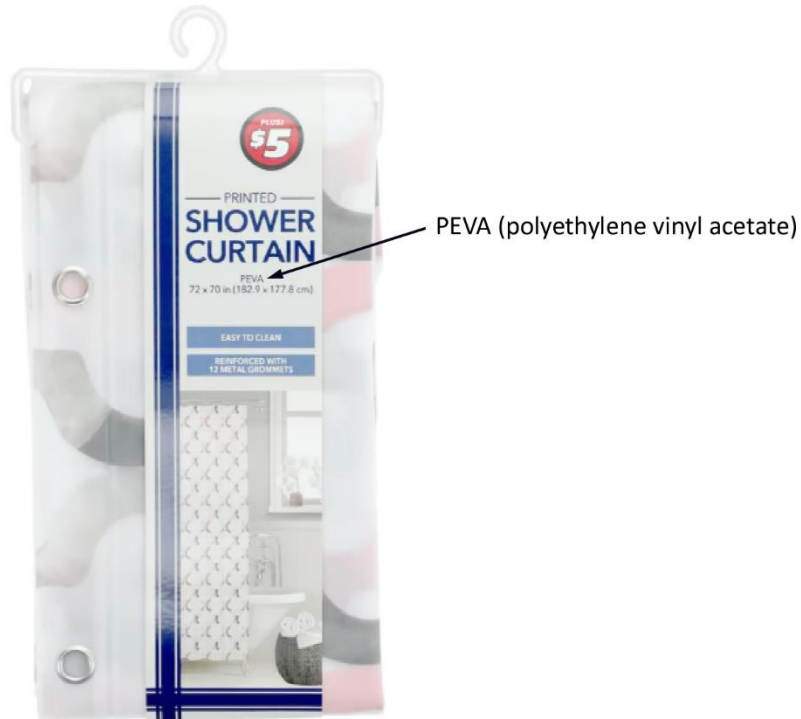
Figure 26. Shower Curtain

The shower curtain was plastic and purchased by the occupant at Dollar Tree. It is likely that the shower curtain was made of polyethylene vinyl acetate (PEVA) and was like that illustrated in Figure 26¹ (Dollar Tree, 2024). PEVA is not listed in the Underwriters Laboratories Fire Safety Research Institute Materials Database.

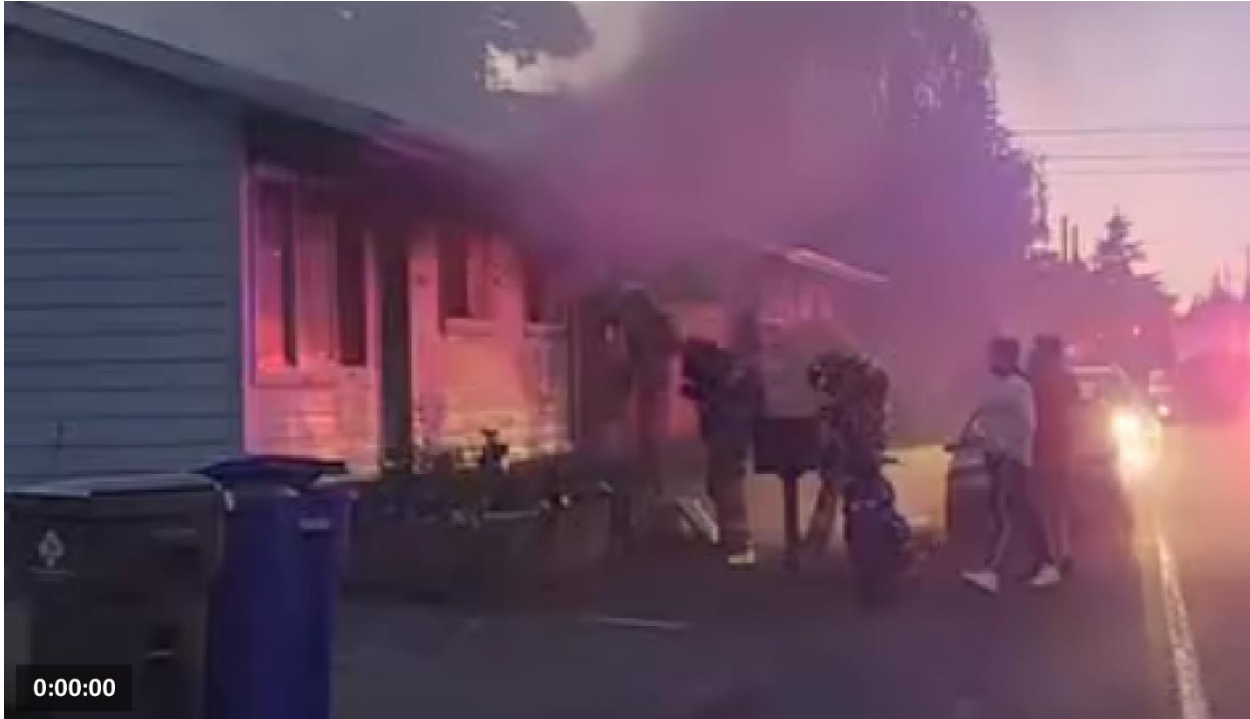
Figure 28. Conditions Prior to Entry

Based on video of the incident after Engine 31 arrived, the door on Side Alpha (182nd Avenue) was fully open and the horizontal sliding windows were partially open. There was a bi-directional flow at the door on Side Alpha and unidirectional (out) flow at the windows on Side Alpha. Smoke was pushing from these ventilation openings with moderate but increasing velocity. The neutral plane at the door on Side Alpha was 8" to 10" from the top of the door frame on arrival, but in less than a minute (prior to entry of Firefighters Tejedas and Pilarski for search without a hoseline) had dropped to approximately 30" from the top of the door frame (see Figures 28-30).

As illustrated by these examples, a ventilation limited fire can present itself in a variety of different ways. In this incident, conditions on Side Alpha when Engine 31 arrived appeared to be somewhat innocuous (as previously illustrated in Figure 28). Several firefighters and officers observed that this appeared to be a typical or routine incident. There was a bi-directional flow with a high neutral plane at the door on Side Alpha and a unidirectional flow (out) from the windows on Side Alpha. Velocity of smoke discharge from openings on Side Alpha was moderate. However, in the short time that it took the

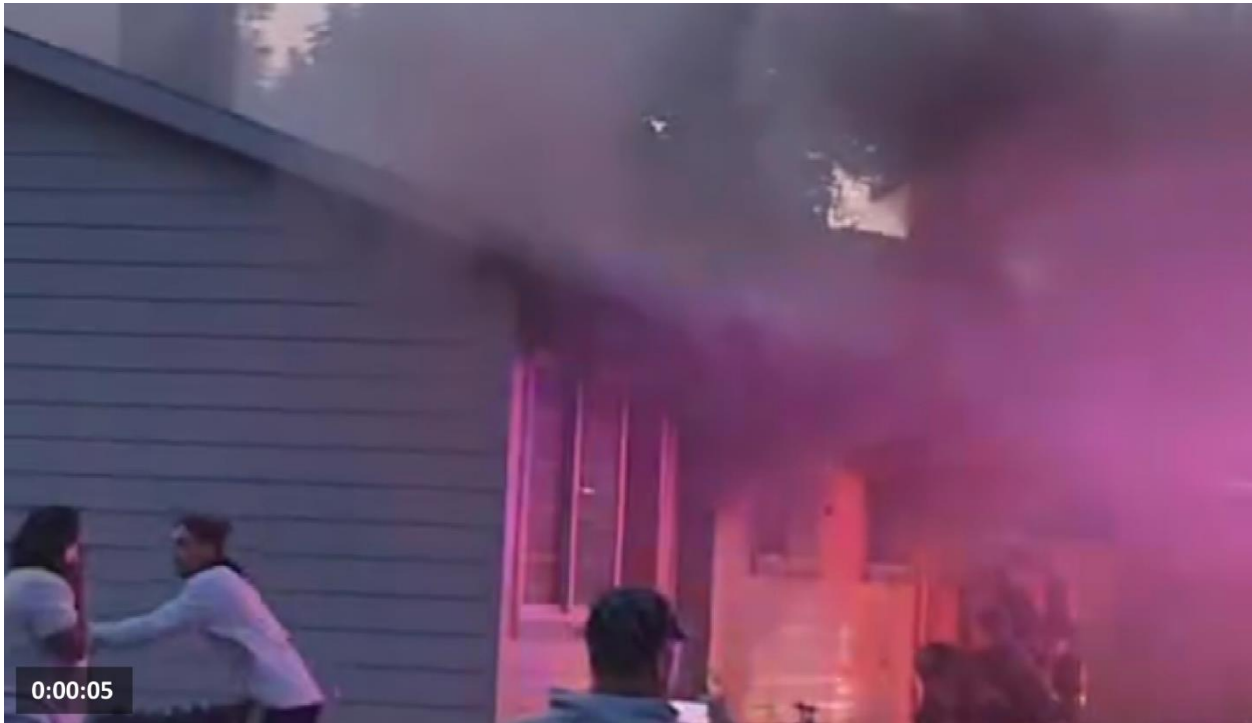
Figure 29. Conditions Prior to Entry

crew from Engine 31 to mask up prior to entry through the door on Side Alpha, the neutral plane at the door had dropped significantly (as previously illustrated in Figures 28 and 29), indicating that this ventilation limited fire had returned to the growth stage and the speed of fire development would continue to increase with any additional ventilation in the absence of effective application of water for fire control.

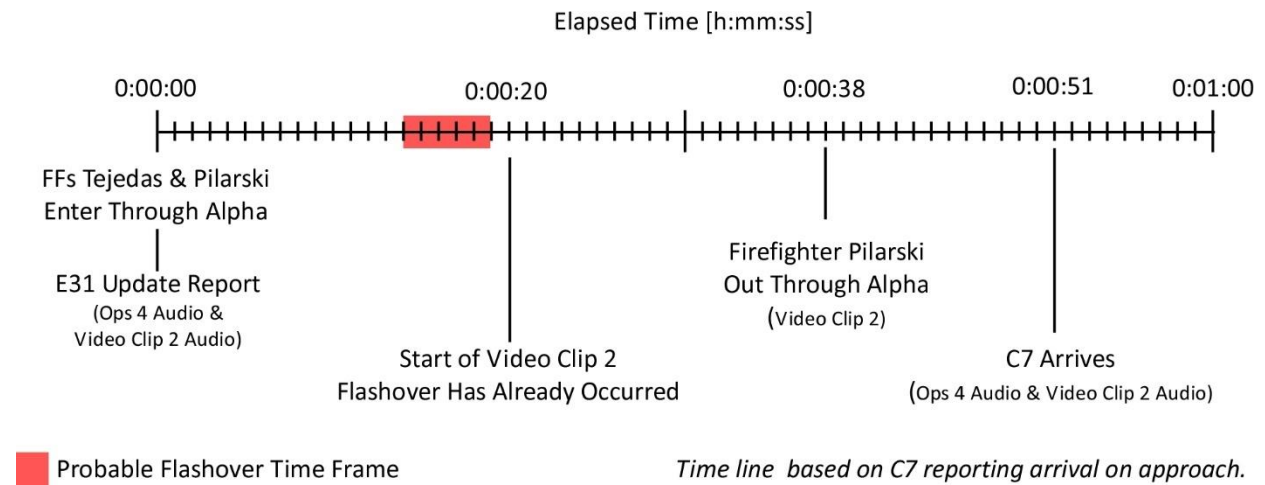
Figure 33. Entry to Flashover Timeline

Firefighters Tejedas and Pilarski had moderate visibility as they entered the house below the smoke layer which was approximately 3' to 4' above the floor at the point of entry. As they advanced along the living room wall to the hallway, fingers of flame from the hallway were visible in the smoke layer. As they turned right at the hallway, rollover was observed on the hallway ceiling. While Firefighter Pilarski searched the first bedroom on the right and Firefighter Tejedas proceeded down the hallway to search the second bedroom on the right, temperature and heat flux in the hallway increased rapidly due to flaming combustion in the upper layer along the hallway ceiling. As Firefighter Tejedas returned to the first bedroom and Firefighters Tejedas and Pilarski attempted to egress to their entry point on Side Alpha, the flashover resulted in rapid transition to a fully developed fire in the hallway, living room, and kitchen.

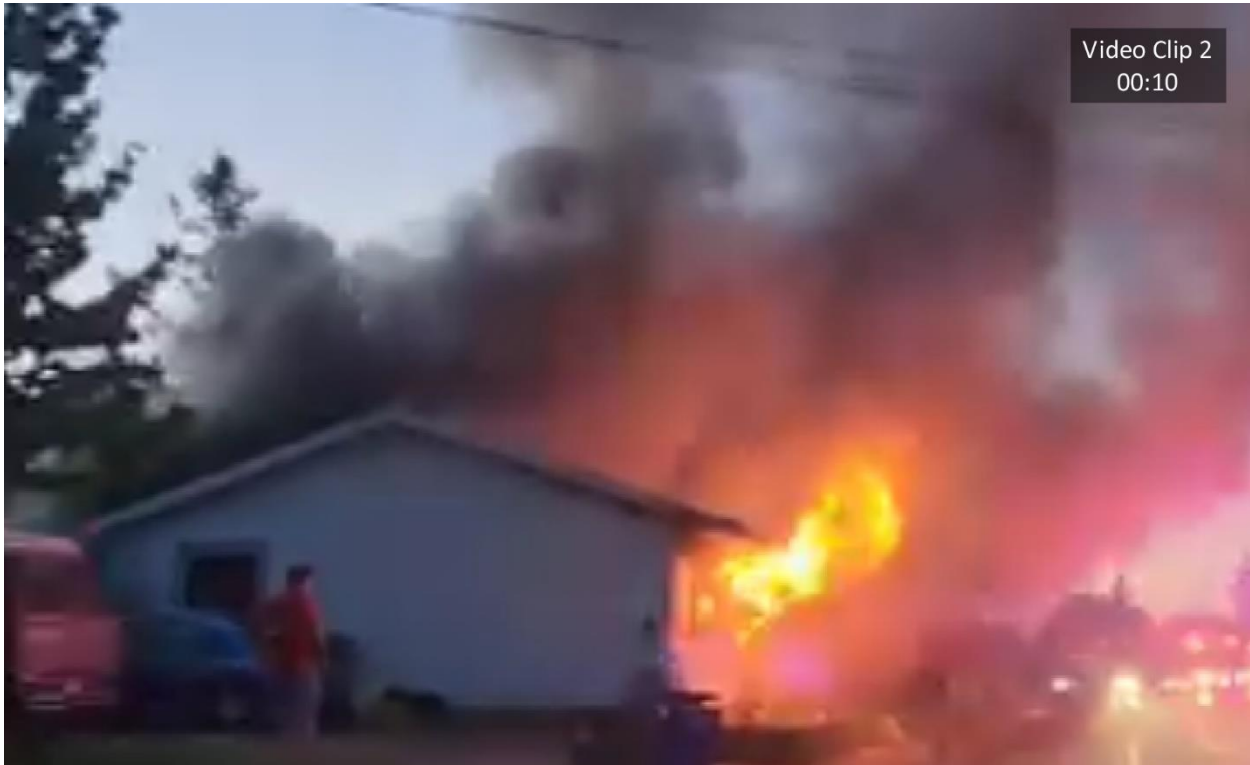
Figure 34. Conditions Post Flashover (Firefighters Tejedas and Pilarski Inside the Fire Occupancy)

As illustrated in Figure 34, the pressure generated by the fully developed fire overcame the pressure from the wind blowing from the northwest on Side Charlie (west aspect) resulting in discharge of a large volume of dark gray to black smoke through openings on Side Charlie (visible above the roofline post flashover). Flaming combustion in the kitchen was visible through the intact window on Side Bravo.

At this stage in the incident, it is likely that the oxygen concentration in Bedrooms 1, 2, and 3 was too low to support flaming combustion immediately after flashover. This is supported by smoke discharge without flaming combustion from the partially open windows in these rooms.

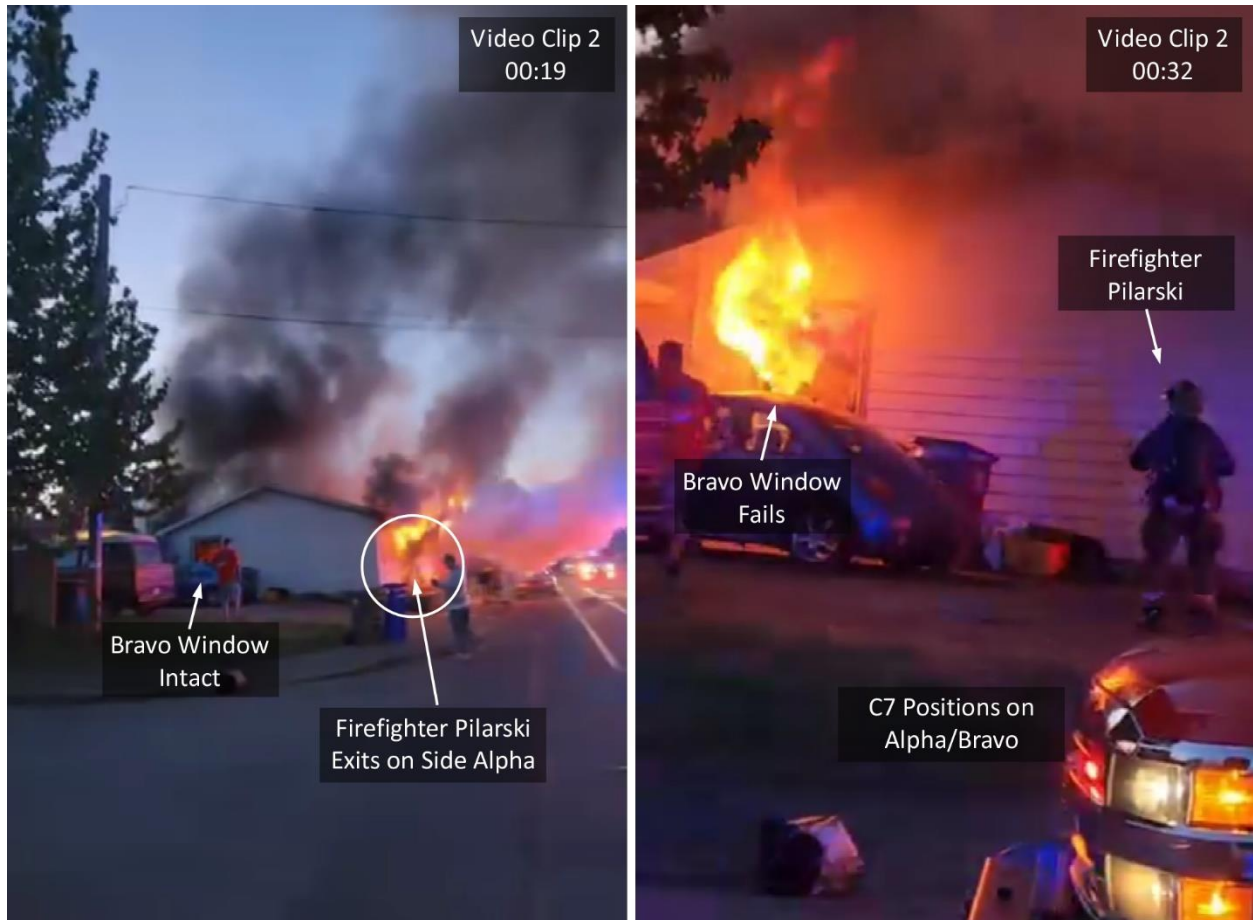
Figure 35. Post Flashover Conditions (Firefighter Pilarski Exits)

Shortly after flashover, Firefighter Pilarski exited through the door on Side Alpha with flames pushing from the open door to within approximately 1' of floor level. Immediately after Firefighter Pilarski exited, the window on Side Bravo failed with flames exiting with a unidirectional (out) flow.

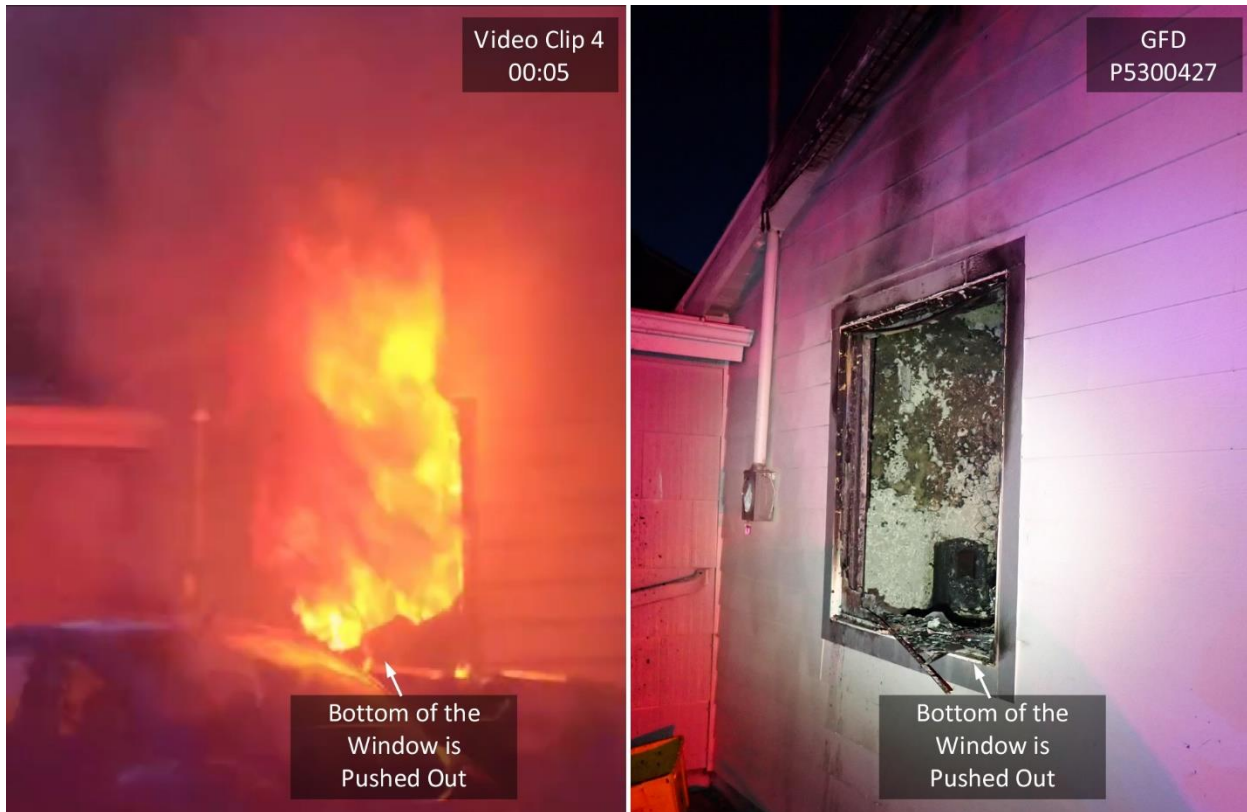
Figure 41. Side Bravo Window

Failure of the window on Side Bravo, large living room window on Side Alpha, and kitchen window resulted in additional ventilation openings each of which had a unidirectional (out) flow. Likely post-flashover flow paths are illustrated in Figure 42.

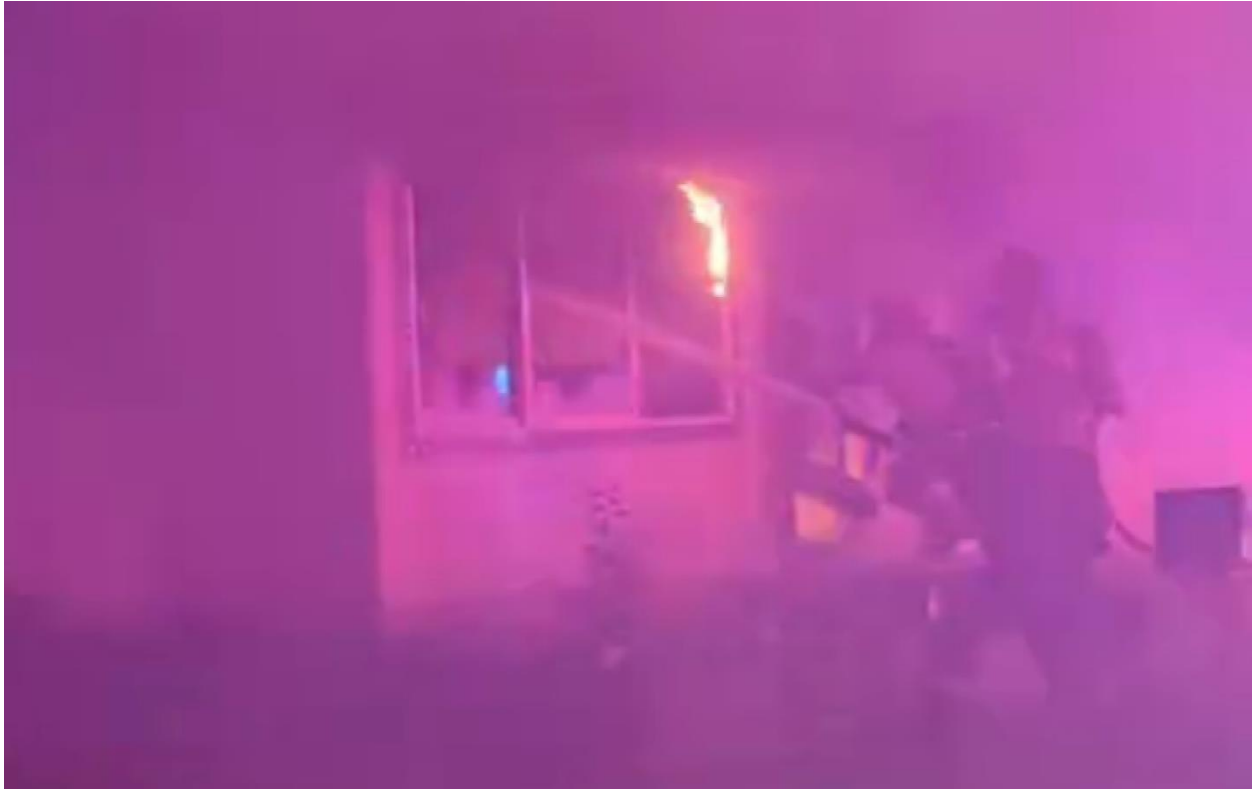
Figure 43. Exterior Attack and Attack Line Entry

A second attack line was stretched, and pressure increased in the initial attack line. As illustrated in Figure 43, once adequate flow rate and pressure was developed, the fire was quickly knocked down. The attack line and backup line were stretched through the door on Side Alpha for fire control and the fire was extinguished. Fire was confined to the interior of the house with no extension into the attic or the attached Bravo 1 Exposure.

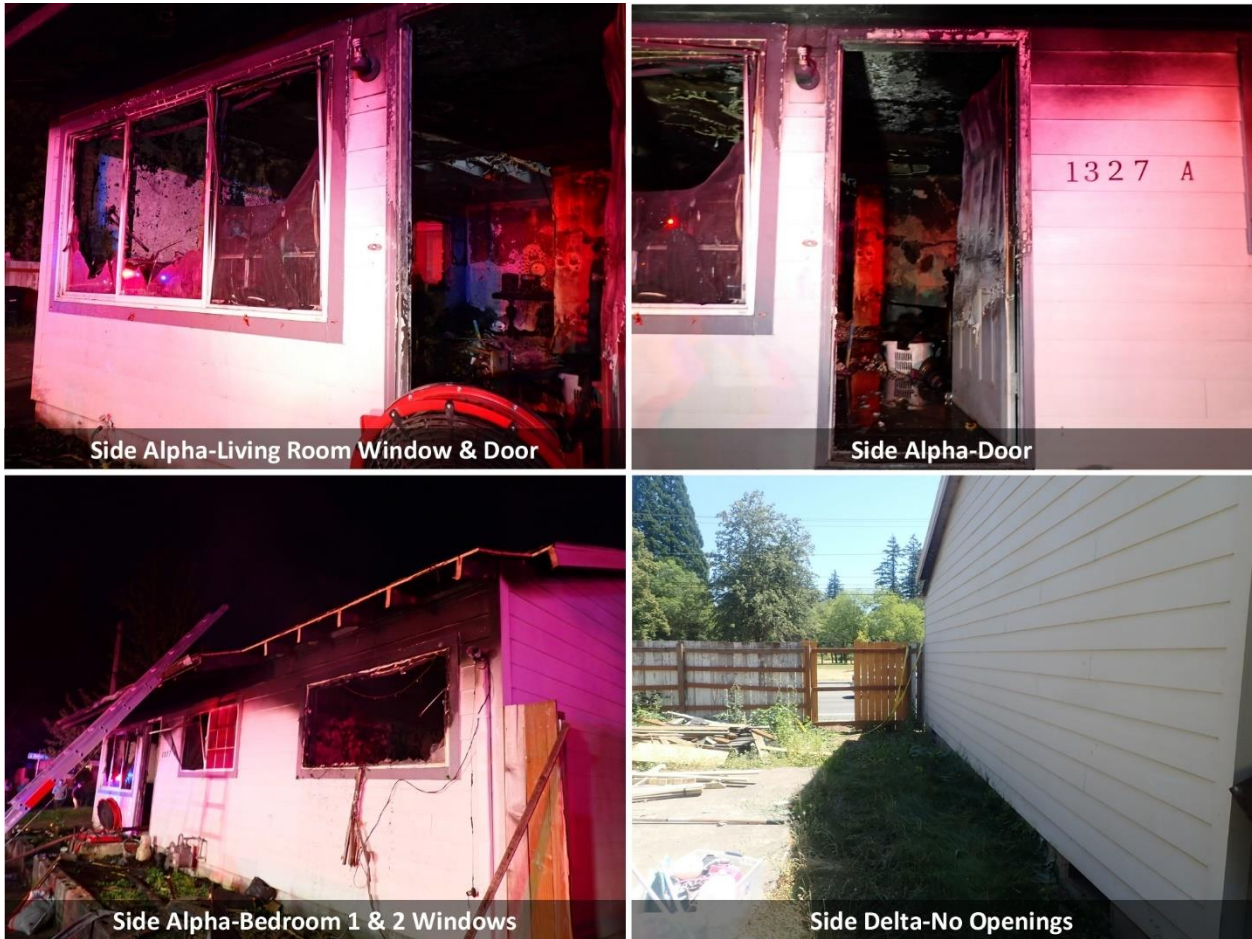
Figure 44. Ventilation Openings on Sides Alpha and Delta

Figure 44 illustrates ventilation openings on Side Alpha and lack of ventilation openings on Side Delta.

- The living room door (2.92' x 6.58', 19.21 ft²) was opened by an occupant and remained open throughout the incident.
- The living room window (three panels with a total opening 8.70' x 4.29', 37.32 ft²) remained intact until post flashover at which point it substantially failed.
- The window in Bedroom 1 (two panels with a total opening 5.87' x 2.96', 17.37 ft²) was slightly open prior to ignition (exact extent undetermined). This window remained intact prior to entry, but one side of the window was vented or failed due to thermal insult (see Figure 45).
- The window in Bedroom 2 (two panels with total opening 5.87' x 2.96', 17.37 ft²) was opened approximately halfway by an occupant after the door on Side Alpha was opened and an attempt was made to enter the house via the door).

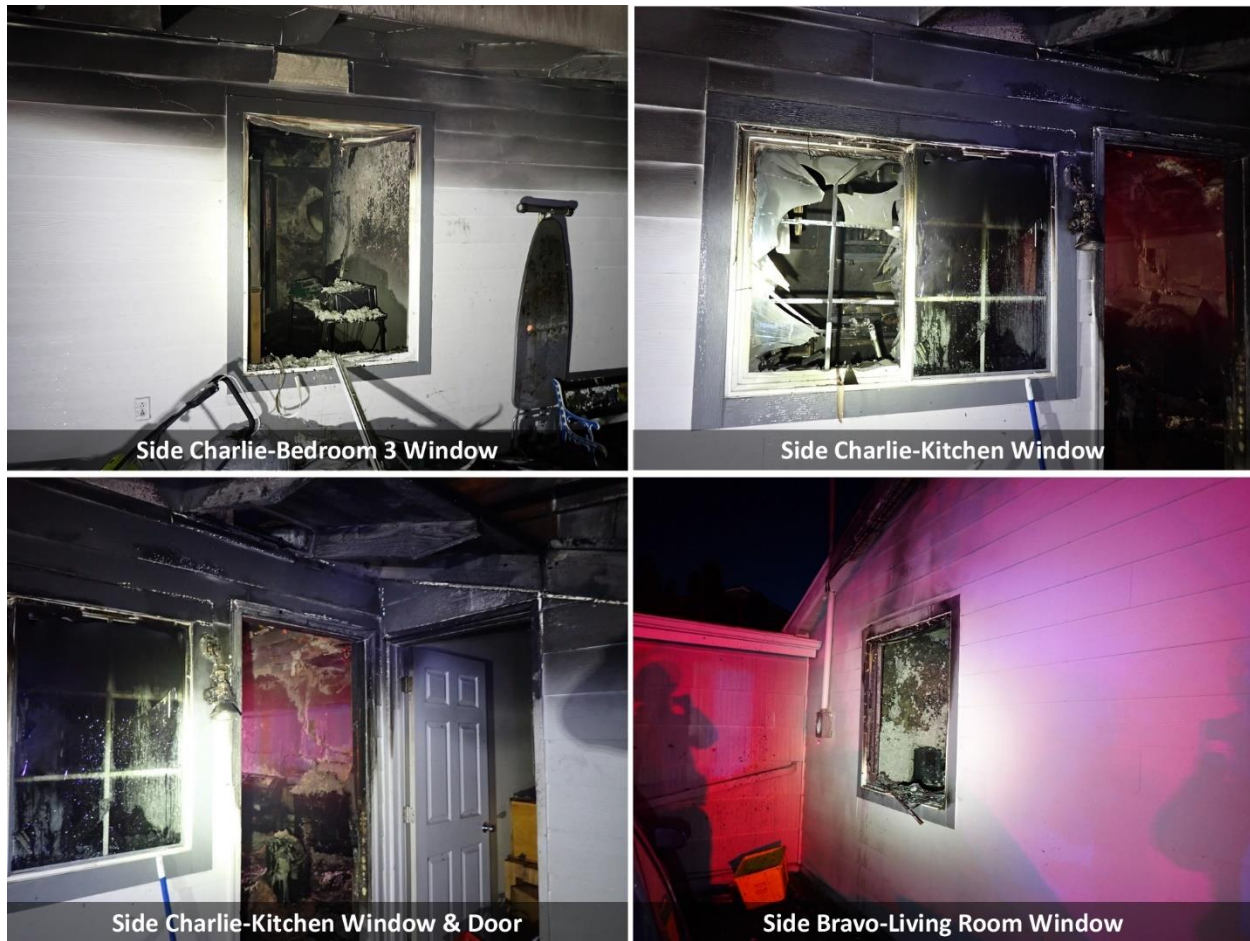
Figure 46. Ventilation Openings on Sides Charlie and Bravo

Figure 46 illustrates the ventilation openings on Sides Charlie and Bravo.

- The window in Bedroom 3 (two panels with total opening 3.37' x 4.58', 15.43 ft²) was reported to have been partially broken (part of a single panel) by civilian bystanders. Truck 71 observed that one side of the window was at least substantially open when they arrived on Side Charlie and took the remainder of the glass and frame.

- The window in the Living Room on Side Bravo (3.83' x 3.83', 14.67ft²) failed post flashover.

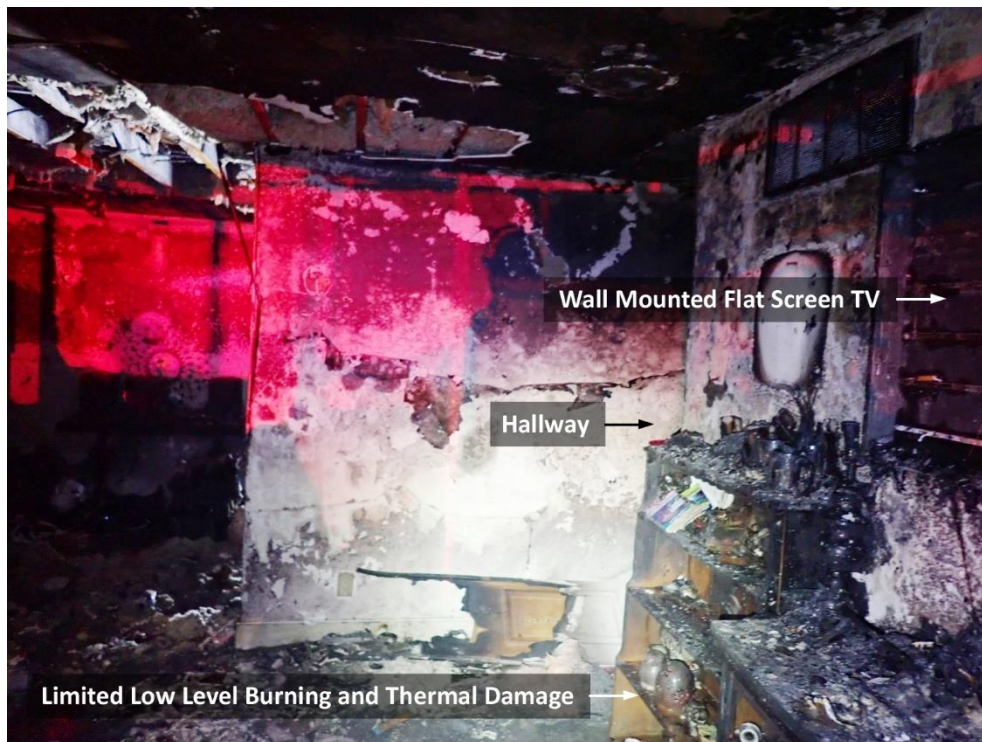
Figure 48. Living Room (looking directly in from the door on Side Alpha)

Figure 48 illustrates post fire conditions immediately inside the door on Side Alpha. This door was the first ventilation opening created by an occupant and it remained open throughout the incident. As the bottom of the door opening was lower than all other ventilation openings created by the occupant and bystanders it served as one of two ventilation openings having a bi-directional flow with the bottom of the door serving as an inlet for fresh air. The limited low level burning and thermal damage to the wooden fuel packages inside the front door is potentially due to the cooling effect of air intake from this opening.

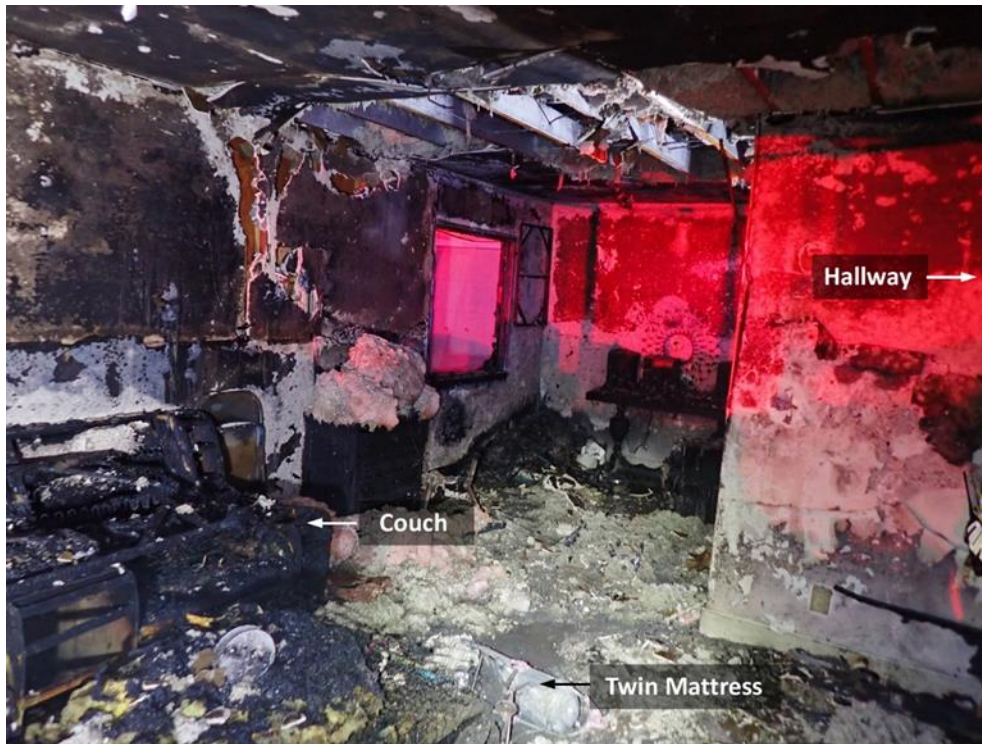
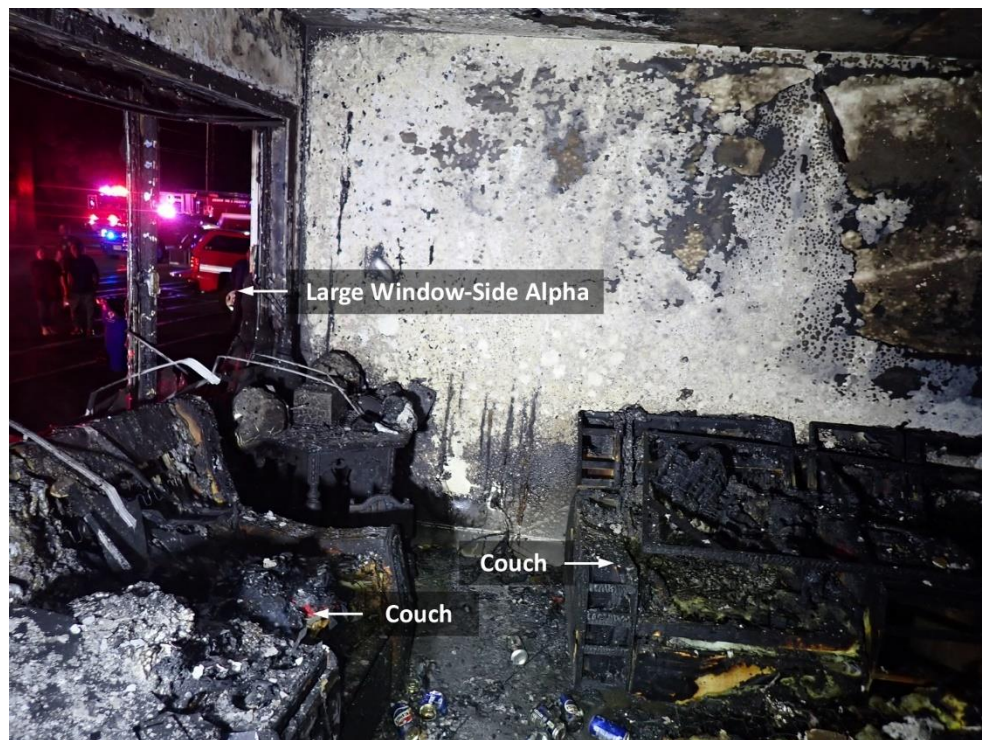
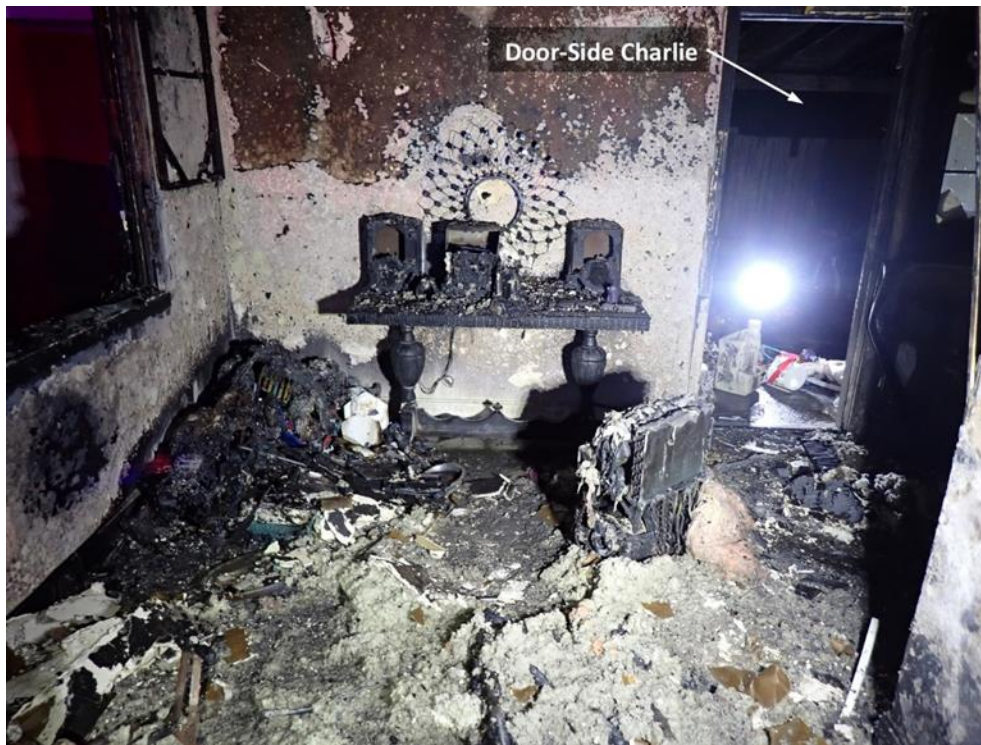
Figures 48 through 51 illustrated post fire conditions in the living room. This room has conditions consistent with post flashover combustion. Fuel packages and compartment linings show evidence of floor to ceiling combustion and significant thermal damage. Conditions in this room are likely a result of the number and type of fuel packages present (two couches, twin mattress, flat screen TV, etc.) as well as the location of this compartment between the doors on Sides Alpha and Charlie, each having a bi-directional flow with the bottoms of both doors serving as inlets for fresh air.

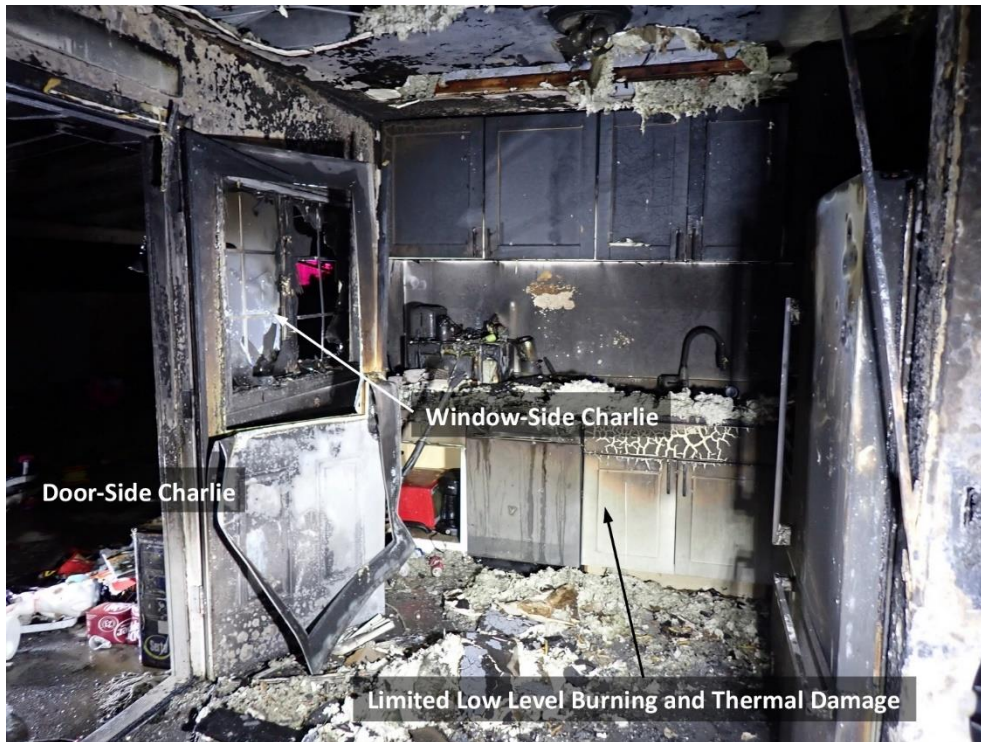
Figure 52. Kitchen (looking towards Side Delta)

Figure 52 illustrates post fire conditions in the kitchen. As illustrated in this photo, the kitchen was immediately adjacent to the door on Side Charlie. The kitchen window on Side Charlie visible behind the open door remained substantially intact throughout the fire. This room shows evidence of burning and significant damage at the upper level with less damage to the lower kitchen cabinets, potentially because of the flow path between the major area of involvement in the living room and hallway and the door on Side Charlie.

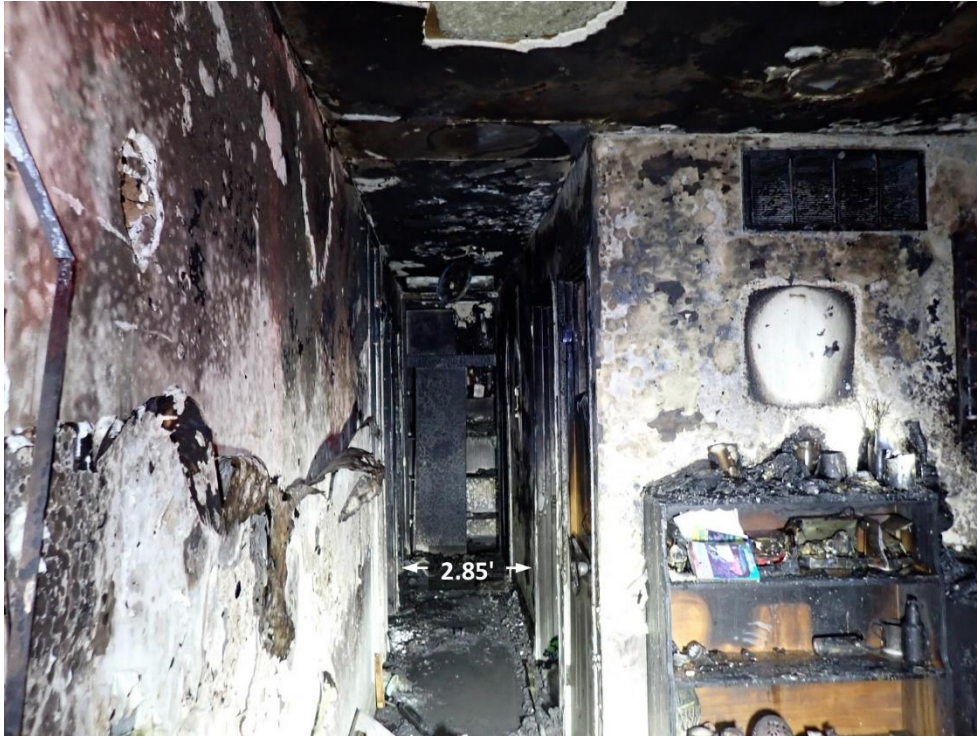
Figure 53. Hallway (looking towards Side Delta from the Living Room)

Figure 53 illustrates post fire conditions in the hallway. The hallway has conditions consistent with post flashover combustion. Compartment linings show evidence of floor to ceiling combustion and significant thermal damage. Conditions in the hallway are likely a result of the flow paths between the exterior doors on Sides Alpha and Charlie and the partially open window in bedroom 1 (Side Alpha) and open windows in bedroom 2 (Side Alpha) and bedroom 3 (Side Charlie). The flow of gases in the hallway between the bathroom (origin of the fire) and the living room was likely bi-directional with air flowing in at floor level and hot smoke and flames flowing outward at the upper level. The flow of gases in Bedroom 1 was likely unidirectional from the hallway through the bedroom due to the partially open window. The flow of gases in the hallway between the bathroom and bedrooms 2 and 3 was likely unidirectional due to the open windows in these rooms.

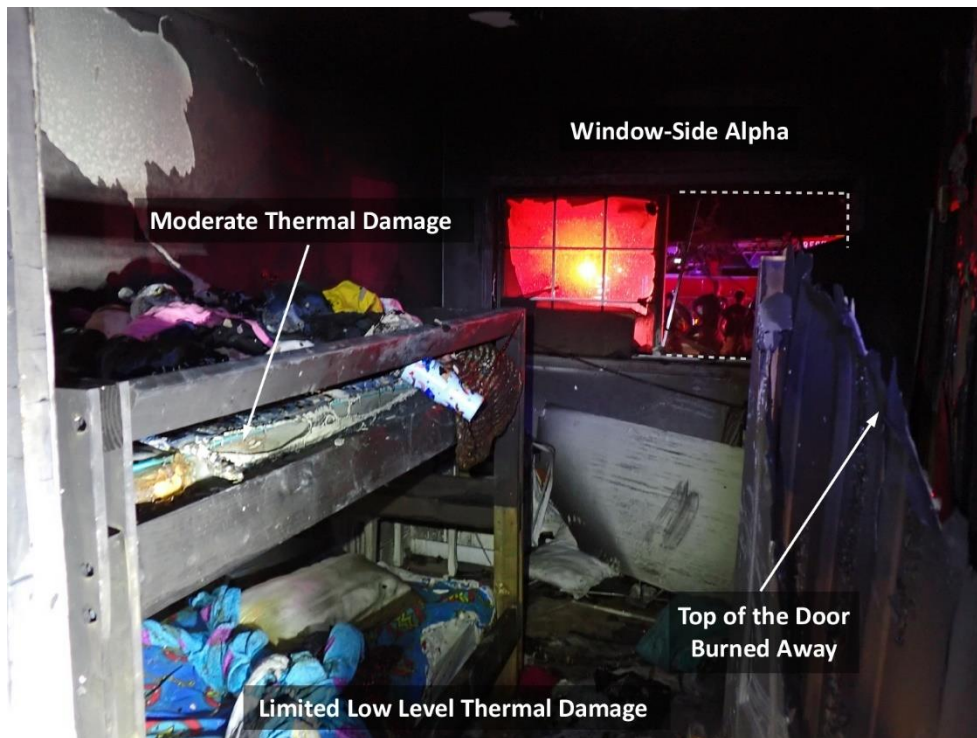
Figure 54. Bedroom 1 (looking towards Alpha from the Hallway)

Figure 54 illustrates post-fire conditions in bedroom 1. Conditions indicate that bedroom 1 did not transition through flashover to a fully developed fire. Thermal damage in this compartment was moderate with no evidence of significant involvement of fuel packages within this room. Incident video and photos (Bystander Video Clip 1, 2, 3, & 4, 2024 and Bystander Photo IMG_6214, 2024) illustrate that the window in bedroom 1 (Side Alpha) showed unidirectional flow of smoke (out), with no flaming combustion throughout the incident. Damage to the bedroom door indicates that the door between bedroom 1 and the hallway had flaming combustion at the doorway to this compartment.

The lack of combustion in bedroom 1 is likely due to consumption of atmospheric oxygen by the post flashover fire in the living room and hallway and the exhaust opening provided by the slightly open window in this room during early stages of the fire and slightly larger opening provided by this window being pushed open or failing due to thermal effects post flashover in the hallway and living room.

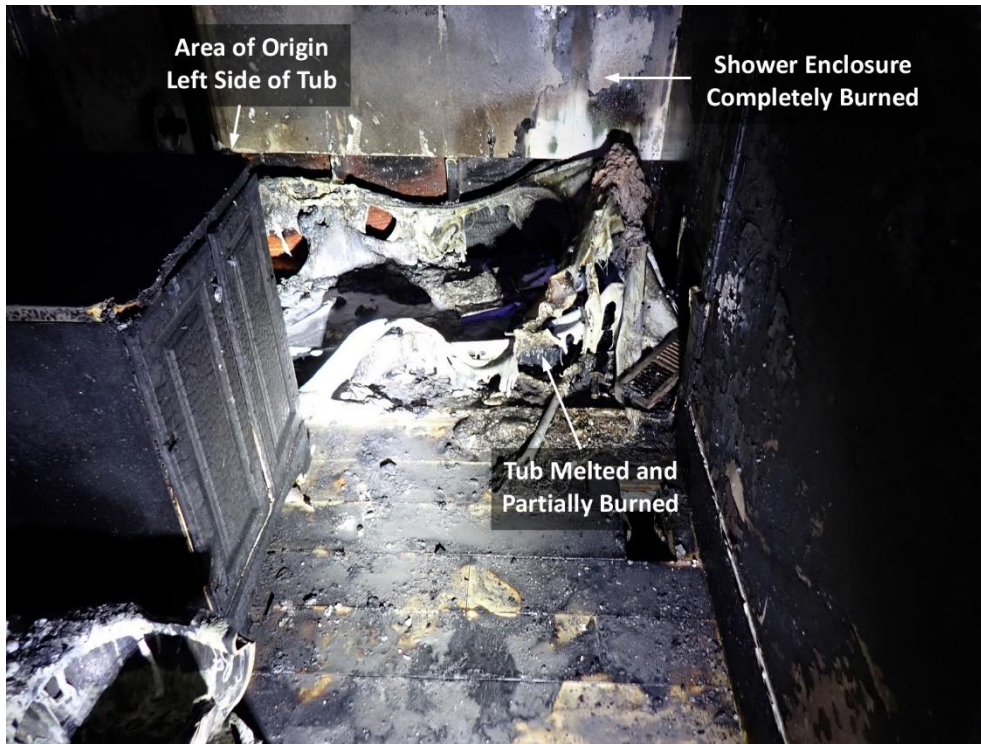
Figure 55. Bathroom (looking towards Side Charlie from the Hallway).

Figure 55 illustrates post fire conditions in the bathroom (room of origin) after removal of gypsum board and insulation from the ceiling opened when firefighters were checking for extension. The bathroom has conditions consistent with post flashover combustion. The acrylonitrile butadiene styrene (ABS) plastic shower enclosure was completely burned, and the bathtub comprised of the same material was melted and substantially burned. Compartment linings and the bathroom sink enclosure (veneer covered particleboard) show evidence of floor to ceiling combustion and significant thermal damage. The ceramic toilet cracked and failed into multiple pieces due to severe thermal exposure.

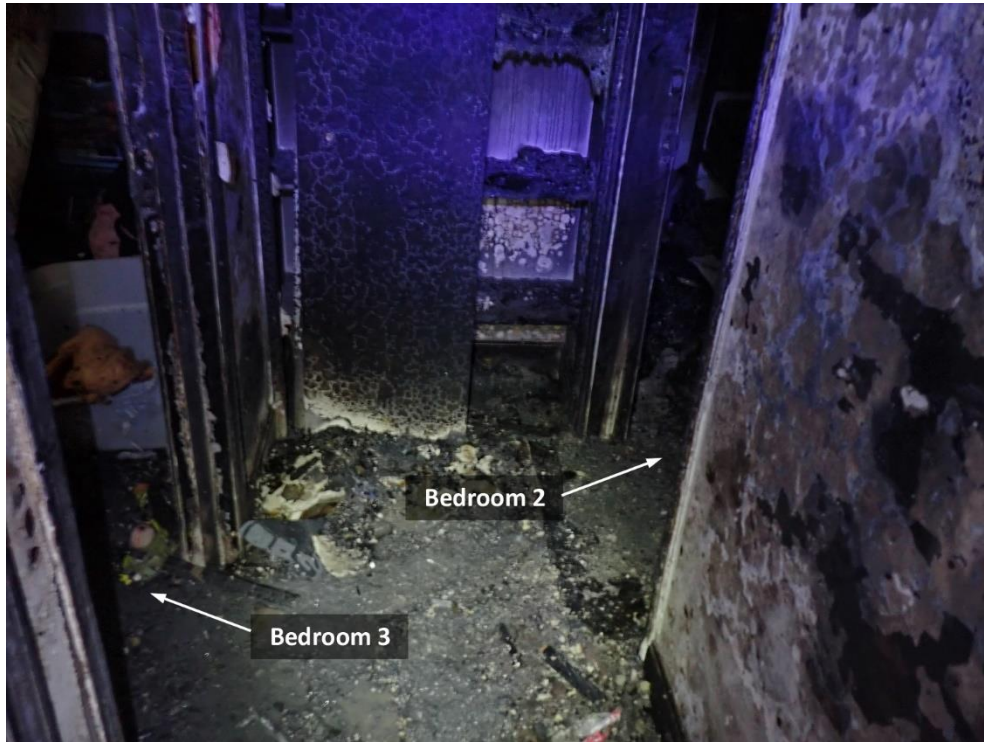
Figure 56. End of the Hallway (Looking towards Side Delta)

Figure 56 illustrates post fire conditions at the end of the hallway (looking towards Side Delta). The hallway has conditions consistent with post flashover combustion. Compartment linings, the closet doors, and shelving show evidence of floor to ceiling combustion and significant thermal damage. There likely was a unidirectional flow from the hallway through Bedroom 2 due to a window in this compartment which was opened by an occupant and subsequently completely broken out by Truck 71 post knockdown of the fire in the living room (but prior to knockdown of fire in the hallway and bathroom). The window in Bedroom 3 was partially broken by a bystander which also would have resulted in a unidirectional flow (out) from the hallway through this room.

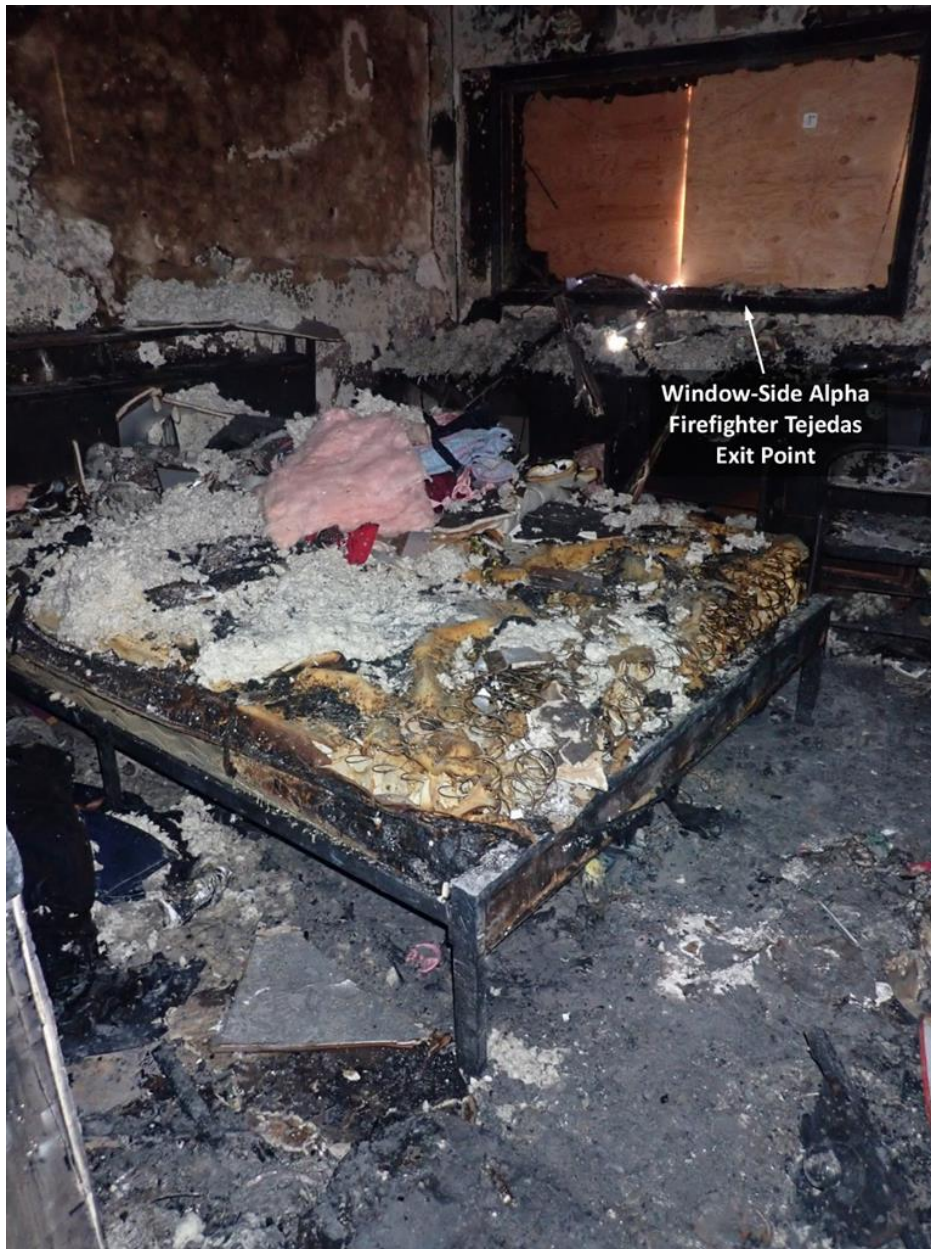
Figure 57. Bedroom 2 (looking towards Side Alpha)

Figure 57 illustrates post-fire conditions in Bedroom 2. This room has conditions consistent with post flashover combustion. Fuel packages and compartment linings show evidence of floor to ceiling combustion and significant thermal damage. The window in this compartment was opened halfway by an occupant after they opened the door on Side Alpha. This resulted in a unidirectional flow from the hallway through bedroom 2. Incident video and photos (Bystander Video Clip 1, 2, 3, & 4, 2024 and Bystander Photo IMG_6214, 2024) illustrate that the window in bedroom 1 (Side Alpha) showed unidirectional flow of smoke (out) prior to Firefighter Tejedas’s exit and until this window was

completely broken out by Truck 71 post knockdown of the fire in the living room (but prior to knockdown of fire in the hallway and bathroom).

When Truck 71 completely cleared the window in bedroom 2 to perform a window-initiated search, the room transitioned through flashover to a fully developed fire. This ventilation action by Truck 71 occurred after the start of fire suppression operations through the door on Side Alpha. It is likely that the fire in the living room and hallway was consuming the oxygen introduced through the doors on Side Alpha and Charlie and that the oxygen concentration in this compartment was insufficient to support flaming combustion prior to knockdown of the fire in the Living Room. Reduction of the oxygen consumption from the fire in the living room combined with increases unidirectional flow through bedroom 2 and out the window, likely resulted in the transition through flashover to a fully developed fire within this compartment. Post knockdown in the living room and kitchen, firefighters quickly pushed down the hallway, knocking down the fire in the hallway, bathroom, and bedroom 2.

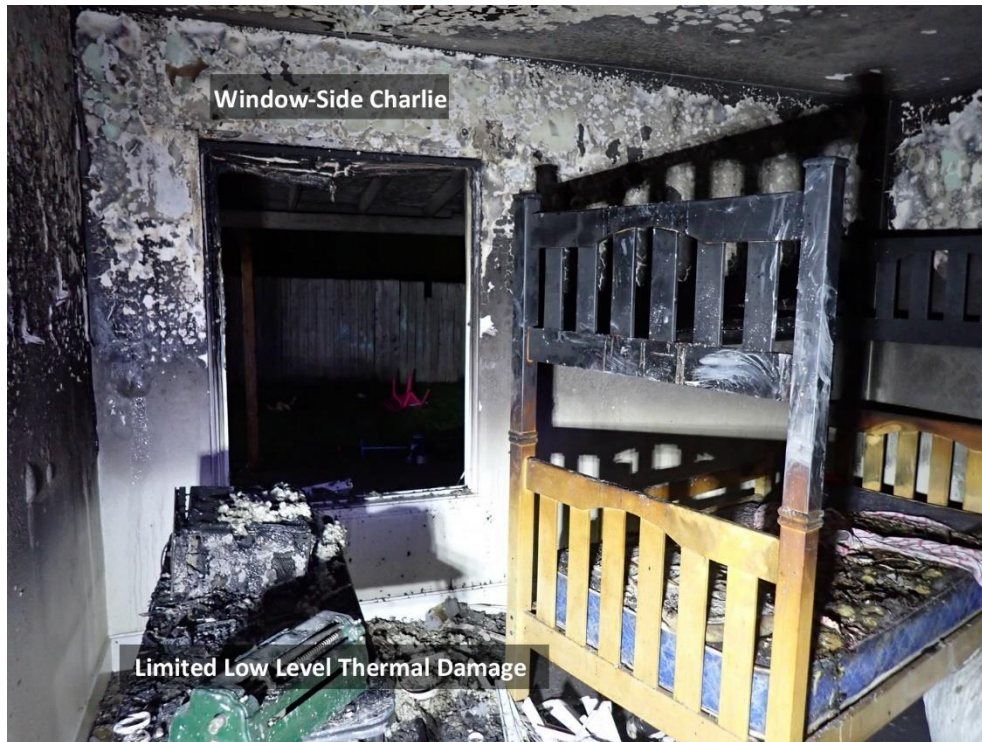
Figure 58. Bedroom 3 (looking towards Side Charlie from the Hallway)

Figure 58 illustrated post-fire conditions in Bedroom 3. Conditions indicate that Bedroom 1 did not transition through flashover to a fully developed fire. However, there is evidence of flaming combustion in the upper level of this compartment. Condition on the exterior of this window reflect high temperature flow of smoke, fire gases and likely flames out this window (Engine 74 reported observing flames from a window on Side Delta (there are none), but this may have been from the bedroom 3 window observed from Side Delta.

The bottom bunk bed had a twin mattress, but the top bunk bed did not appear to have been in use (no twin mattress). However, there was a crib sized mattress on the floor next to the bunk beds. Both mattresses showed thermal damage but were not significantly burned.
