Gresham Fire Department

Serious Injury Incident Investigation

1327 SE 182nd Avenue Duplex Fire
Gresham, Oregon
May 30, 2024

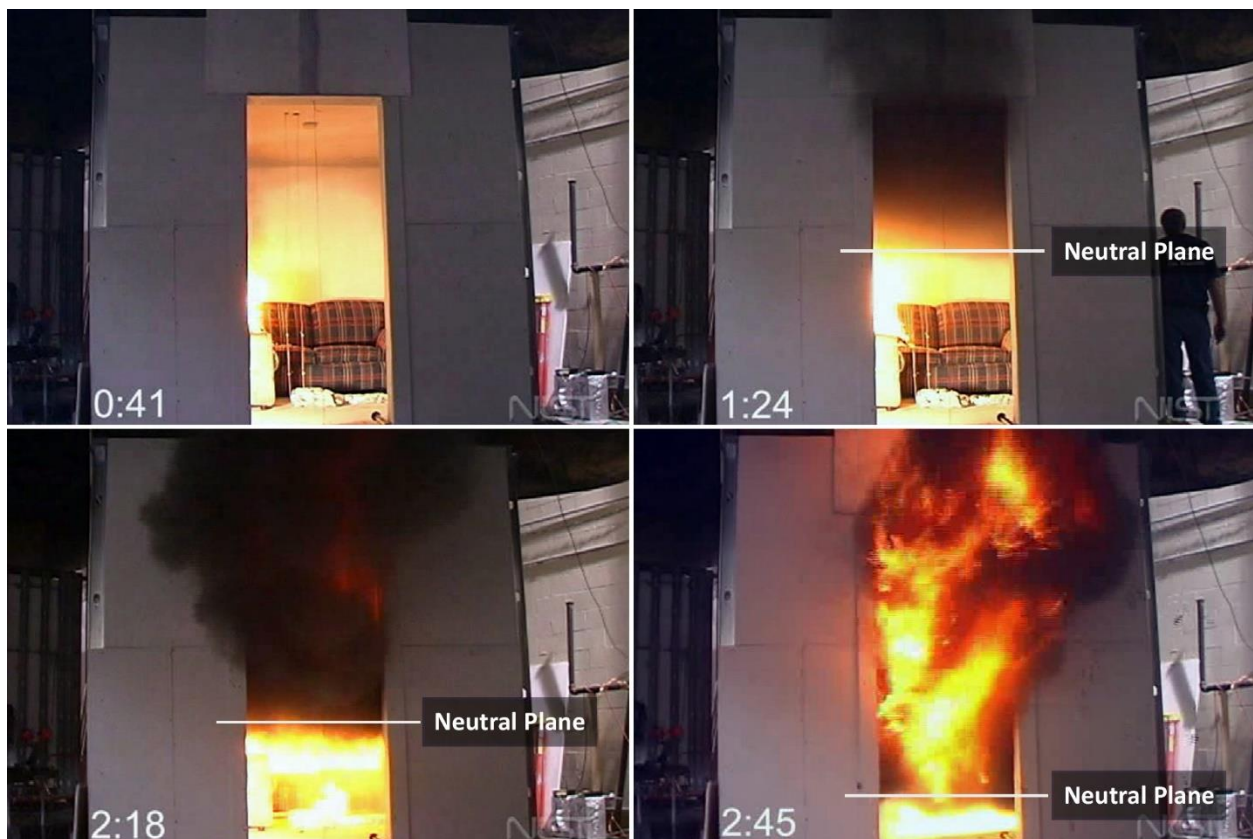
Figure 66. Fire Development in a Single Compartment and Changes in the Neutral Plane

- Little to no smoke showing with condensed pyrolysis products on windows and possibly fingers of soot around doorways (vent limited decay stage fire).
- Flames and/or smoke showing from one or more openings (vent limited growth stage or fully developed fire).
- Bi-directional flow with a well-defined and lowering neutral plane at one or more openings (growth stage ventilation limited fire as illustrated in Figure 66).

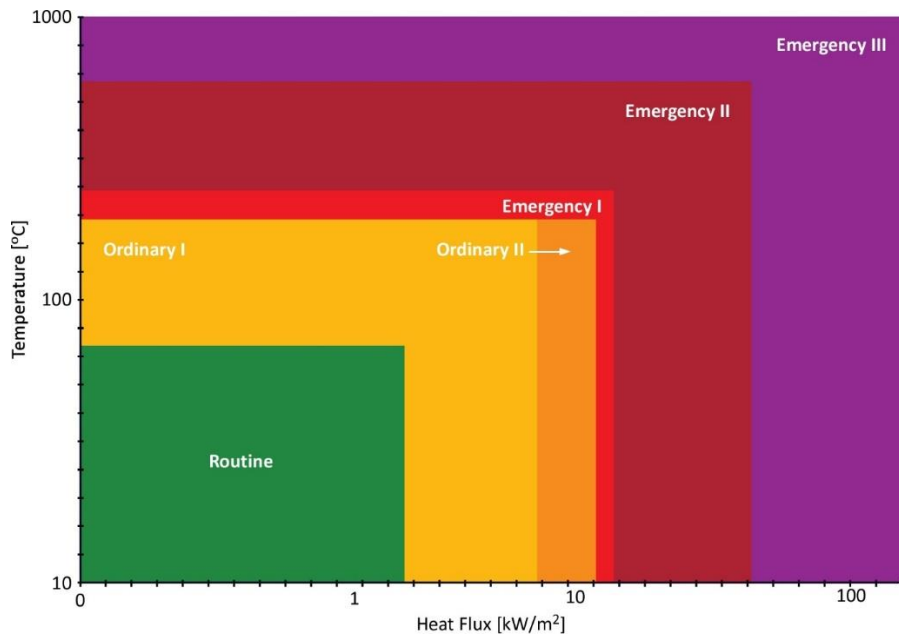
Figure 37. Thermal Classes

Weinschenk, Knight, & Regan (2024) have extended research conducted by Utech (1973) to identify six thermal classes based on the protective characteristics and more importantly the limitations of current firefighters protective clothing and self-contained breathing apparatus (see Figure 67 and Table 4).

It is likely that Firefighters Spencer Tejedas and Jack Pilarski encountered thermal classes that transitioned quickly from Routine on the exterior of the building just prior to entry through Ordinary I and II as they made their way through the living room to the hallway. Conditions in the hallway likely transitioned to Emergency I when beginning their search down the hallway and into the bedrooms on Side Alpha. As Firefighters Tejedas and Pilarski began their egress through the hallway, conditions transitioned to the Emergency II thermal class and post flashover to the Emergency III thermal class.

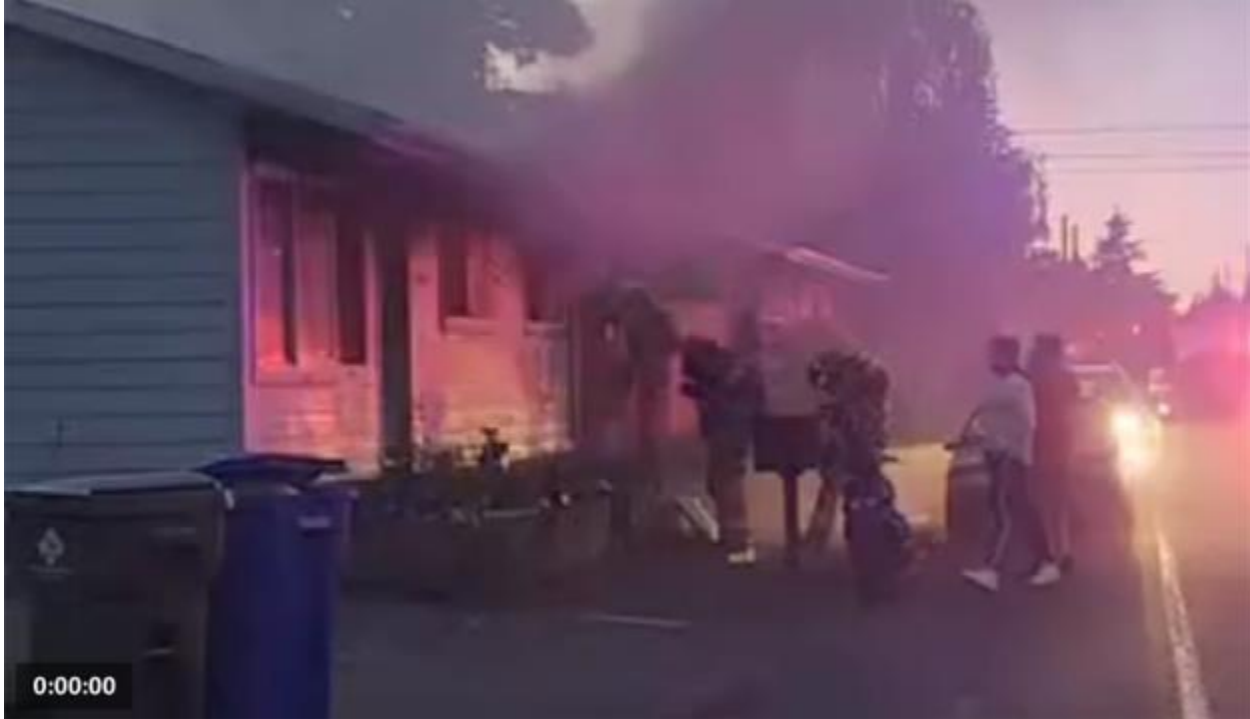
Figure 68. Firefighters Tejedas and Pilarski prepare to enter the building.

At 21:07:08 hours Engine 31 arrived on scene, established Command (initial Incident Commander), and reported a "1-story, wood-frame house, smoke showing on the alpha side." Incident Command announced, "Engine 31 pulling an inch and three-quarter to the front door, Rescue 31 you're going to be Backup." Engine 31B (Hydrant Firefighter and Nozzle Firefighter) departed the apparatus, approached the doorway on the alpha side, and donned SCBA masks.

ISSUE – An offensive strategy is inferred based on the order to stretch a line to the front door. This is not a direct statement of the strategy. This inference is common on fire scenes and can lead to confusion.
