Fire Behavior Case Study

On February 22, 2008 at approximately 1340 hours, the Durango Fire and Rescue Authority responded to a commercial fire in downtown Durango, Colorado. Before this incident was concluded, nine firefighters and officers were transported to the hospital following an explosion. Several of the injured had serious injuries and were admitted and the others were treated for minor injuries and released.

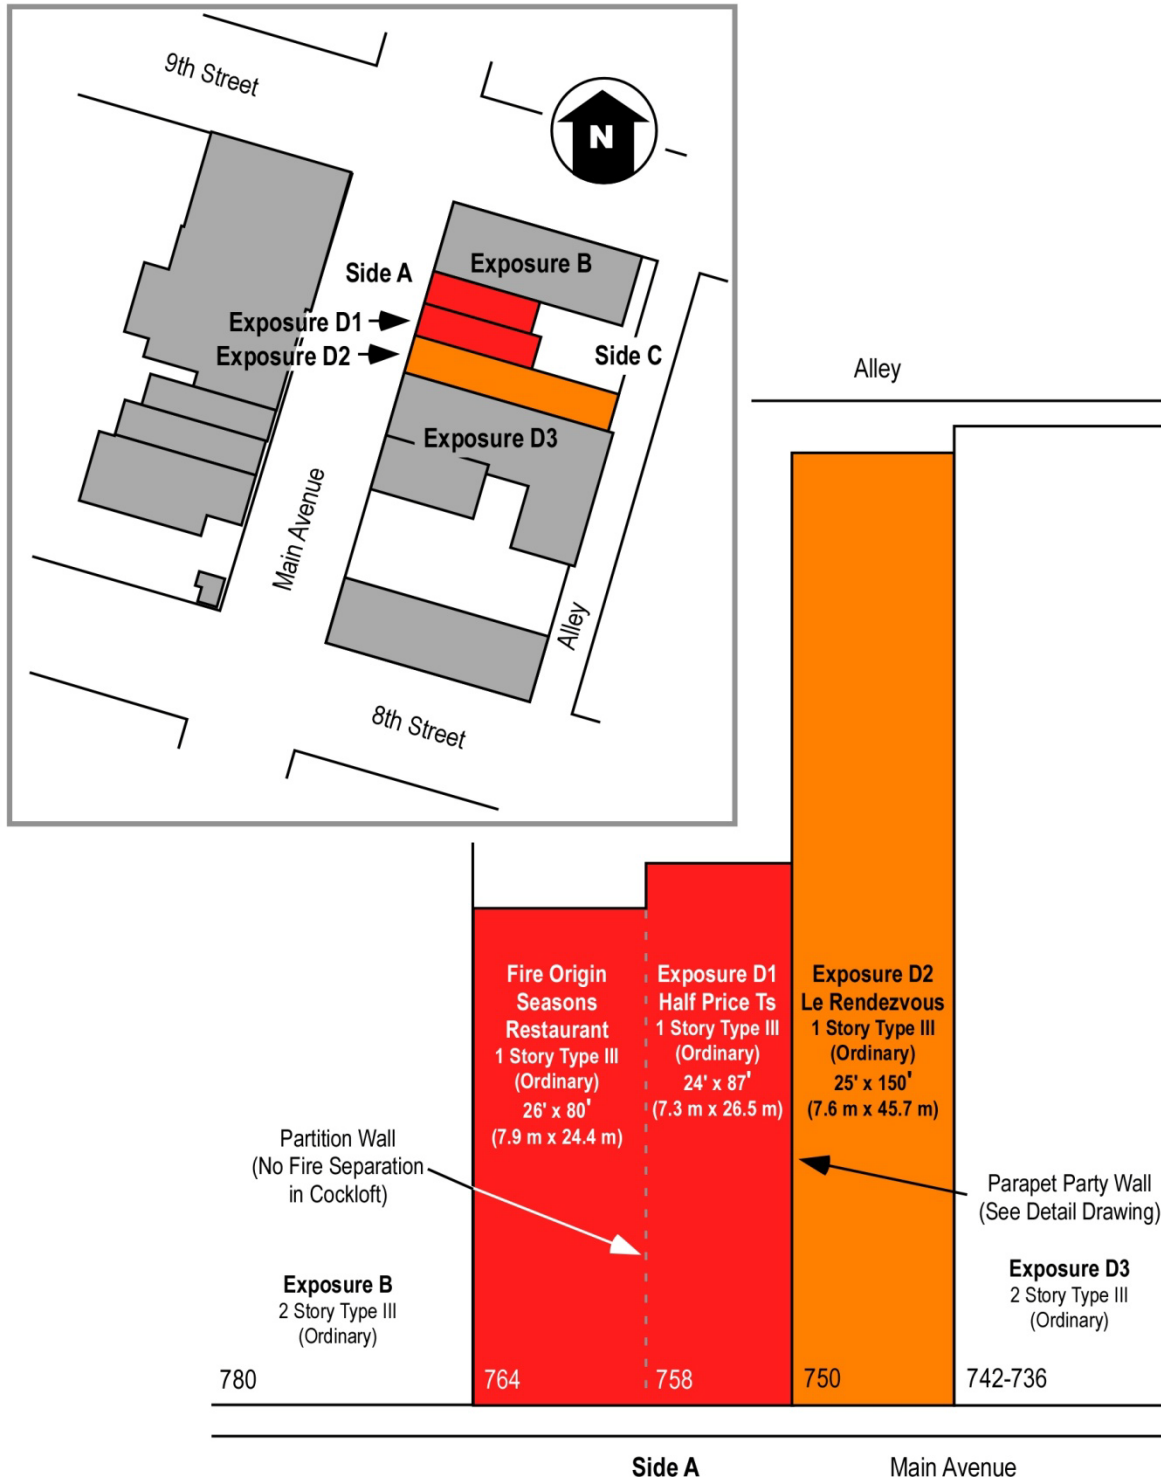
Figure 2. Plot Plan of 780-736 Main Avenue

This incident involved two buildings. One building contained the Seasons Restaurant (764 Main Avenue) and Half Price Ts (Exposure D1, 753 Main Avenue), and the other housed the Rendezvous Swiss Bakery (Exposure D2, 750 Main Avenue) as illustrated in Figure 2. Both buildings were one-story, Type III (Ordinary Construction) and were built in the 1900s. Both buildings had basements. The buildings had brick exterior walls and full dimension wood joists. Exposures B and D3 were two-story buildings of ordinary construction.

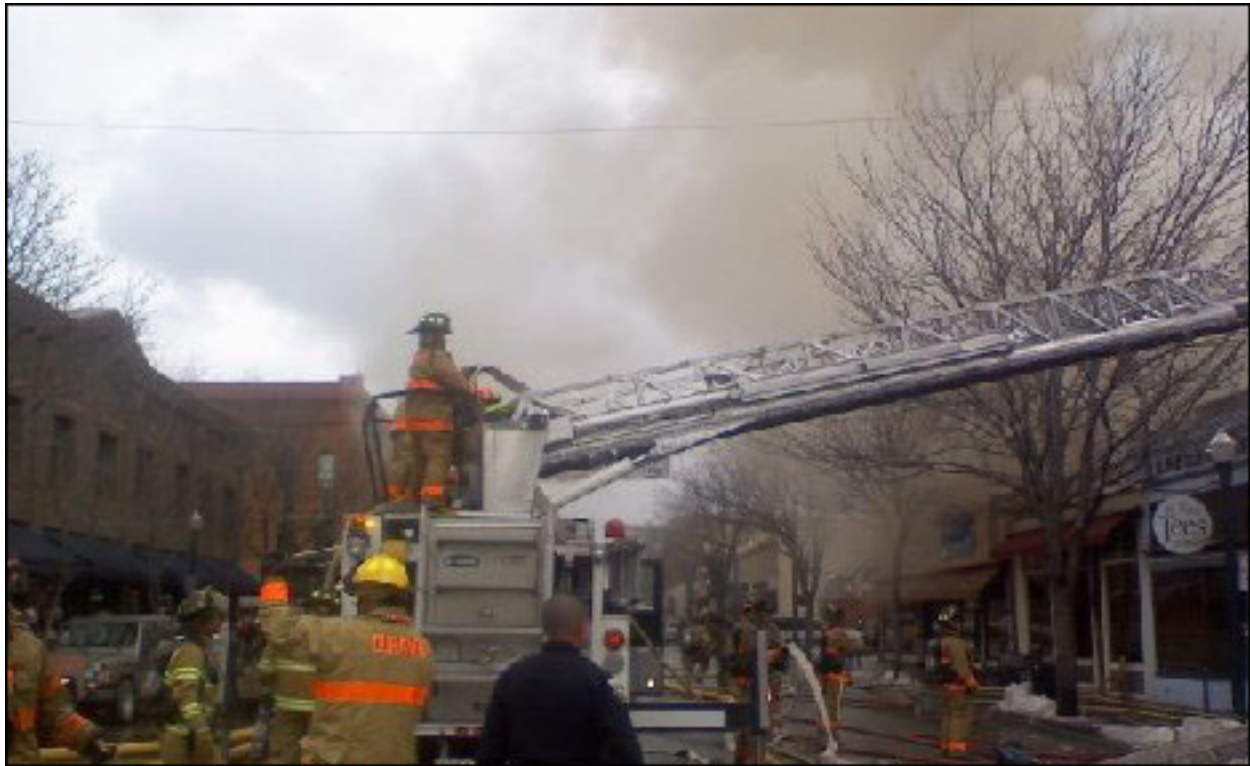
Figure 7. Ladder 2 Operating on Side A.

Engine 2 to Ladder 2). The Captain of Engine 1 assumed Command and assigned his crew as the Rapid Intervention Team (RIT). Engine 2 was tasked with investigating conditions in the Seasons Restaurant and Exposure D1.

At 1352, BC 1 arrived and assumed Command, reassigning the Engine 1 Captain as Operations. Ladder 1 arrived at 1356, positioned on 9th Avenue, just east of Main Avenue and deployed their aerial to the roof of Exposure B and checked for extension in Exposure B. At approximately the same time, the utility company reported that power had been shut off to Seasons and the exposures.

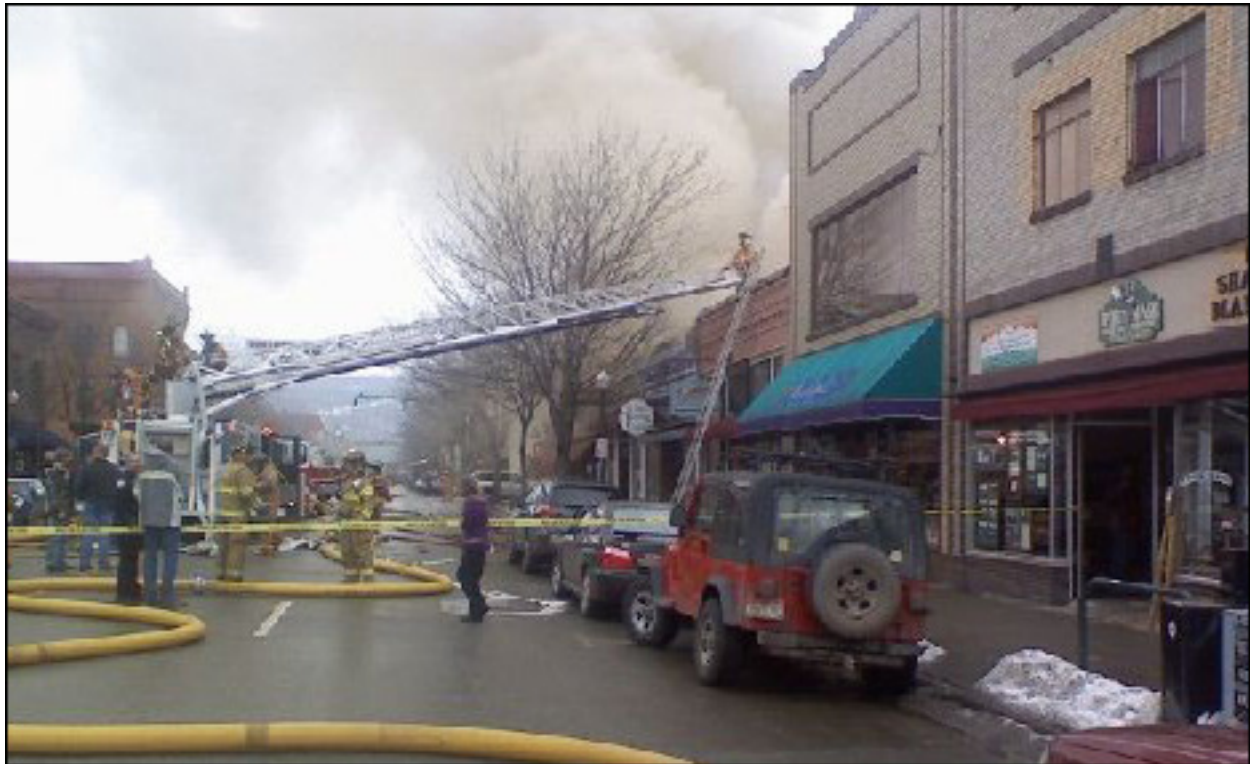
Figure 8. Side A at Approximately 1400 Hours

Using a chain saw, Ladder 2 (DC and Firefighter) began roof ventilation over Exposure D1. Roof operations are hampered by thick smoke and roof construction and Ladder 2 was unsuccessful in creating an adequate exhaust opening over Exposure D1. A large volume of thick, light brown smoke is pushing from the partially completed ventilation opening. Command reassigns Engine 2 from the interior to support Ladder 2 on the roof with a 1-3/4" (45 mm) hoseline.

The natural gas service to Seasons was shut off by the utility company at 1402. However, the meters to Exposure D1 and D2 were obstructed by deep snow delaying control of the utilities to the D Exposures. Exposure B is evacuated at approximately 1404 and at 1405, the Incident Commander (BC 1) ordered Central Dispatch to recall all off duty personnel.

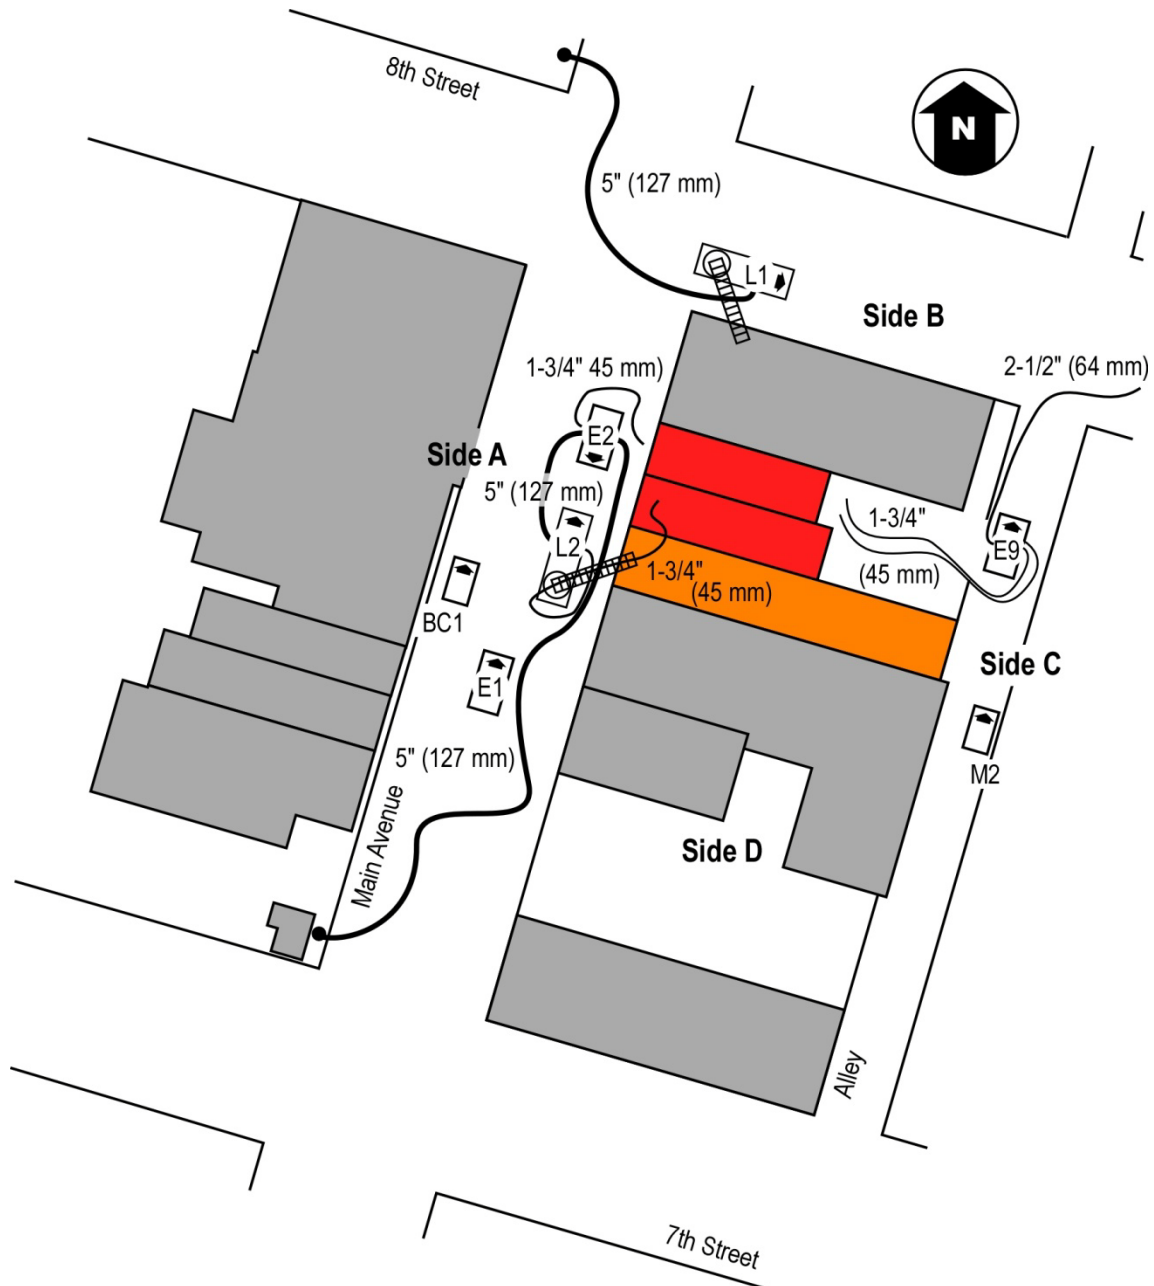
Figure 9. Approximate Locations of First Alarm Companies

and Exposure D1 were closed to slow fire development and buy time to complete vertical ventilation. However, the doors on Side C remained open).

At approximately 1415, the fire self-vents through the roof above Seasons with flames extending 4'-5' (1.2 M-1.5 M) above the roof. Engine 2 operate their 1-3/4" (45 mm) hoseline on the flames coming from the roof and onto the common wall between Seasons and Exposure B. Ladder 2 relocated on the roof of Exposure D1 and again attempted to cut an opening for vertical ventilation.
