Fire Behavior Case Study

The Case

Figure 1. Cross Section of 3146 Cherry Road NE

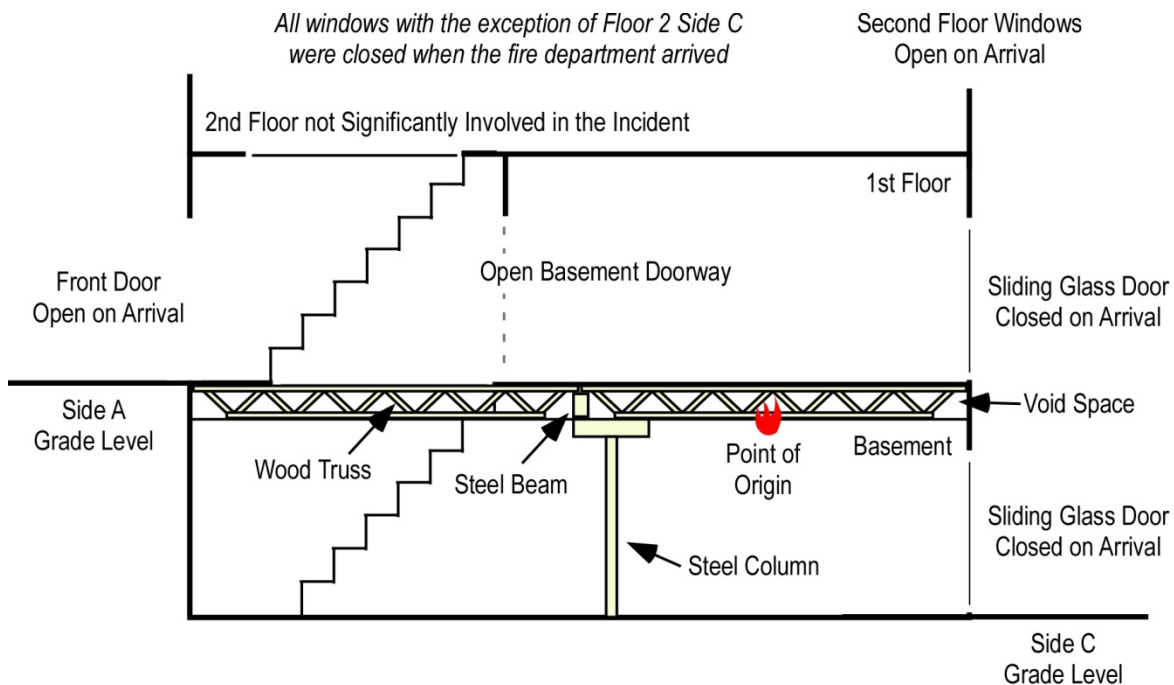
In 1999, two firefighters in Washington, DC died and two others were severely injured as a result of being trapped and injured by rapid fire progress. The fire occurred in the basement of a two-story, middle of building, townhouse apartment with a daylight basement (two stories on Side A, three stories on Side C).

The fire originated in an electrical junction box attached to a fluorescent light fixture in the basement ceiling (see Figures 1 and 3). The occupants of the unit were awakened by a smoke detector. The female occupant noticed smoke coming from the floor vents on Floor 2. She proceeded downstairs and opened the front door and then proceeded down the first floor hallway towards Side C, but encountered thick smoke and high temperature. The female and male occupants exited the structure, leaving the front door open, and made contact with the occupant of an adjacent unit who notified the DC Fire & EMS Department at 00:17 hours.

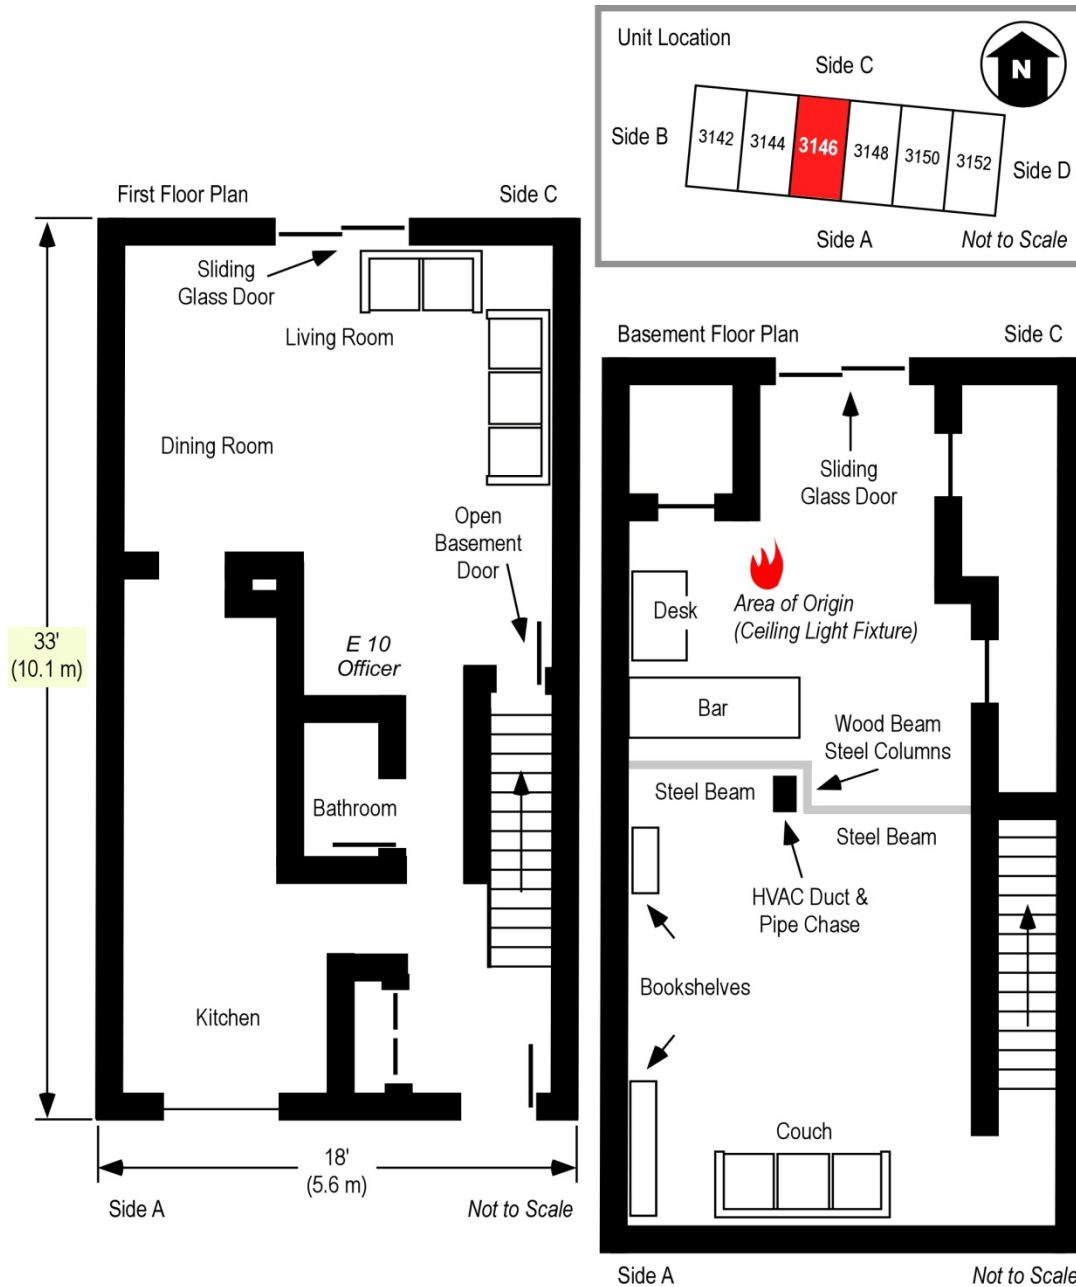
Figure 3. Plot and Floor Plan-3146 Cherry Road NE

The trusses ran from the walls on Sides A and C and were supported by steel beams and columns at the center of the unit (See Figure 3). The basement ceiling consisted of wood fiber ceiling tiles on wood furring strips which were attached to the bottom chord of the floor trusses. Basement walls were covered with gypsum board (sheetrock) and the floor was carpeted. A double glazed sliding glass door protected by metal security bars was located on Side C of the basement, providing access from the exterior. Side C of the structure (see Figure 3) was enclosed by a six-foot wood and masonry fence. The finished basement was used as a family room and was furnished with a mix of upholstered and wood furniture.

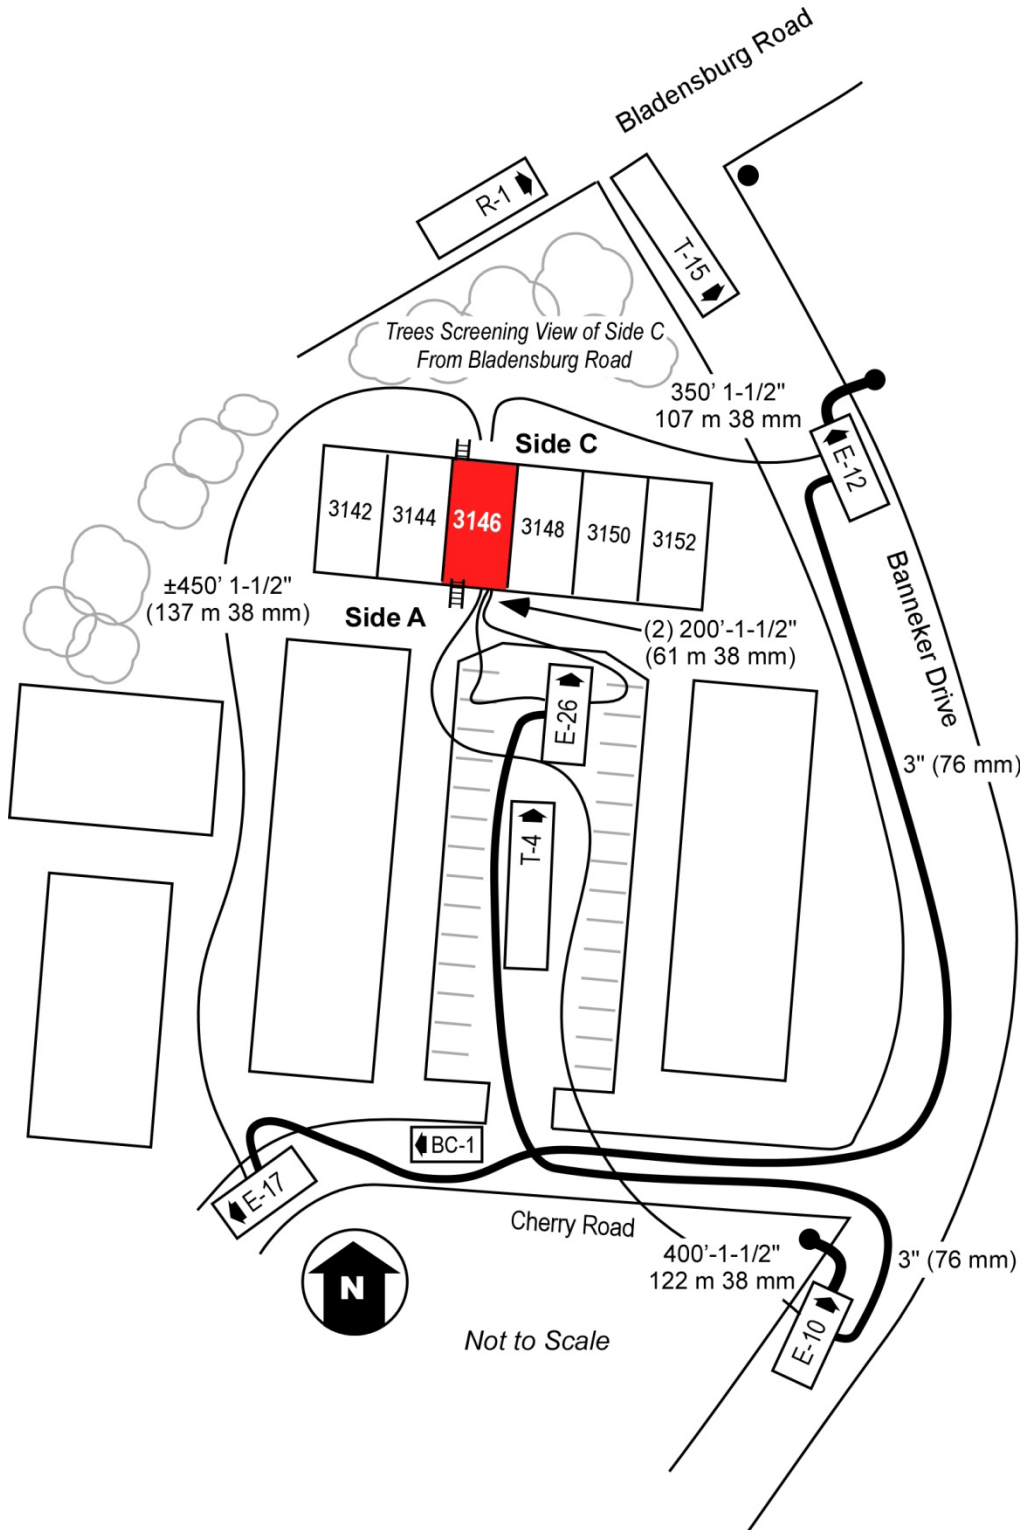
Figure 6. Location of First Alarm Companies and Hoselines

First due, Engine 26 laid a 3" (76 mm) supply line from a hydrant at the intersection of Banneker Drive and Cherry Road NE, positioned in the parking lot on Side A, and advanced a 200' 1-1/2" (61 m 38 mm) pre-connected hoseline to the first floor doorway of the fire unit on Side A (see Figure 6). A bi-directional air track was evident at the door on Floor 1, Side A with thick (optically dense) black smoke from the upper area of the open doorway. Engine 26's entry was delayed due to a breathing apparatus facepiece malfunction. The crew of Engine 26 (Firefighters Mathews and Morgan and the Engine 26 Officer) made entry at approximately 00:24.

Engine 17, the second due engine, arrived at 00:24, laid a 3" (76 mm) supply line from the intersection of Banneker Drive and Cherry Road NE, to a position on Cherry Road NE just past the parking lot, and in accordance with department procedure, stretched a 350' 1-1/2" (107 m 38 mm) line to Side C (see Figure 6).

Engine 12, the fourth arriving engine, picked up Engine 17's line, completed the hoselay to a hydrant on Banneker Drive (see Figure 6). The crew of Engine 12 then advanced a 200' 1-1/2" (61 m 38 mm) hoseline from Engine 26 through the front door of the involved unit on Side A and held in position approximately 3' (1 m) inside the doorway. This tactical action was contrary to department procedure, as the fourth due engine has a standing assignment to stretch a backup line to Side C.

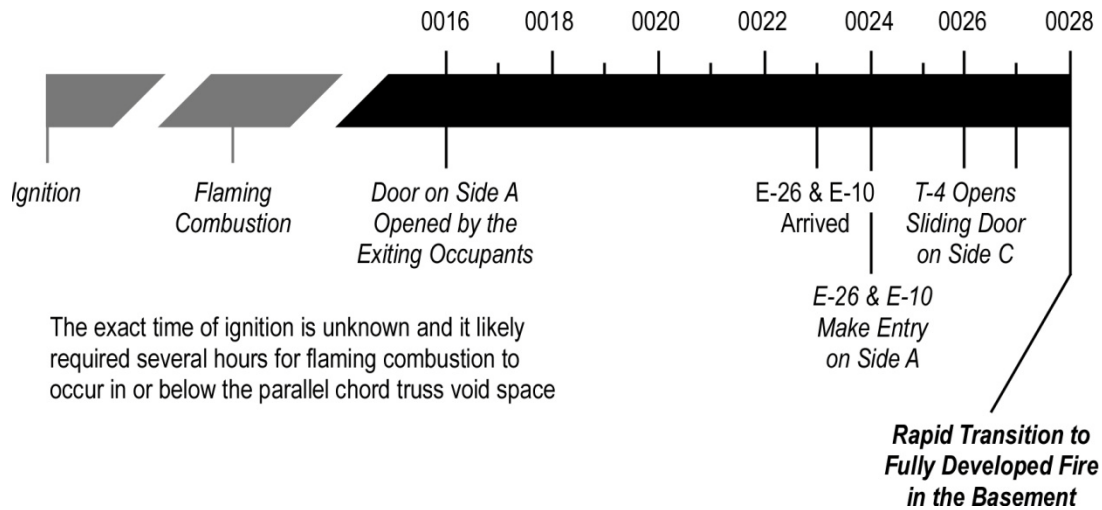
Figure 7. Timeline Leading Up to the Extreme Fire Behavior Event

The timeline illustrated in Figure 7 is abbreviated and focuses on a limited number of factors. A detailed timeline, inclusive of tactical operations, fire behavior indicators, and fire behavior is provided in a subsequent section of the case.

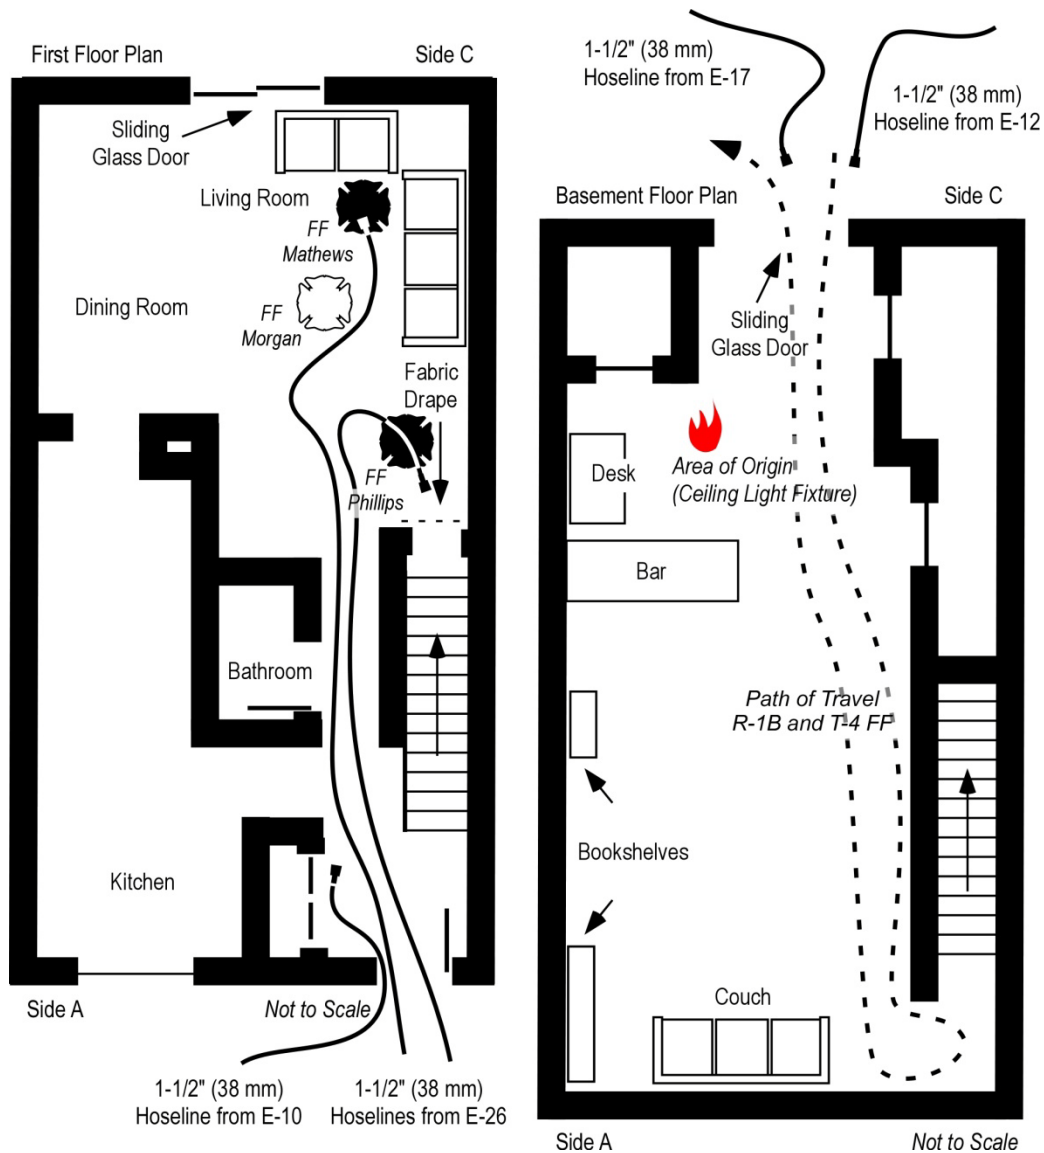
Figure 10. Location of Firefighters on Floor 1

After the exit of the officers from Engine 26 and Engine 10, the three firefighters (Mathews, Phillips, and Morgan) remained on Floor 1. However, neither Command (Battalion 1) nor a majority of the other personnel operating at the incident recognized that the firefighters from Engines 26 and 10 had been trapped by the rapid extension of fire from the Basement to Floor 1 (see Figure 10).

While at their apparatus getting a ladder to access the roof from Side B, Truck 4B observed the rapid fire development in the basement and pulled a 350' 1-1/2" (107 m 38 mm) line from Engine 12 to Side C, backing up Engine 17 (see Figures 6 and 10).

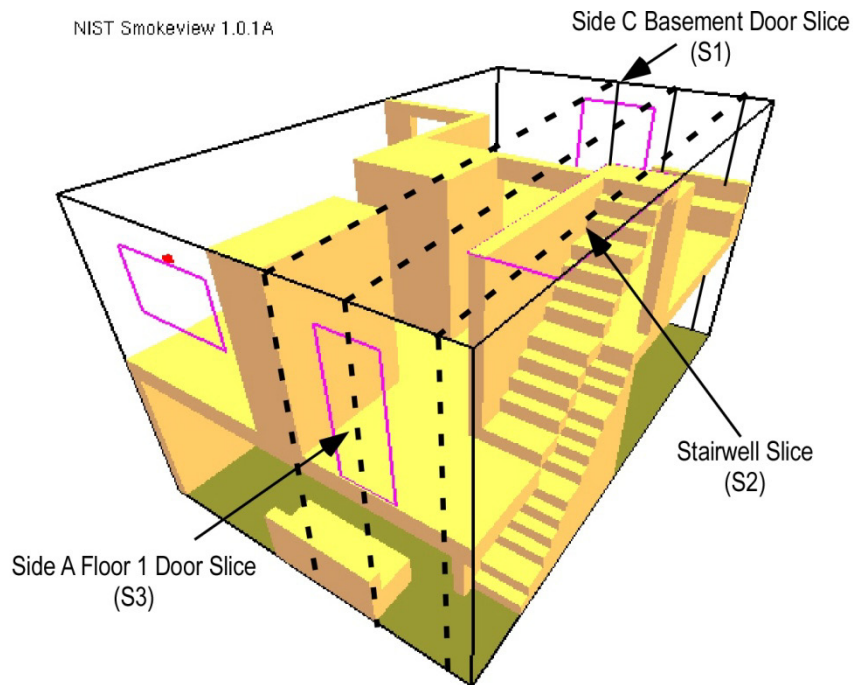
Figure 13. Perspective View of 3146 Cherry Road and Location of Slices

Smokeview is a visualization program used to provide a graphical display of a FDS model simulation in the form of an animation or snapshot. Snapshots illustrate conditions in a specific plane or slice within the building. Three vertical slices are important to understanding the fire dynamics involved in the Cherry Road incident, they are: 1) midline of the door on Floor 1, Side A, 2) midline of the Basement Door, Side C, and midline of the Basement Stairwell (see Figure 13). Imagine that the building is cut open along the slice and that you can observe the temperature, oxygen concentration, or velocity of gas movement within that plane.

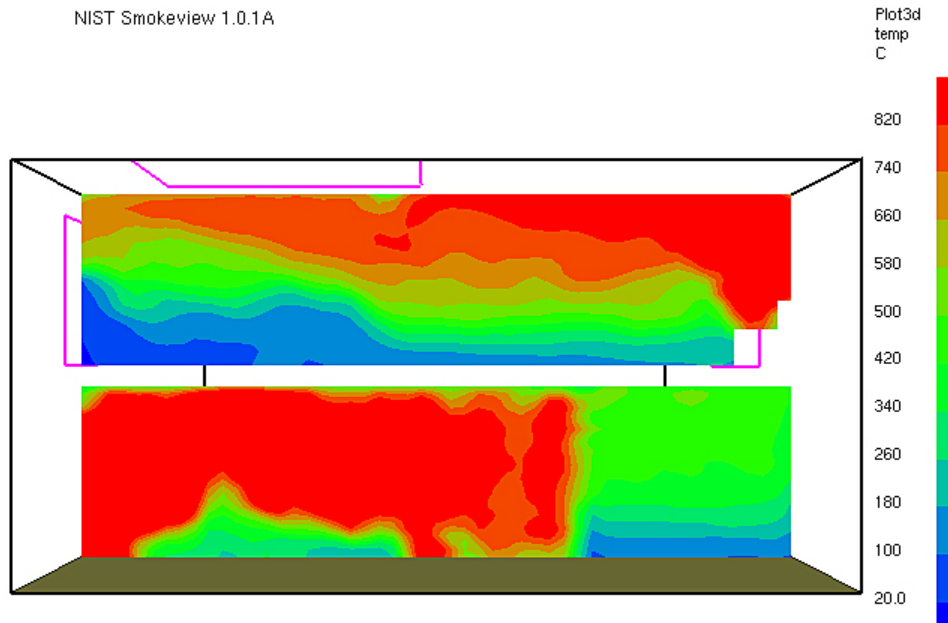
Figure 20. Temperature Slice Along Centerline of Floor 1 Door Side A (S3) at 200 s

Figures 14-21 illustrate conditions at 200 seconds into the simulation, which relates to approximately 00:27 during the incident, the time at which the fire in the basement transitioned to a fully developed stage and rapidly extended up the basement stairway to Floor 1. Data is presented as a snapshot within a specific slice. Temperature and velocity data are provided for each slice (S1, S2, & S3 as illustrated in Figure 13). Oxygen (O₂) concentration data is provided for the basement (S1) and stairwell (S2).
