# In-Station Training

## TM 18-20 Lancaster PA Mayday

This incident involved a fire in a small, two-story row house at 225 East Madison Street in Lancaster PA at 04:25 on February 18, 2013. Review the map and photos (Figures 1-5) to gain an understanding of area and building involved.

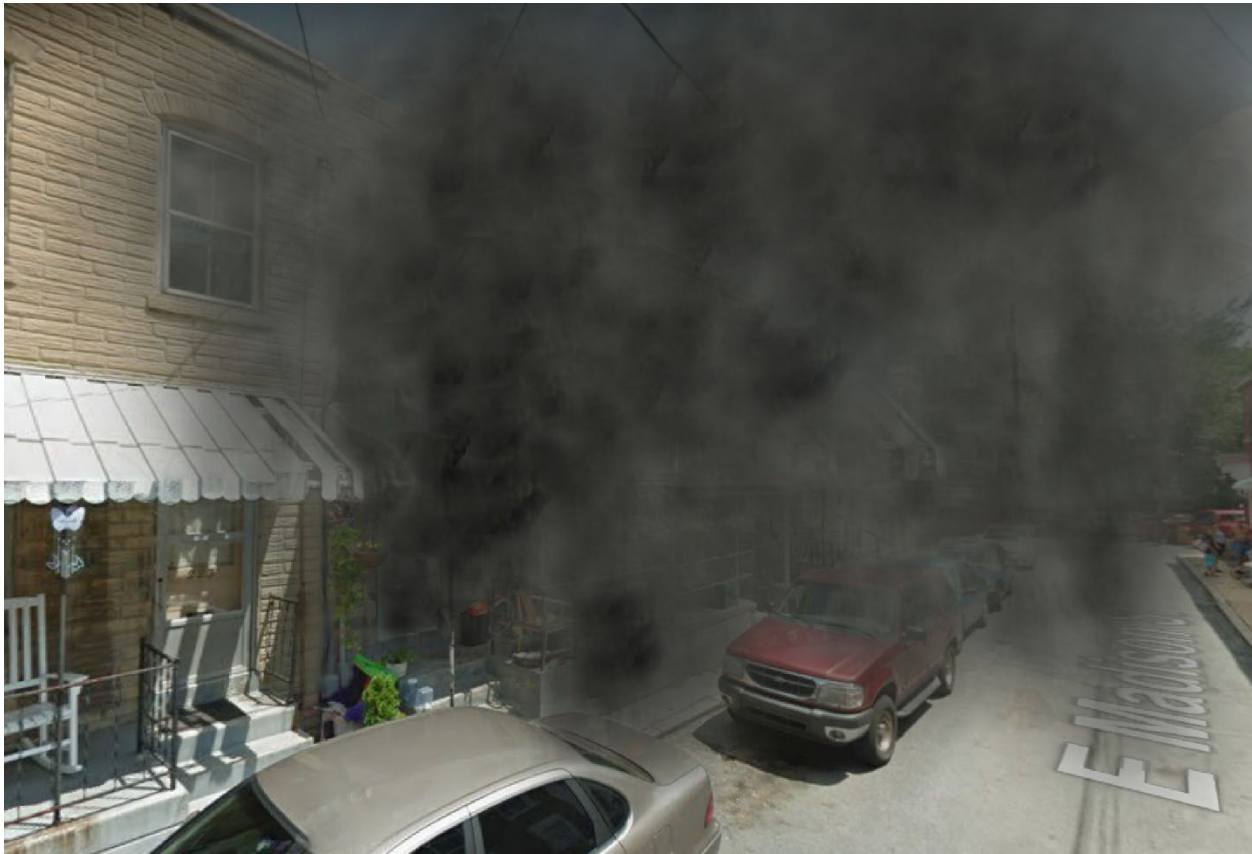
Figure 6. Conditions on Arrival Side Alpha [Simulation]

Listen to the first 1:30 of the [audio recording](#) of radio traffic for this incident. There is no photograph or video of conditions on arrival. Figure 6 is a simulation based on conditions reported to the investigators in the after-action report on this incident (Smith & Shouldis, 2013).
