In-Station Training

TM 20-43 Basement Fire-Mayday!

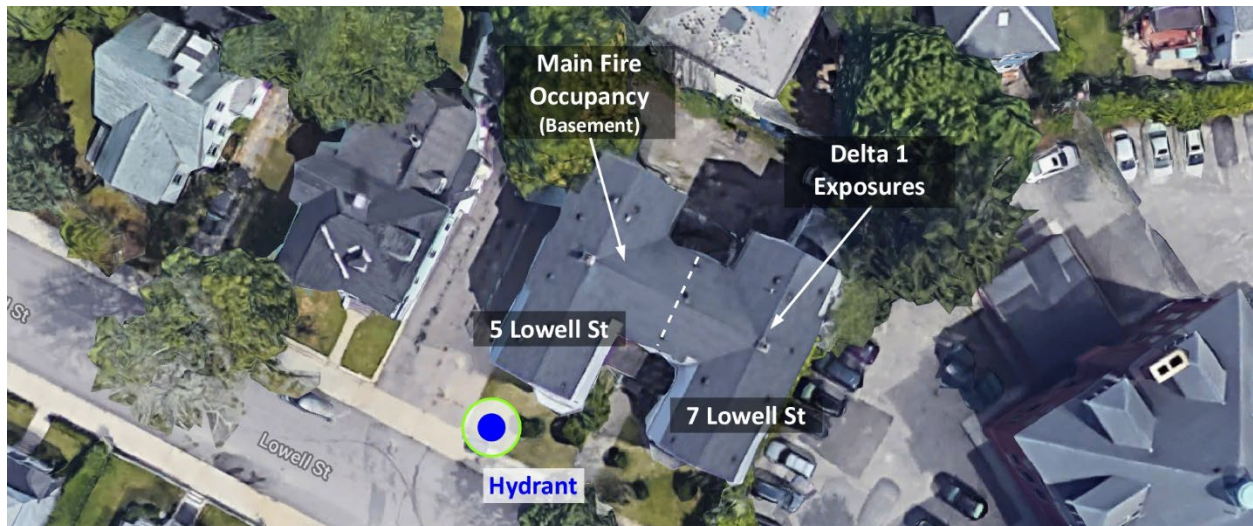
Figure 2. Aerial View

The fire building is a three-story, wood (balloon) frame “H” shaped structure built in 1900. The building contains six dwelling units (three in each side of the “H” and two per floor) and a full basement.

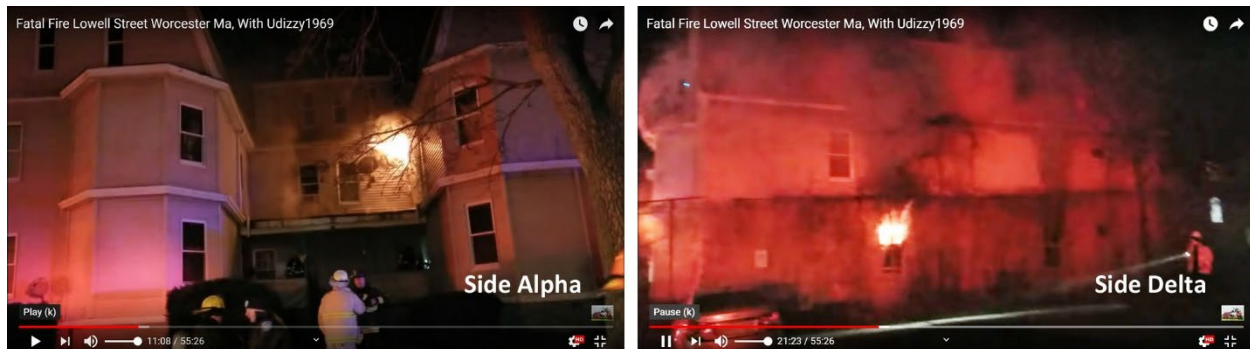
Figure 7. Developing Fire Conditions

2. What is the significance of the location of the fire observed in these two video segments to the company or companies working on the second floor? What communication should take place between companies assigned to fire control or to check for extension and command when they discover fire in structural voids that is not quickly controlled?

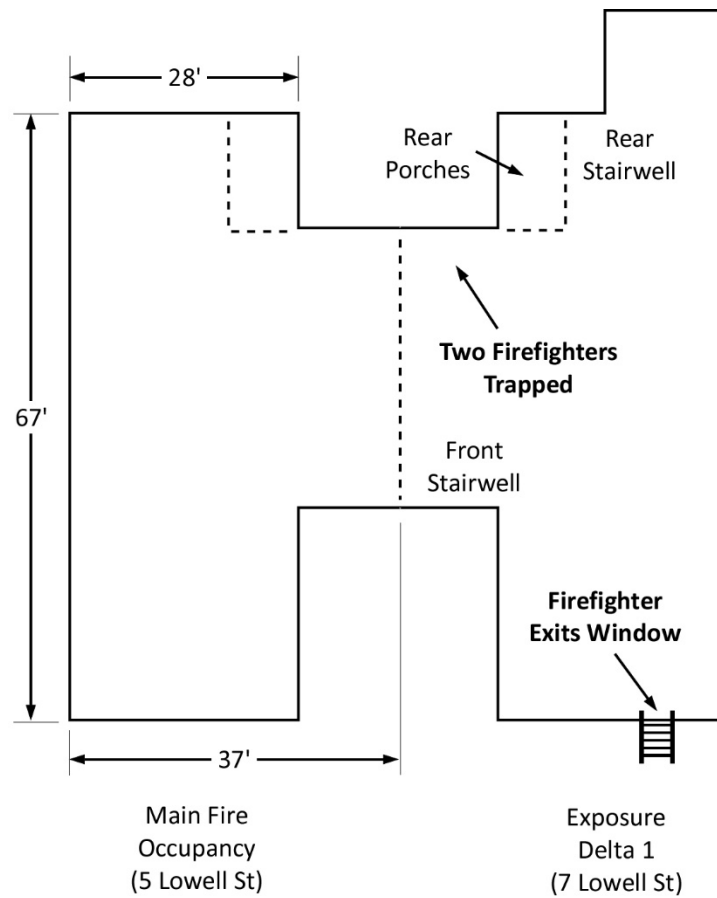
Figure 8. Building Configuration and Location of Mayday Firefighters

7. Write two Mayday messages, one for a firefighter trapped on Floor 2 Side Alpha of Exposure Delta 1 and the second for two firefighters trapped on Floor 2 Side Charlie of Exposure Delta 1.
