In-Station Training

TM 22-33a Residential Fire Mayday

Purpose

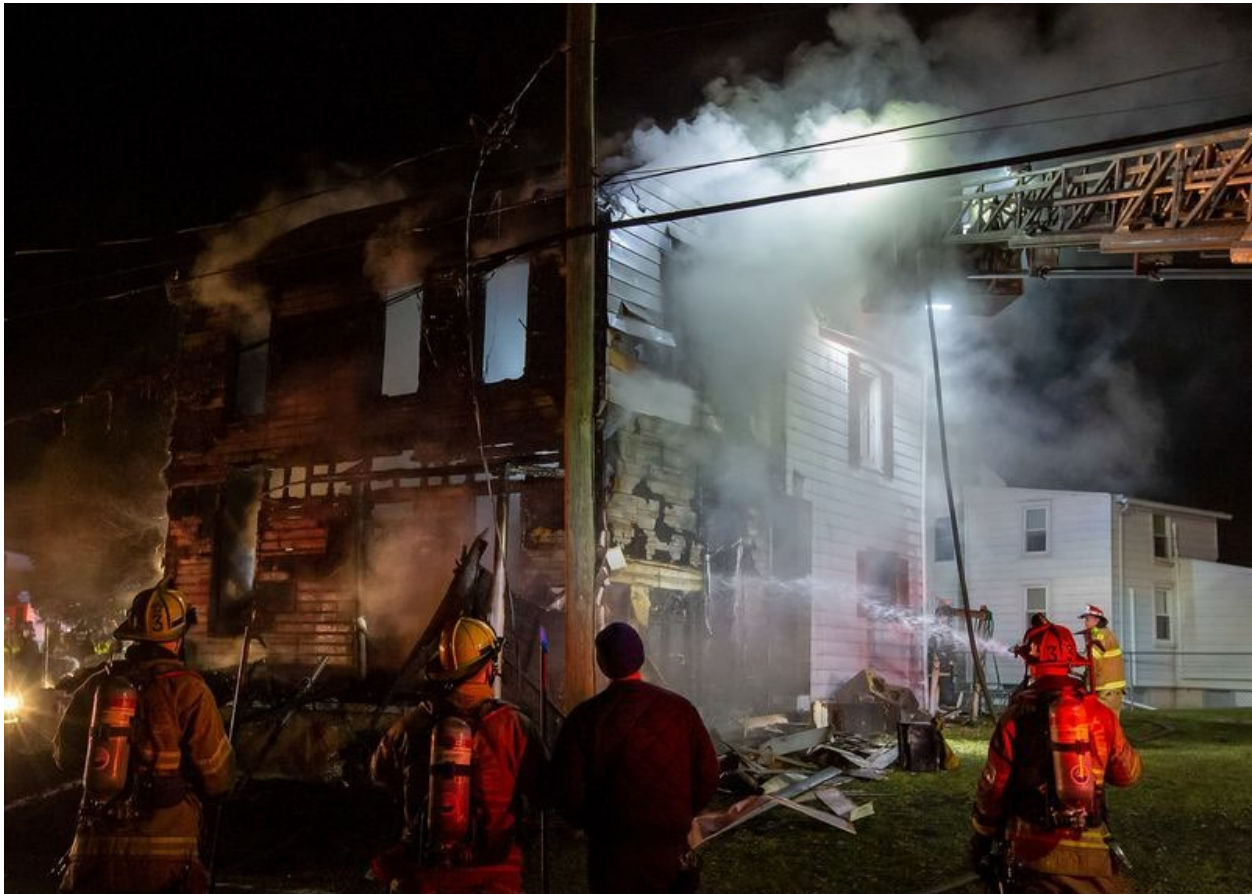
Figure 7. Conditions after Fire Control

Companies operating on the interior (one on Floor 1 and one on Floor 2). Companies are on-deck on Sides Alpha and Bravo. Incident organization is as you have specified in earlier questions in this 10-Minute Training. The engine on Floor 1 reports that they have located a deceased occupant on Floor 1 in the Alpha/Bravo corner. The engine on Floor 2 reports that they have an all clear on Floor 2. You have just received radio reports of fire control on Floors 1 and 2 and have transmitted the fire control benchmark to ICOM.
