While most residential fires start on the interior, fires starting outside and extending into the building can provide unique challenges. Firefighters and officers need to understand the impact of building design and construction on fire spread and the impact of tactical operations.

This incident involved a residential fire at 115 Ray Lee Drive in Park Hills, Missouri on January 10, 2023 at 15:30 (Daily Journal Missouri, 2023 & Radford, 2023). Review the map and photos (Figures 1-7) to gain an understanding of area and building involved.

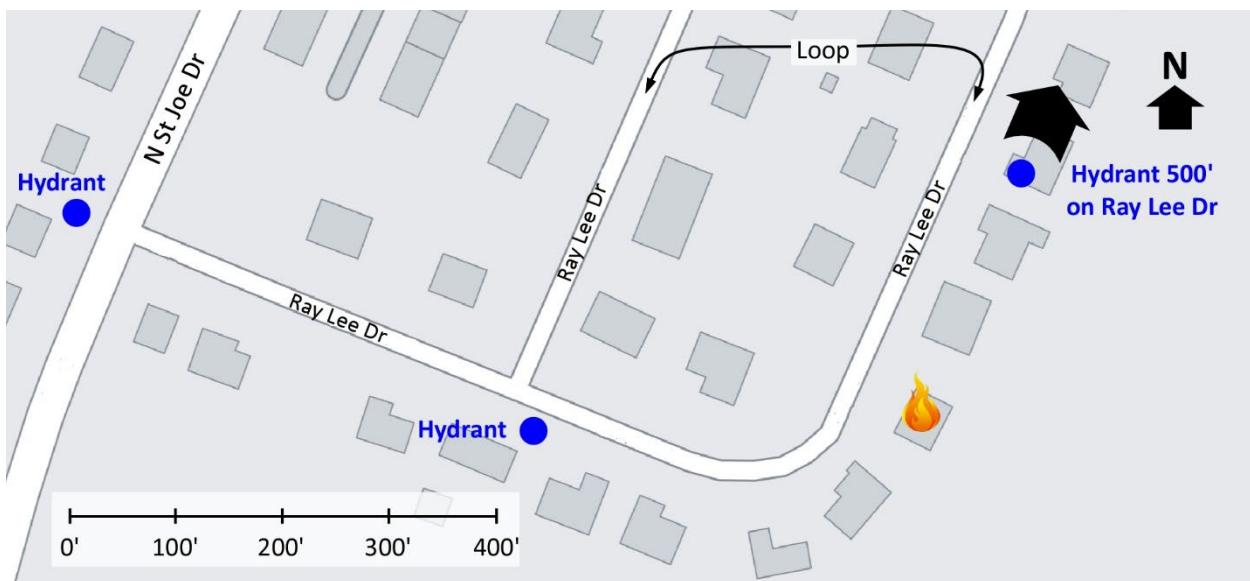
Figure 1. Map of the Incident Area

The closest hydrant is located on Ray Lee Drive in the direction of travel from North Saint Joe Drive. Additional hydrants are located on North Saint Joe Drive and Ray Lee Drive as illustrated in Figure 1.

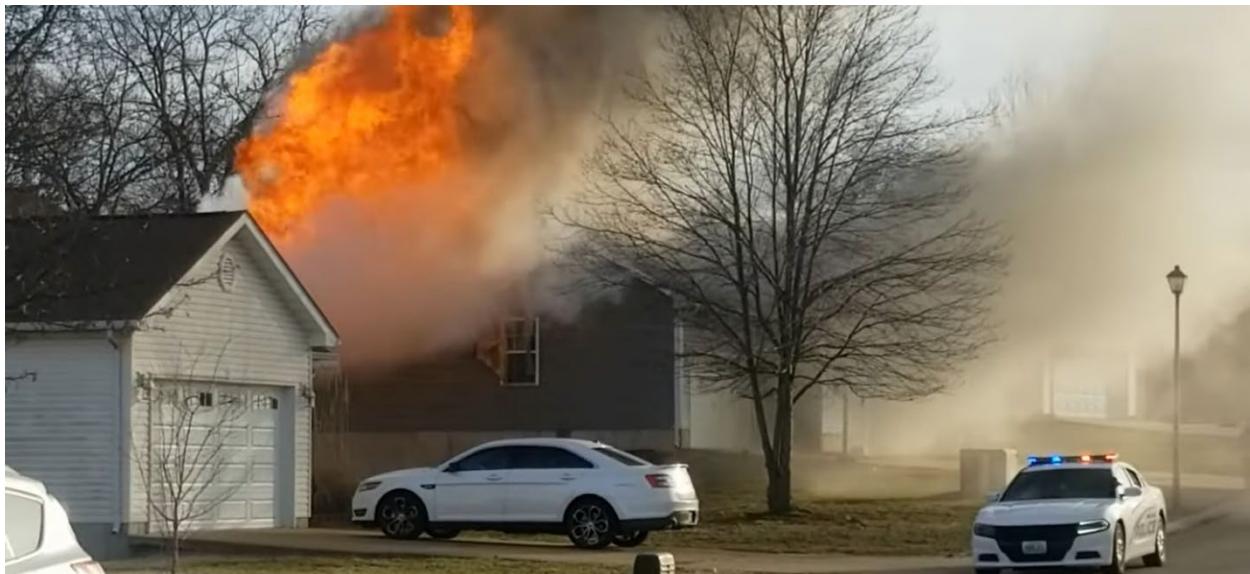
Figure 8. Conditions on Arrival

While responding you hear a command officer, engine and advanced life support ambulance with typical staffing for your agency go enroute. The second engine will arrive approximately six minutes after you, followed by the command officer. The ALS ambulance will arrive approximately eight minutes after you arrive. All other units dispatched on the first alarm will arrive after the command officer. You are arriving from the northwest on Ray Lee Drive. Examine Figure 8 illustrating conditions on arrival.

There is a fire involving the first-floor deck on Side Charlie with extension to the attic and first floor. There are no indications of fire in the walk out basement. Conditions on Side Delta are consistent with those on Side Alpha.

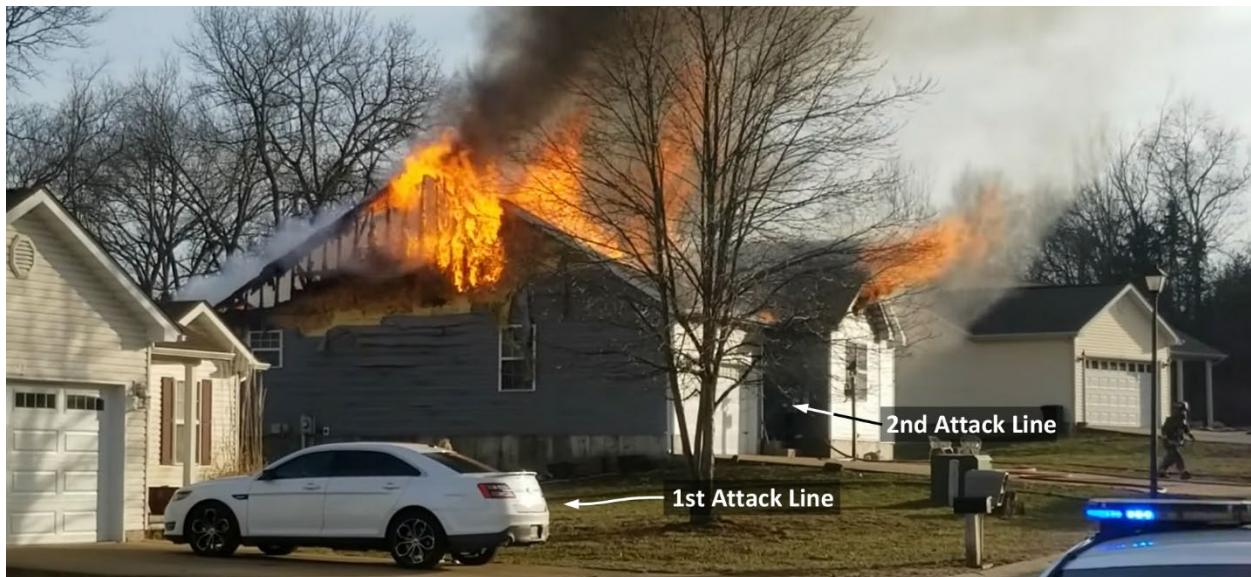
Figure 9. Attack Line Deployment

As illustrated in Figure 9, the first attack line was stretched on¹ Side Charlie and the second line was stretched through Aide Alpha

8. Was the placement of the initial attack line on Side Charlie consistent with your initial line placement? What factors influenced placement of your initial attack line?

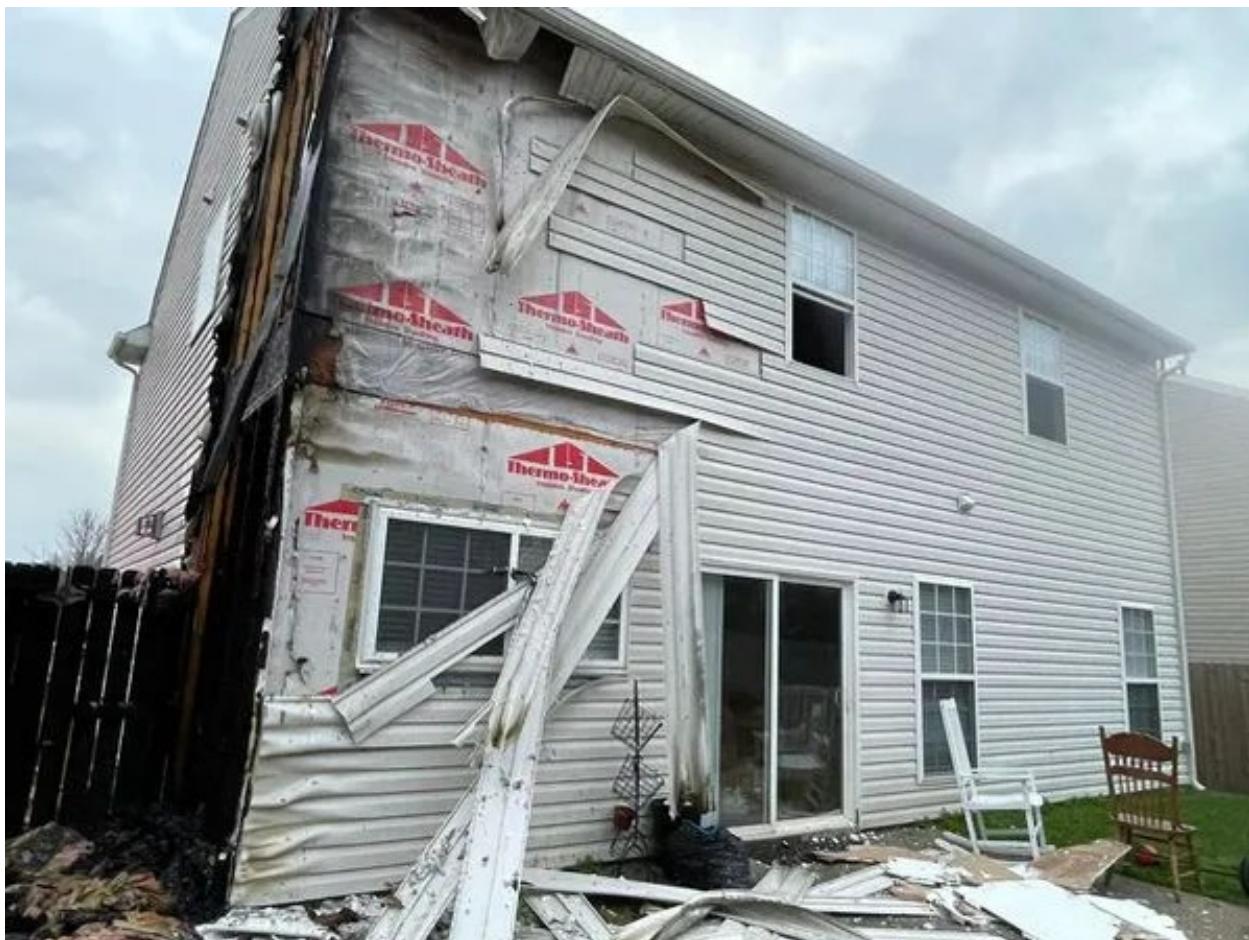
Figure 10. Vinyl Siding and Soffits

door into the attic or trussloft. Figure 10 illustrates fire extension on the exterior with penetration through a melted vinyl soffit.

Have a look at [Soffit installation - Vinyl Siding Guide](#) (VSI, 2023) to learn how vinyl soffits are constructed and consider how this may influence extension of an exterior fire or overlapping fire from a window or
