In-Station Training

TM 23-17 Commercial Vehicle Fire

Commercial vehicle fires can present significantly different challenges than passenger cars and small trucks. The size and type of truck, type of cargo, and access are important critical fireground factors when responding to this type of incident.

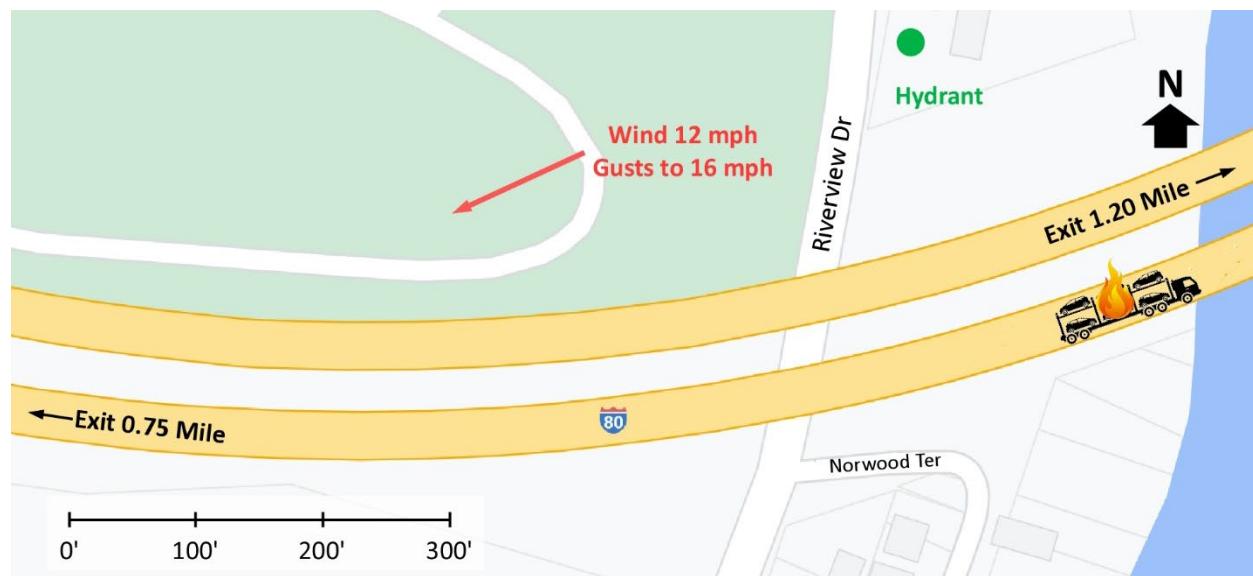
Figure 1. Map of the Incident Area

The closest hydrant is located on Riverview Drive (below the interstate highway) as illustrated in Figures 1 and 5. Other hydrants are located near the interstate exits to the east and west of the incident location.

This incident involved a commercial vehicle fire on eastbound Interstate 80 in Woodland Park, New Jersey on April 5, 2023, at 10:30 (Tornadochaser66, 2023; Quinn, & Fagan, 2023). Review the map and photos (Figures 1-5) to gain an understanding of the area involved.

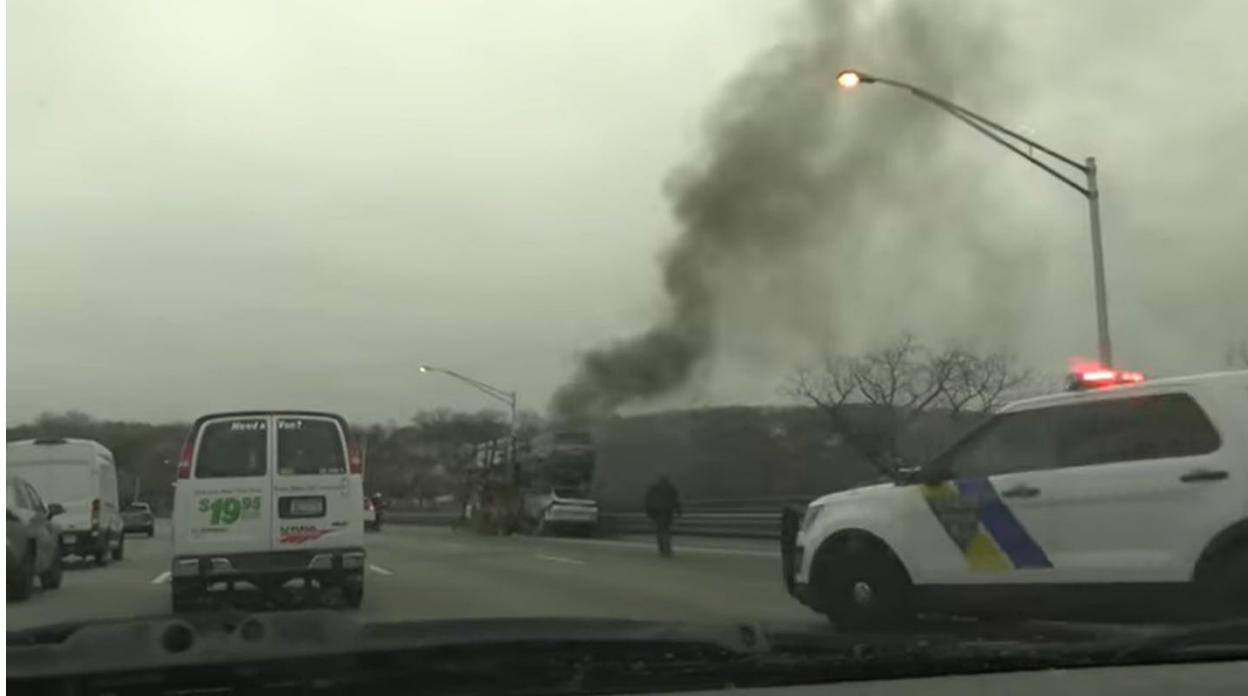
Figure 6. Conditions on Arrival

Watch the first 0:15 of the [incident video](#) (Tornadochaser66, 2023) and examine Figure 6 illustrating conditions on arrival.

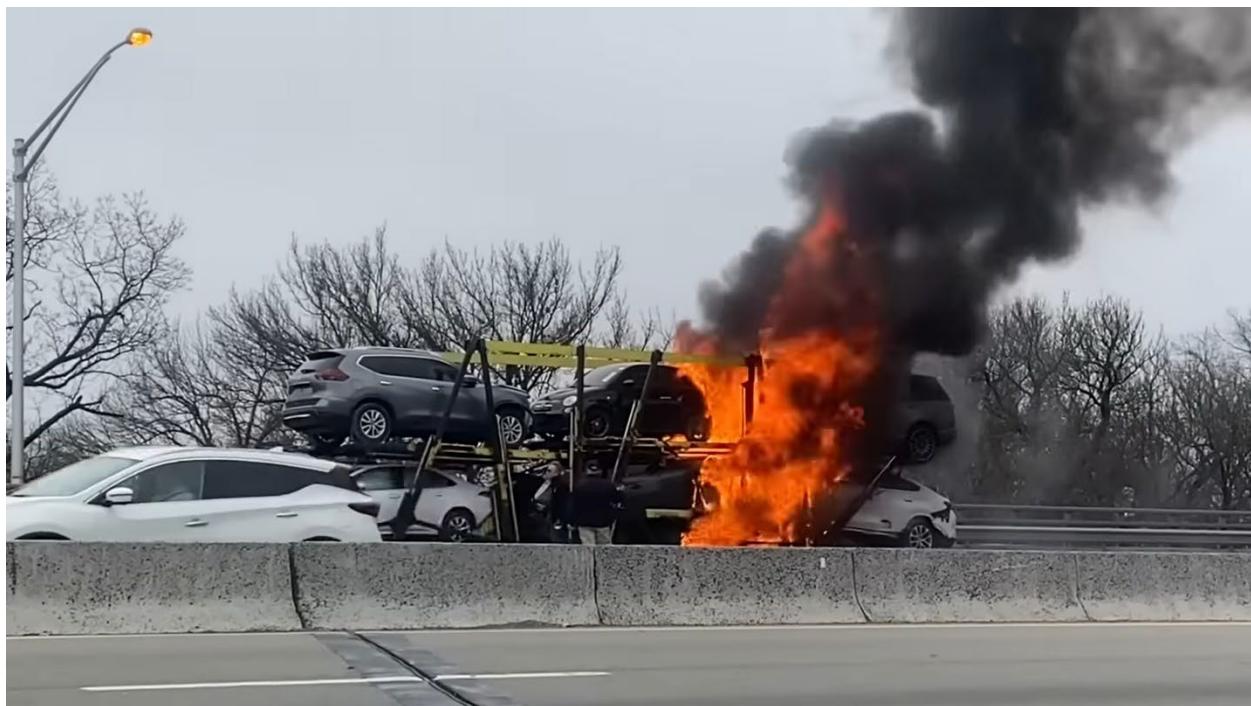
Figure 7. Conditions Shortly After Arrival

Watch the incident video from 00:15 to 00:30 and examine Figure 7. You are unable to perform 360° reconnaissance due to the position of the vehicle in the breakdown lane, the guardrail, height of the highway above grade, and fire conditions. It does not appear that the involved and exposed vehicles are electric or hybrid.
