In-Station Training

TM 23-27 Apartment Fire

Fire behavior and building construction are at the center of strategic and tactical decision-making in structural firefighting. IC's must not only be able to recognize what is happening in the moment but also be able to project what is likely to happen as the incident progresses. Similarly, water supply for firefighting operations should be based on potential changes in fire conditions.

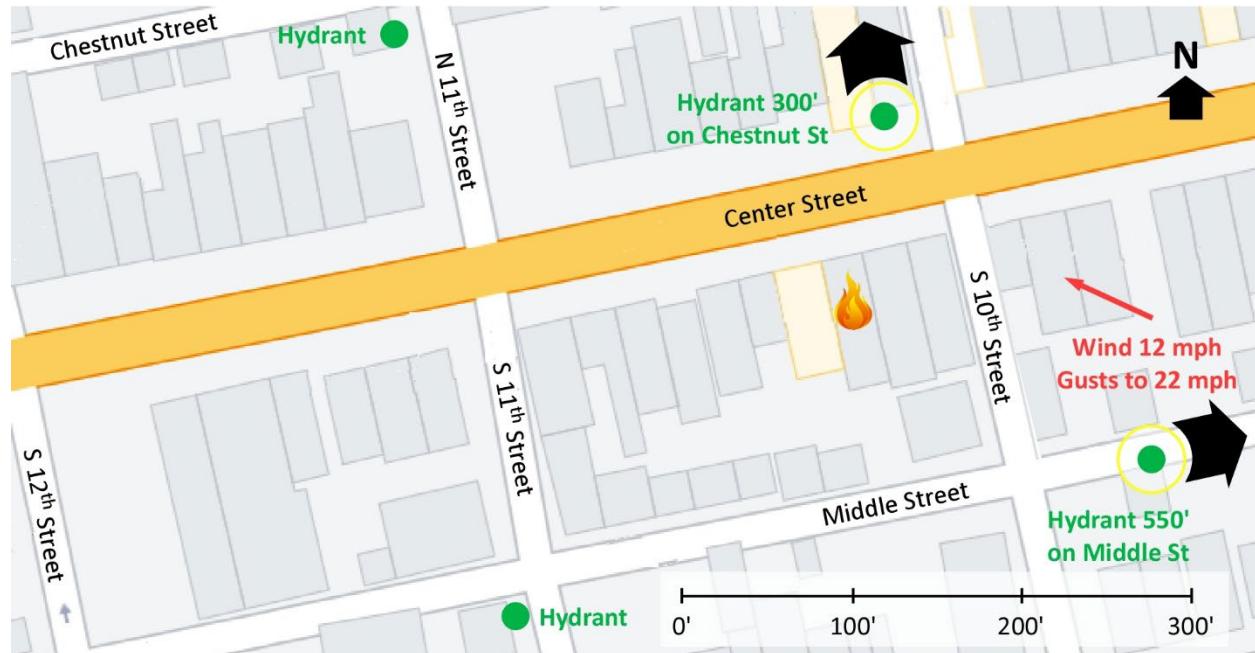
Figure 1. Map of the Incident Area

The closest hydrant is located to the south southeast of the incident location on Middle Street at S 10th Street. Several other hydrants are in the area as illustrated in Figure 1.

This incident involved a fire at 1010 Center Street in Ashland, Pennsylvania on June 3rd, 2023, at 20:20 (Skook News, 2023; WNEP Web Staff, 2023; & Sylvester, 2023). Review the map and photos (Figures 1-4) to gain an understanding of the area and building involved.

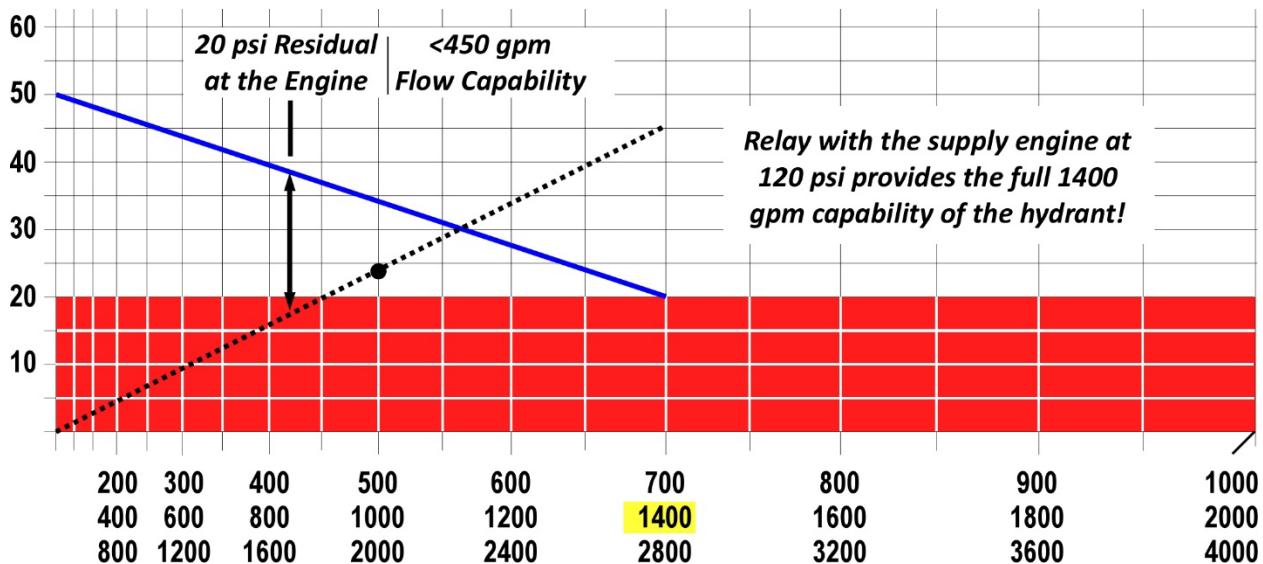
Figure 6. Hydrant and Supply Line Capability and Limitations

Figure 6 illustrates that using a forward lay provides a flow capability on the fireground of less than 450 gpm. However, an engine placed on the hydrant (either by using a reverse lay or having the supply engine take over the hydrant and pump an existing supply line) will allow delivery of the full 1400 gpm capability of the hydrant.

Consider the following situation. The distance between the fire and the closest hydrant is 300' (as in the incident in this 10-Minute Training). The static pressure at that hydrant is 50 psi and the flow capability from the hydrant is 1400 gpm at a residual pressure of 20 psi. You are using a 5" supply line which has a friction loss of 8 psi/100' at 1000 gpm.
