# In-Station Training

## TM 23-30 Residential Fire

This incident involved a residential fire at 281 19th Avenue, Brick, New Jersey on June 15, 2023, at 11:13 (Jersey Shore Fire Response, 2023; Costello, 2023; & Rossics, 2023). Review the map and photos (Figures 1-6) to gain an understanding of the area and building involved.

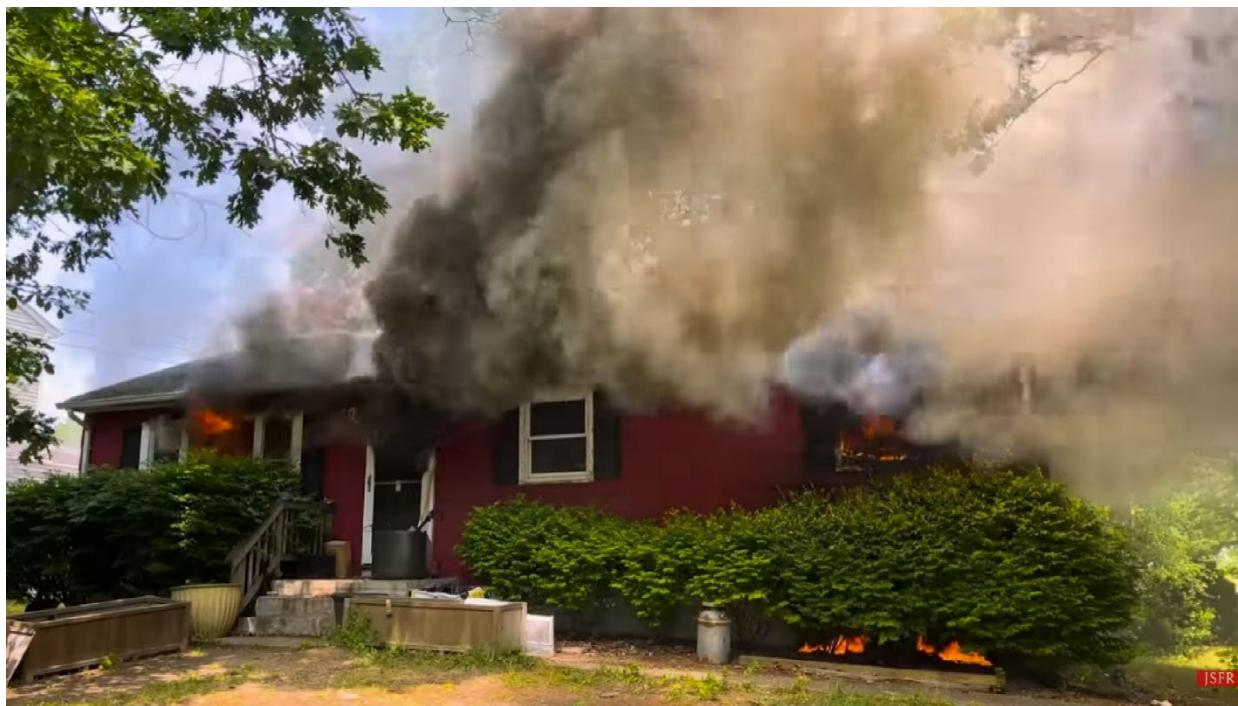
Figure 7. Conditions on Arrival

Watch the [incident video](#) (Jersey Shore Fire Response, 2023) from 04:30 to 05:00 and examine Figure 6 illustrating conditions on arrival.

Smoke is visible from the eaves on Side Charlie with smoke blowing from Bravo/Charlie to Alpha/Delta. Law enforcement officers advise that the occupants are out of the building and their two dogs are secured in the back of a police vehicle.

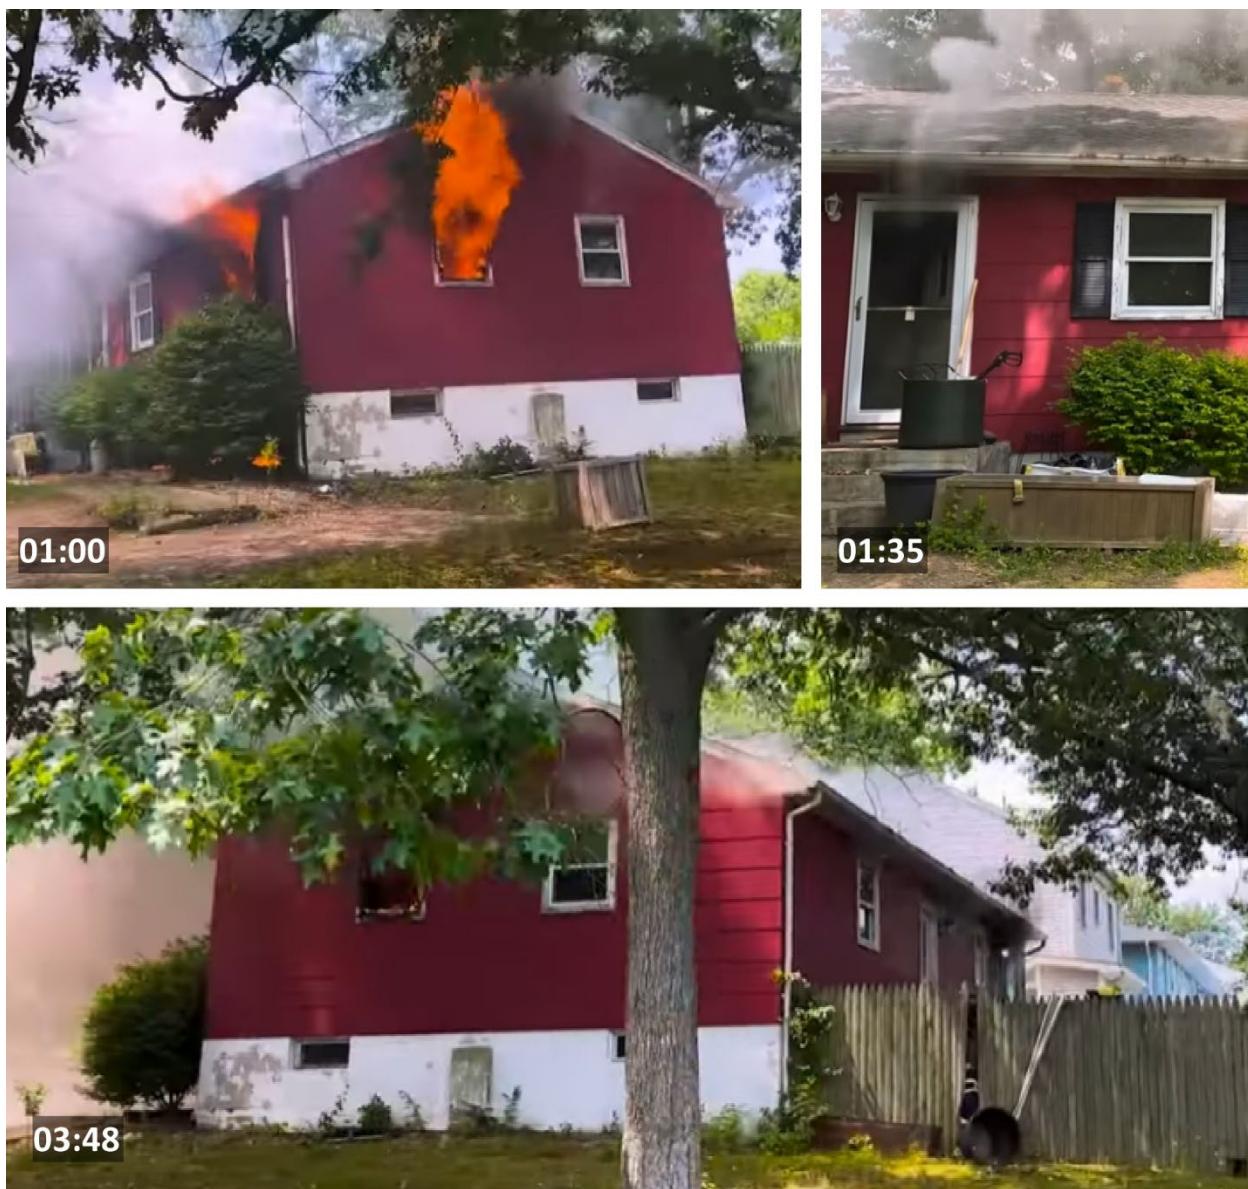
Figure 8. Ventilation Profile &amp; Flow Path

Watch the [incident video](#) (Jersey Shore Fire Response, 2023) from 1:00 to 05:00 and examine Figure 8, which illustrates the initial ventilation profile (over several minutes early in the incident). Discuss how failure of the bedroom windows on the Alpha/Delta corner, the open front door (the screen door is closed), and wind speed and direction may have influenced fire development and spread from the bedroom (room of origin) throughout the first floor.

How would closing the door have influenced the air track from the windows on Sides Alpha and Delta (as illustrated in Figure 8)? Would the air track have remained unidirectional, or would it likely have become bi-directional (taking air in the lower area of the window and the upper area remaining exhaust)? How would this have impacted the heat release rate from the fire?

It appears that the openings (door and windows) on Side Charlie were closed. But if there was an opening on Side Charlie, how might closing the door on Side Alpha have influenced fire development and spread? How would this have influenced the air track from the windows on Sides Alpha and Delta (as illustrated in Figure 8)?
