In-Station Training

TM 23-47 Propane Facility Leak and Fire

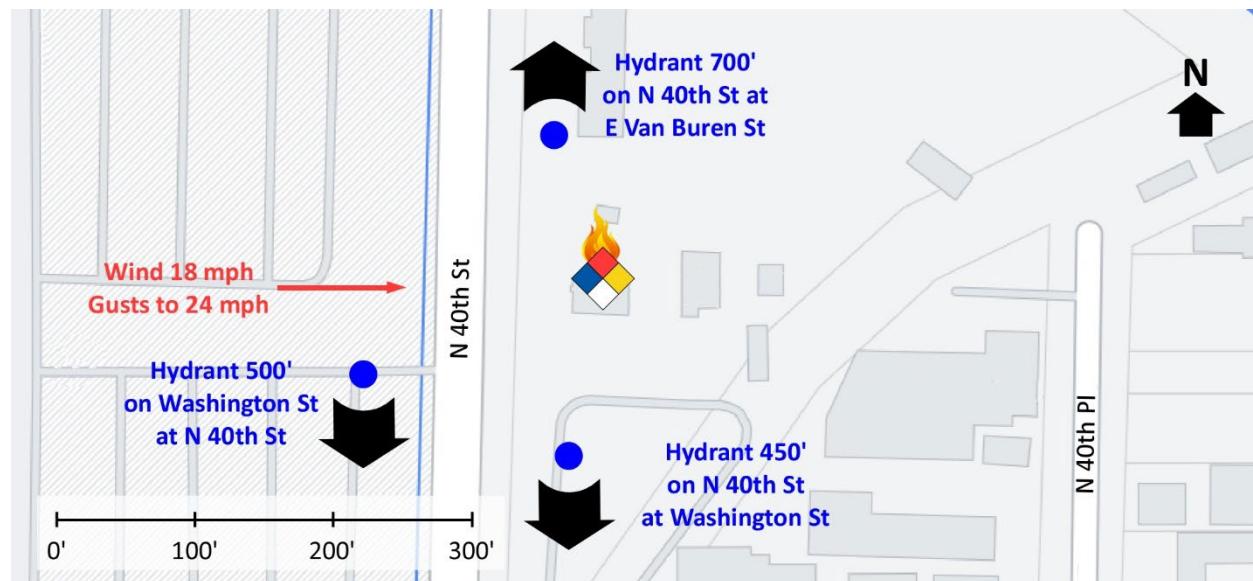
Figure 1. Map of the Incident Area

The closest hydrants are located on N 40th Street at Washington Street with an additional hydrant at N 40th Street and E Van Buren Street as illustrated in Figure 1.

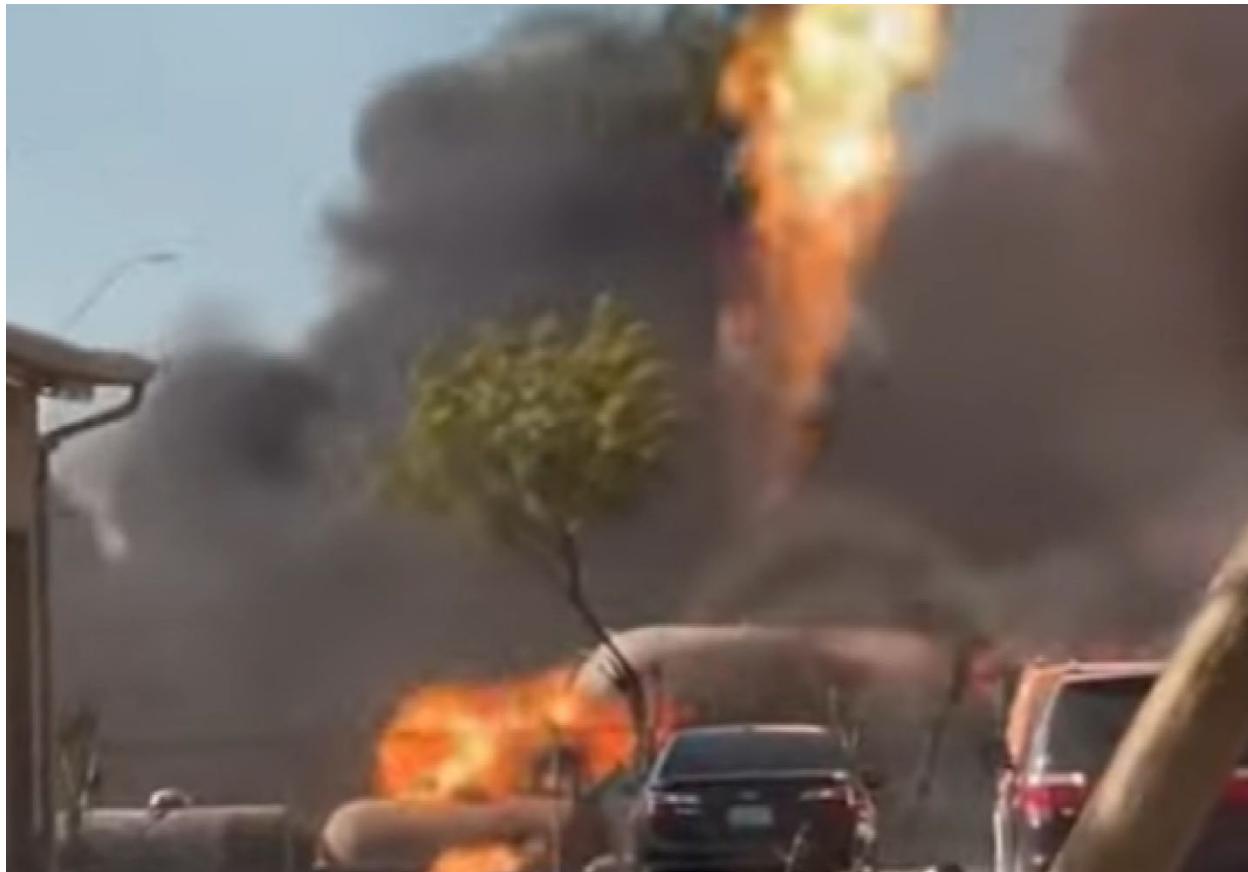
Figure 7. Conditions on Arrival

Watch the incident video (Deusterman, 2023) and examine Figure 7 illustrating conditions on arrival. The video and photo illustrate conditions from Washington Street (Side Bravo) and then from the intersection of North 40th Street and Washington Street.
