# In-Station Training

## TM 24-10 Residential Fire

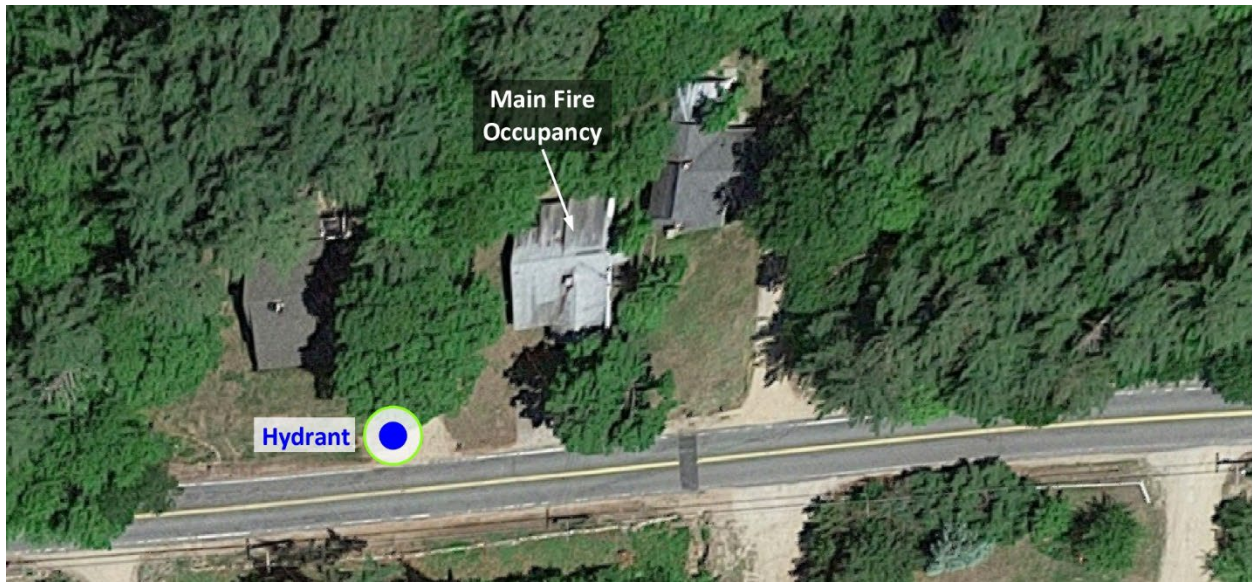
Figure 2. Aerial View

The closest hydrant is adjacent to the main fire occupancy on Route 16A as illustrated in Figures 1 and 2.

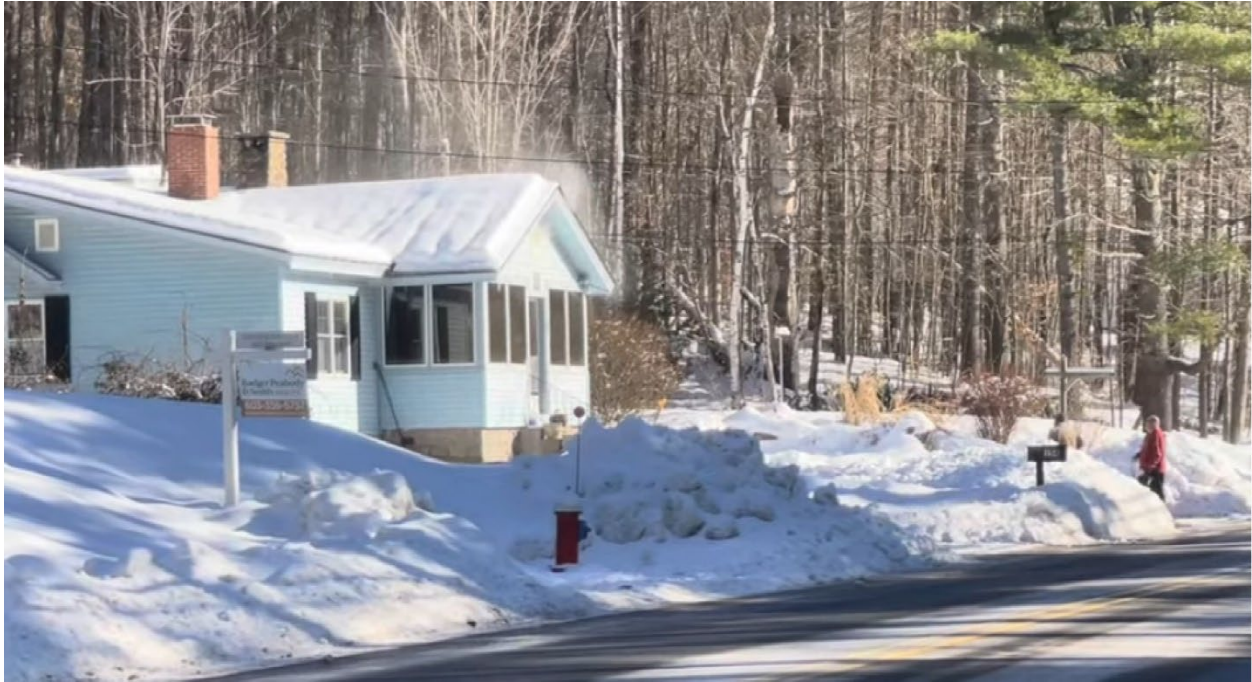
Figure 5. Conditions on Arrival

Watch the of the incident video (Metro Fire, 2024) from 00:05 to 00:35 and examine Figure 5 illustrating conditions on arrival.

Conditions on Sides Bravo, Charlie, and Delta are consistent with those observed on Side Alpha with a small amount of smoke issuing from the building at the eaves on Side Delta and from the peak of the gable roof on Side Charlie. If the door is opened to check for life, fire, and layout as part of 360-degree reconnaissance, watch the [incident video](#) (Metro Fire, 2024) from 02:48 to 02:58 and examine Figure 6, do not see or hear any evidence of building occupants, and observe the door on Side Alpha enters a small front porch, a closed door between the front porch and the interior of the house and a fire in the living space towards the middle of the house.
