# In-Station Training

## TM 24-12 Residential Fire

### Purpose

Chimney fires are often confined to the inside of the flue. However, this is not always the case. Firefighters and fire officers must understand and recognize the characteristics of masonry and metal chimneys and related building construction features that impact fire spread when a chimney fire extends beyond the flue.

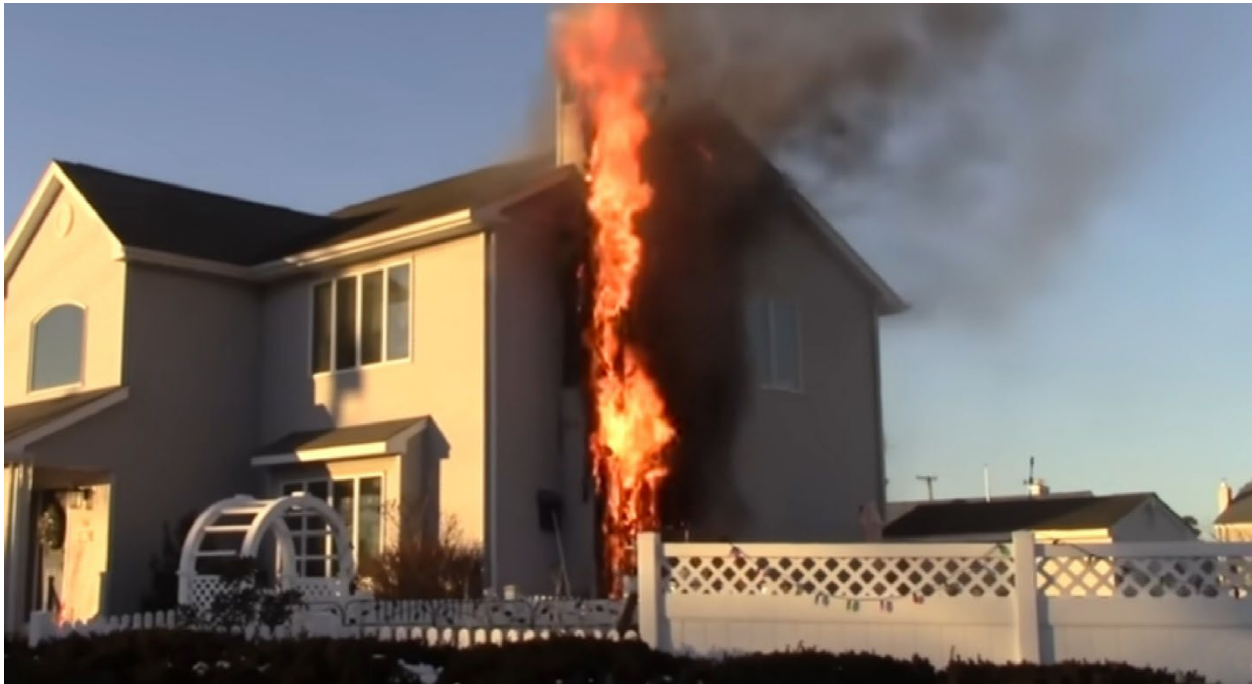
Figure 7. Conditions on Arrival

Watch the first 00:30 of the incident video (Demonracer2, 2024) and examine Figure 7 illustrating conditions on arrival.

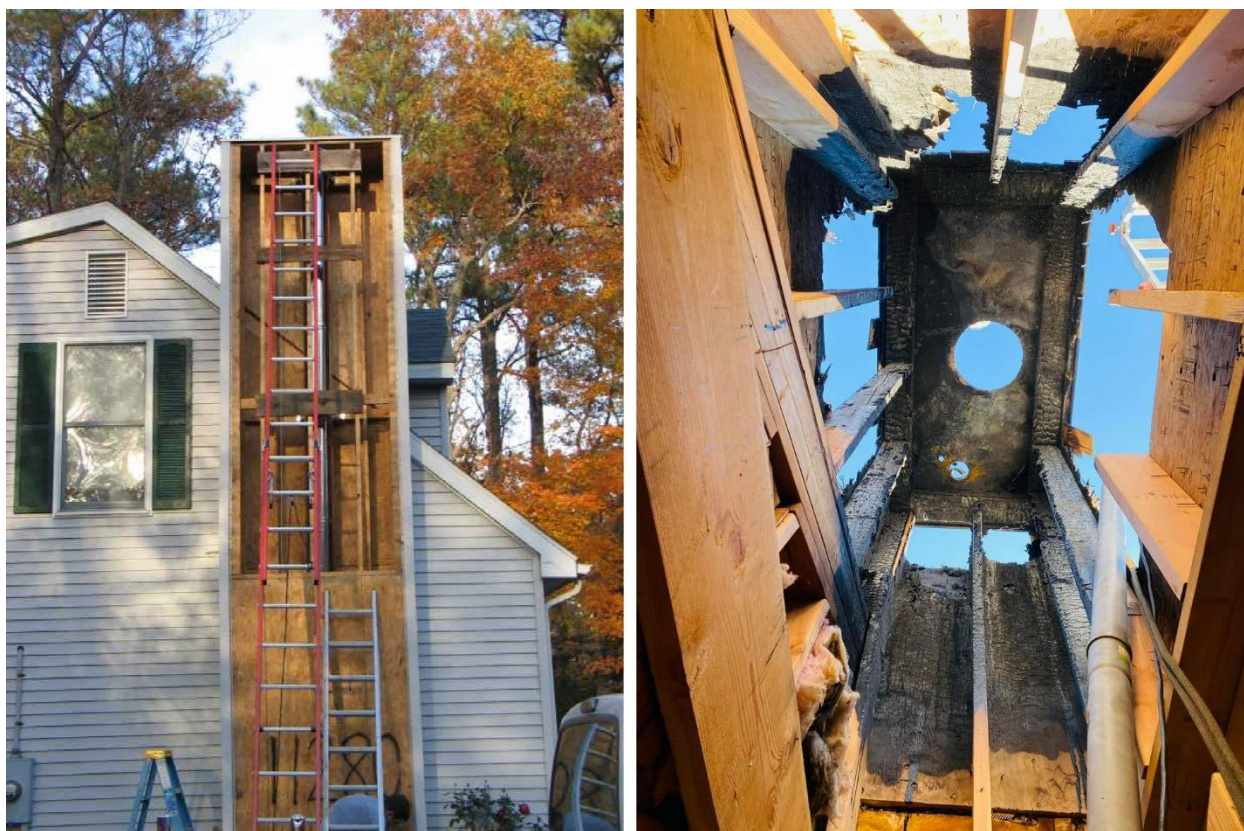
Figure 8. Wood Framed Chimney Chases

Newer homes with wood burning fireplaces or stoves commonly have a prefabricated metal chimney inside of a wood framed chimney chase. In some cases, as in this incident, the wood framed chase is exposed on the exterior and/or above the roofline. In other cases, a masonry veneer of brick or stone is attached to the exterior surface of the wood framed chase, giving the appearance of a masonry chimney. The wood framed chimney chase may have multiple openings to structural framing voids and the attic of the house, providing avenues for fire spread.

Read [All About Prefabricated Fireplaces](#) (Bianco, 2022) and examine Figure 8 illustrating two different wood frame chimney chases (neither of these photographs were of the building involved in this incident).
