In-Station Training

TM 24-27 Residential Fire-Entrapment

Response to a residential fire with a report of multiple trapped occupants presents a considerable challenge for the first arriving companies with the need to rapidly prioritize and address fire control and life safety priorities.

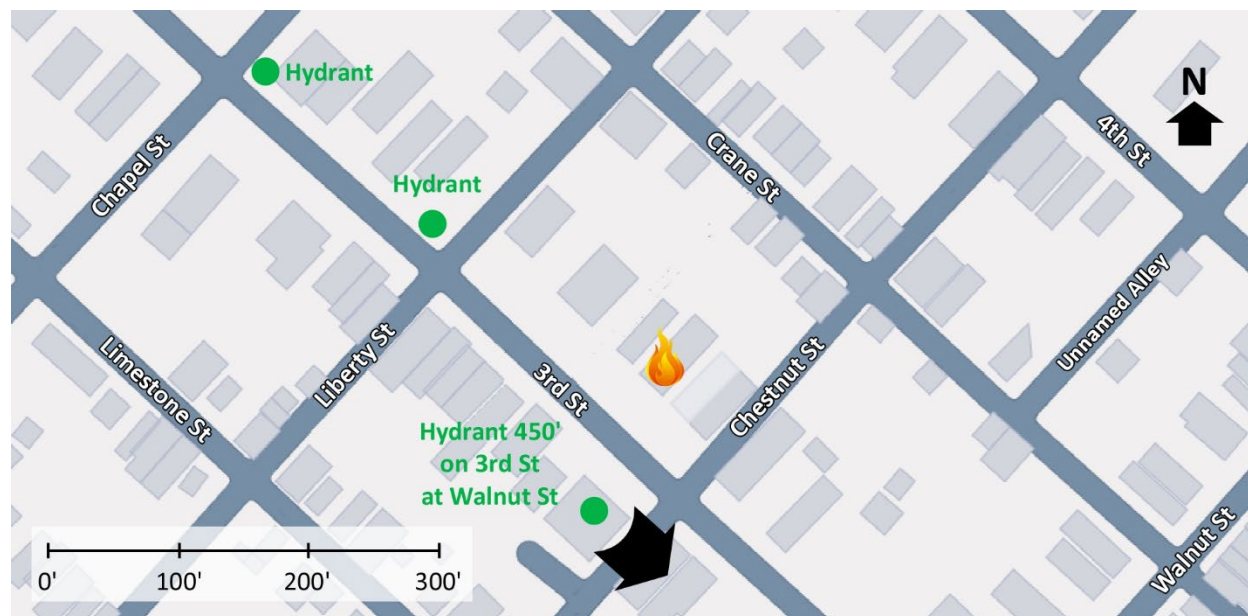
Figure 1. Map of the Incident Area

Hydrants are located to the northwest and southeast of the incident location on 3rd Street as illustrated in Figure 1.

This incident involved a residential fire in a duplex located at 729 3rd Street, Catasauqua Borough, Pennsylvania on February 25, 2024, at 11:27 (Newsworking, 2024a, 2024b, Reinhard, 2024, & Broadcastify, 2024a, 2024b). Review the map and photos (Figures 1-5) to gain an understanding of the area and building involved.

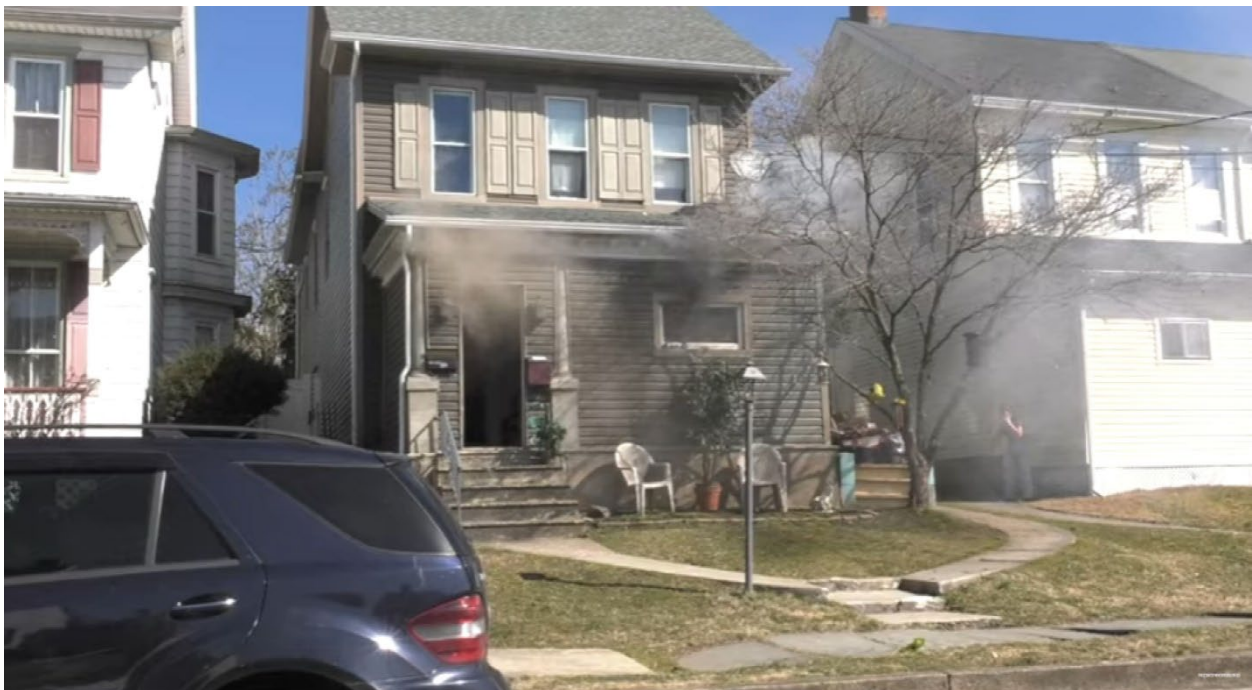
Figure 6. Conditions on Arrival

Watch the [incident video](#) (Newsworking, 2024a) from 00:48 to 00:58 and examine Figure 6 illustrating conditions on arrival. Important! *The incident audio is not synchronized with the video. Chief 18 made entry to rescue an occupant but was out of the building when the first engine arrived. For the purposes of this 10-Minute Training, the engine arrives prior to the chief.*

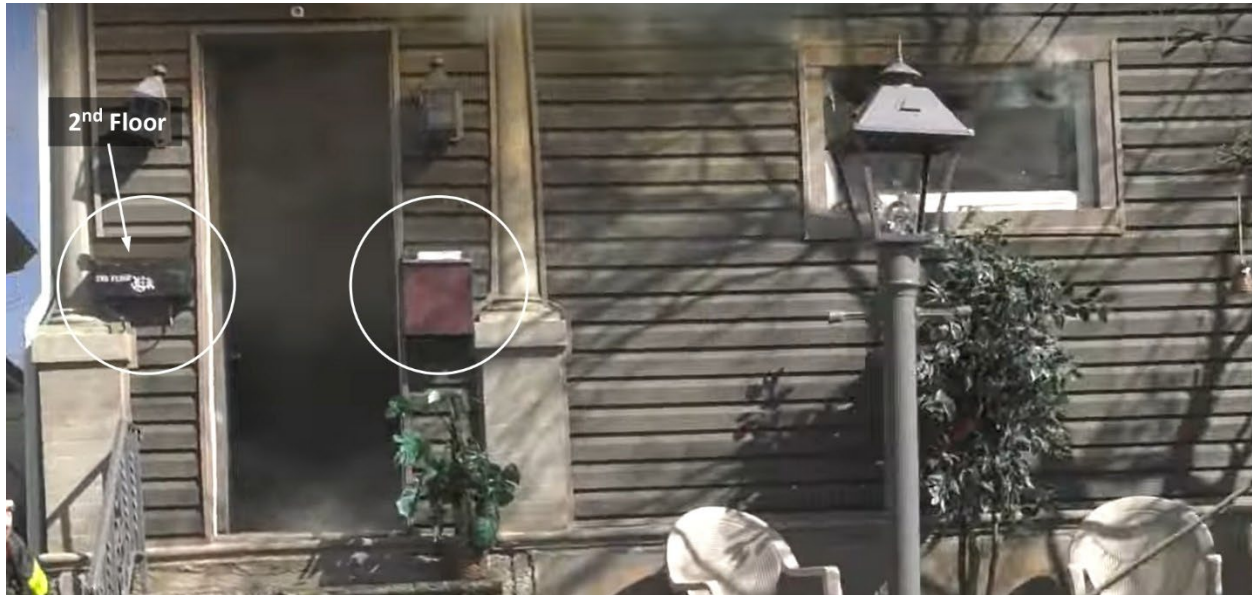
Figure 7. Door on Side Alpha

Examine Figure 7. What might the presence of a second mailbox labeled “2nd Floor” indicate? How might this impact floor plan and arrangement?

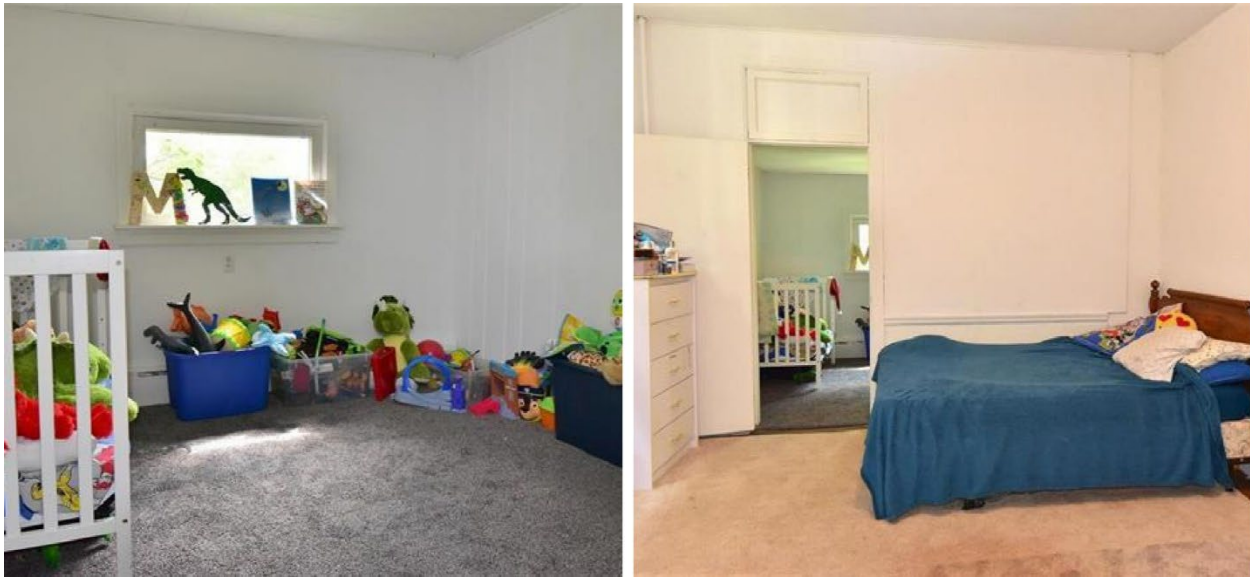
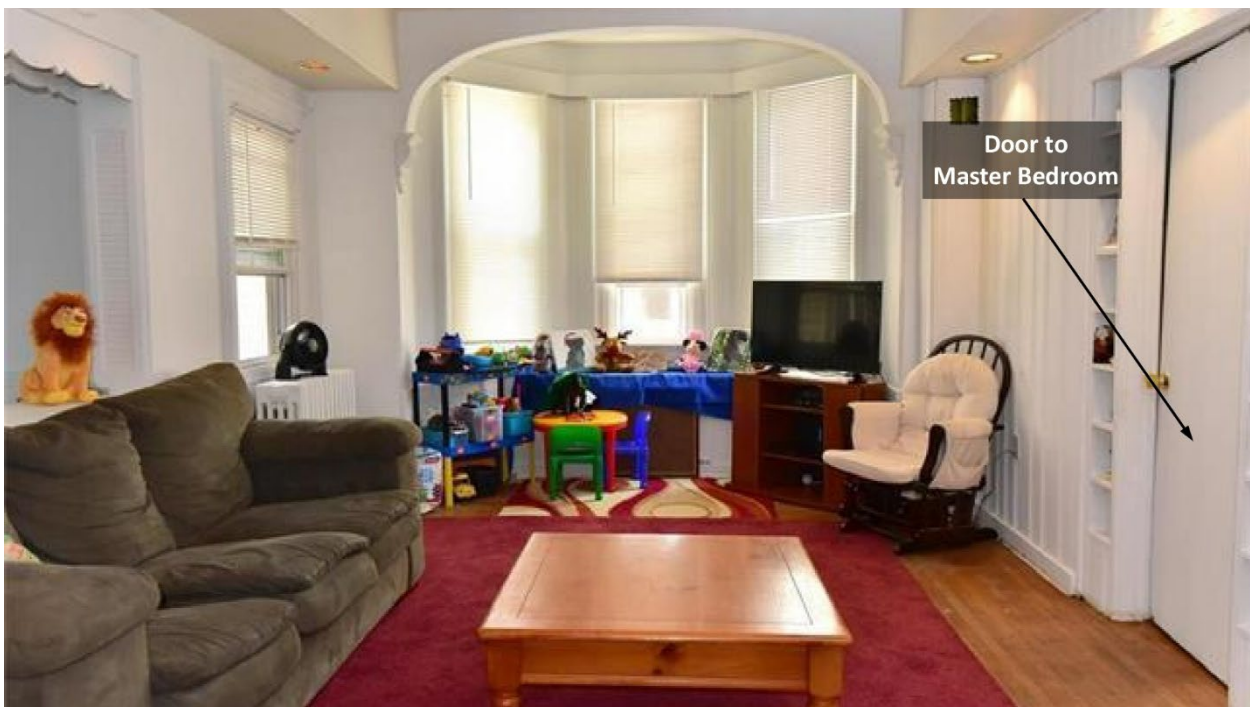
Examine Figures 8 and 9, illustrating the child’s bedroom (room of origin) and master bedroom on Floor 1, Side Alpha and the living room in the middle of the house (windows on Side Delta). It is likely that the first-floor unit was accessed via a hallway between the front door and the living room. How would this floor plan and configuration have impacted fire development and stretching the initial attack line for fire control and primary search on Floor 1?

Figure 8. Floor 1 Bedrooms

Figure 9. Floor 1 Living Room

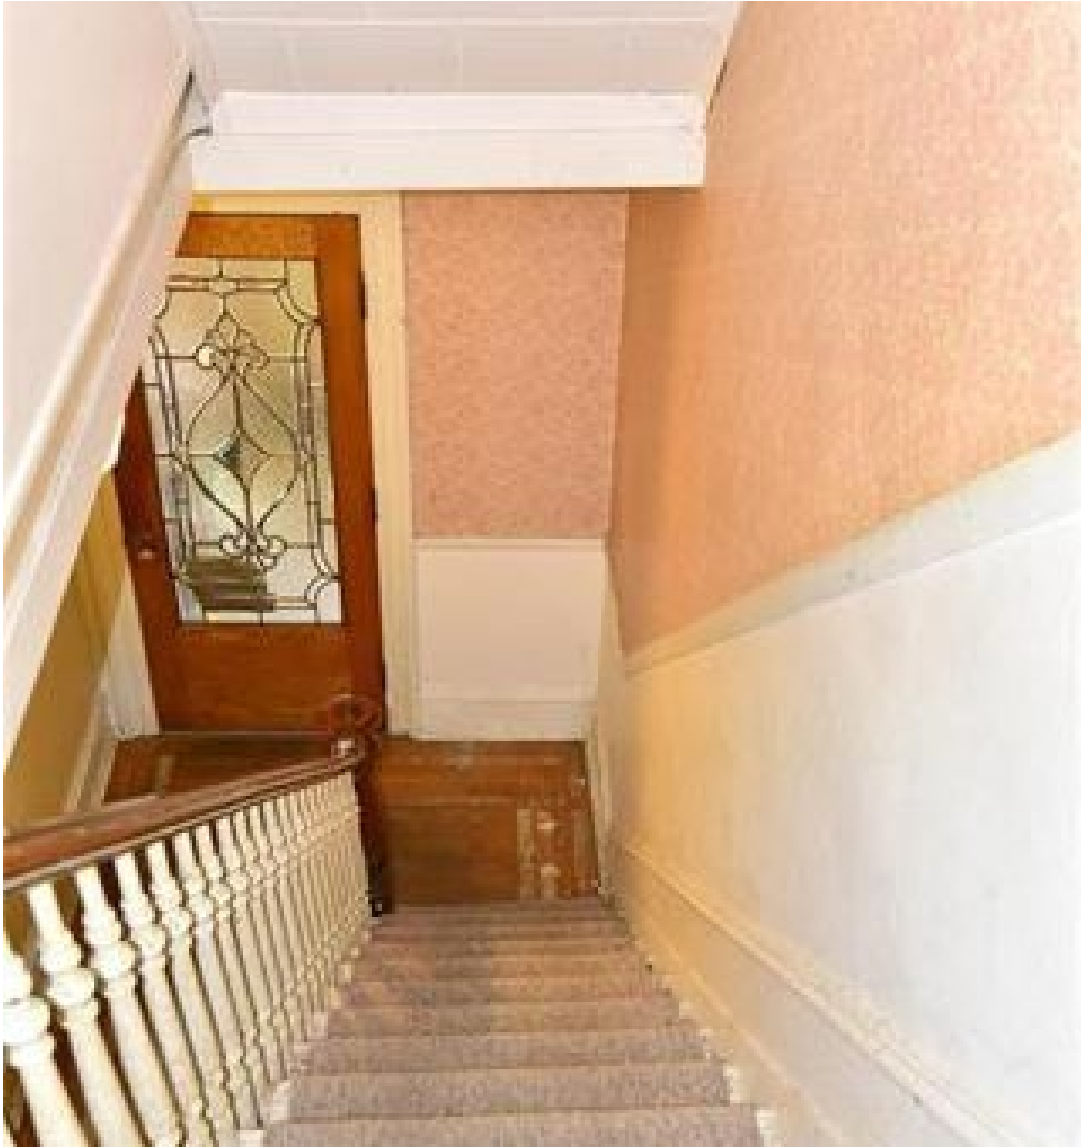
Figure 10. Interior Door, Hall, and Stairwell

Examine the interior door, hall, and stairwell illustrated in Figure 10. How would this interior configuration have impacted access to the first and second floor units (consider the direction of swing on the interior door)?
