In-Station Training

TM 25-04a Rural Commercial Fire

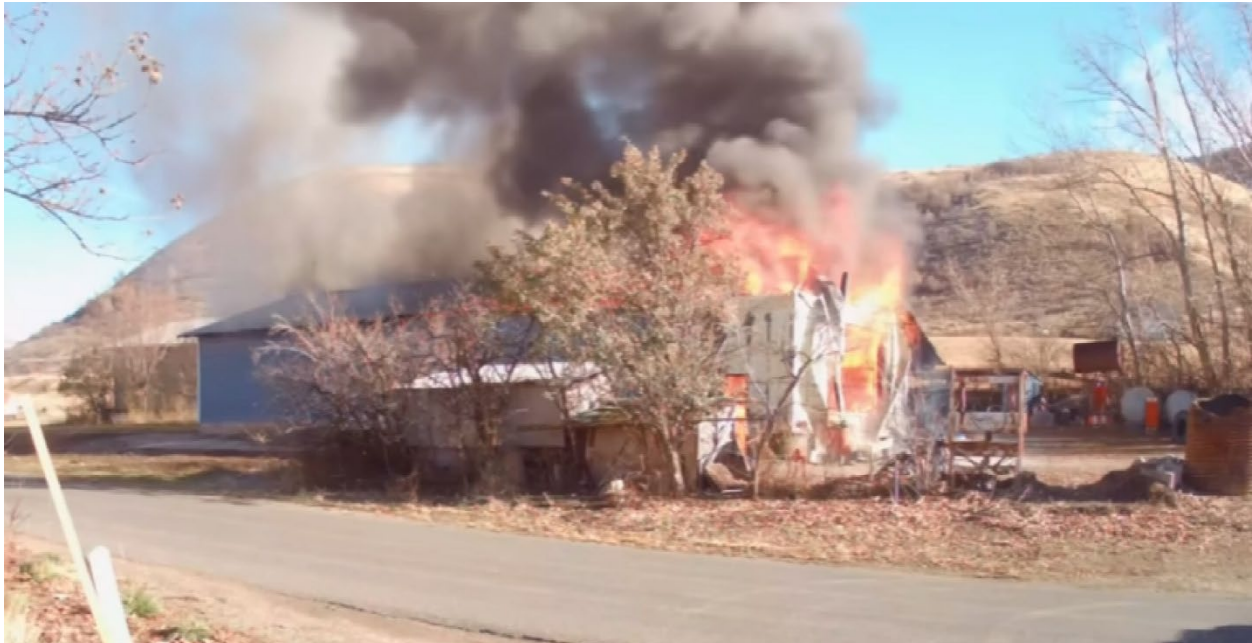
Figure 5. Conditions on Arrival

Note: Adapted from Fire 100 Response Films. (2024). *Responding to a commercial structure fire* [video]. <https://bit.ly/3VSNhSt>.

Watch [incident video](#) (Fire 100 Response Films, 2024) from 03:50 to 04:50 and examine Figure 5, illustrating conditions on arrival.
