In-Station Training

TM 25-16 Reported Residential Fire

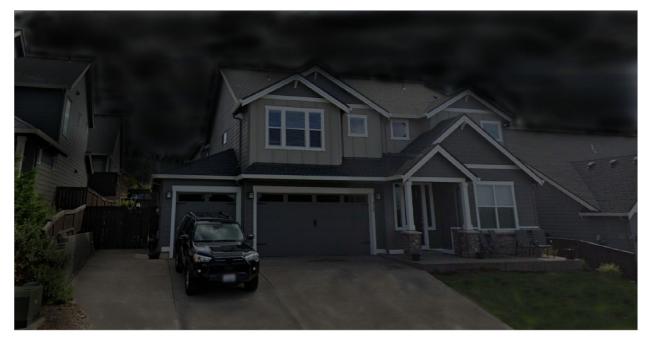
Figure 7. Conditions on Arrival

Examine Figure 7 illustrating conditions on arrival.

An occupant reports that everyone is out and that there is a strong smell of smoke upstairs. Conditions on Side Charlie are unremarkable with no smoke visible from the exterior of the house.

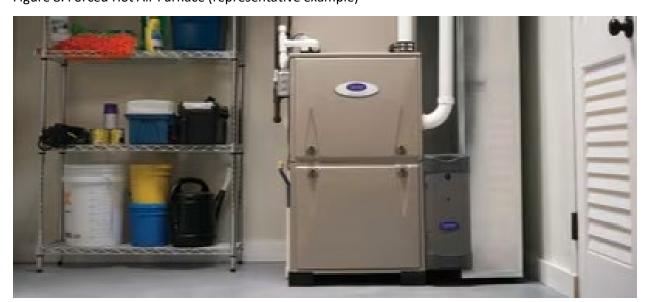
Figure 8. Forced Hot Air Furnace (representative example)

Accessing the garage, you observe a forced hot air furnace like the one shown in Figure 8. Using a thermal imager, the exterior of the furnace does not show an elevated temperature, and it is cool to the touch.

Important! Remember that hot air furnaces are insulated, and the exterior surface can be at ambient temperature even when there are overheated components or even incipient flaming conditions inside the furnace. Remove exterior access panels to investigate conditions inside the furnace.
