In-Station Training

TM 25-21 Smoke in the Area

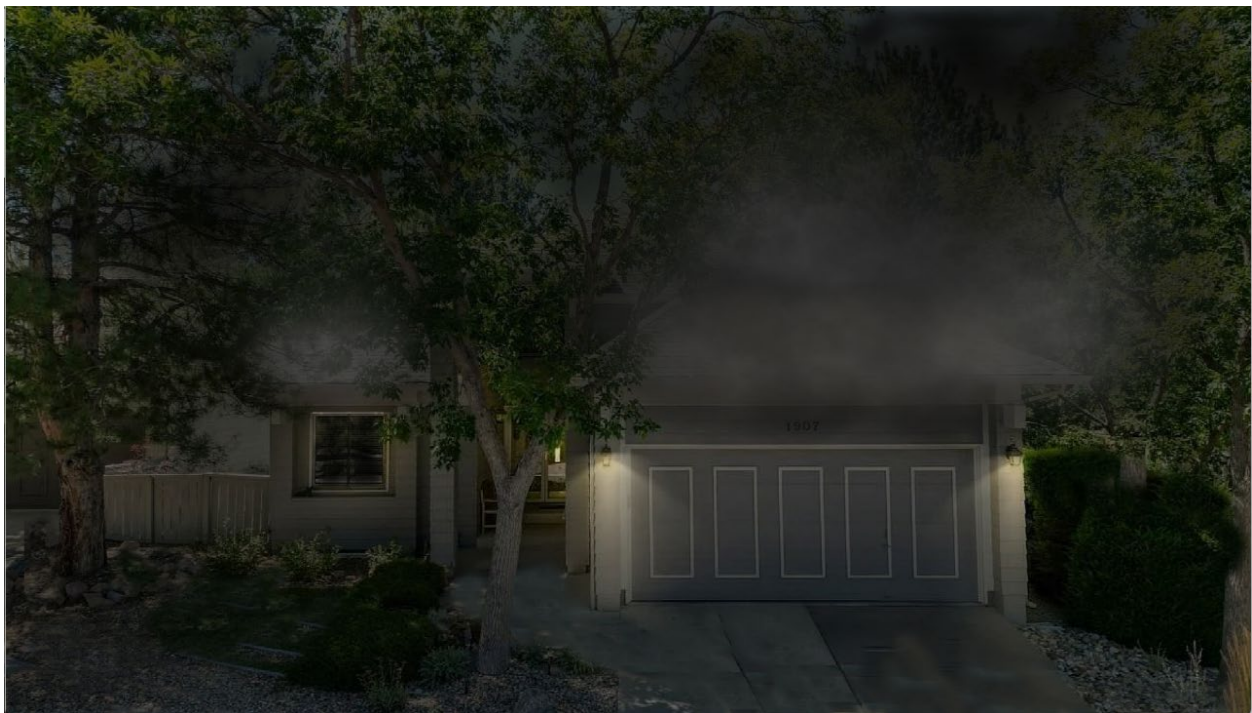
Figure 10. Conditions on Arrival

Arriving in the area you initially do not find anything, but after continuing your investigation for approximately 25 minutes, you encounter heavier smoke than would be anticipated by a recreational fire in a fire pit or chiminea. You arrive at 1907 Tee Lane and observe smoke from the chimney and the eaves of the house. Watch the first 30 seconds of the [incident simulation video](#) (Hartin, 2025) and examine Figure 10, illustrating conditions on arrival.

Smoke is visible from the chimney (as observed on approach) and from the eaves on all sides of the main fire occupancy. You hear three engines, medic unit, and command officer dispatched to provide the balance of a first alarm assignment for a residential fire (if your resource determination included any additional resources, they will also be dispatched and will arrive after first alarm companies). Based on the location of the incident, you anticipate that an engine company and medic unit will arrive in approximately five minutes followed by the command officer.
