In-Station Training

TM 25-31 Residential Fire

This incident involved a residential fire at 105 Sunset Oaks Drive, Holly Springs, North Carolina on Saturday, July 19, 2025, at 22:00 (JPope537, 2025; Overton, 2025; WRAL, 2025; & Legeros, 2025). Review the map and photos (Figures 1-7) to gain an understanding of the building and area involved.

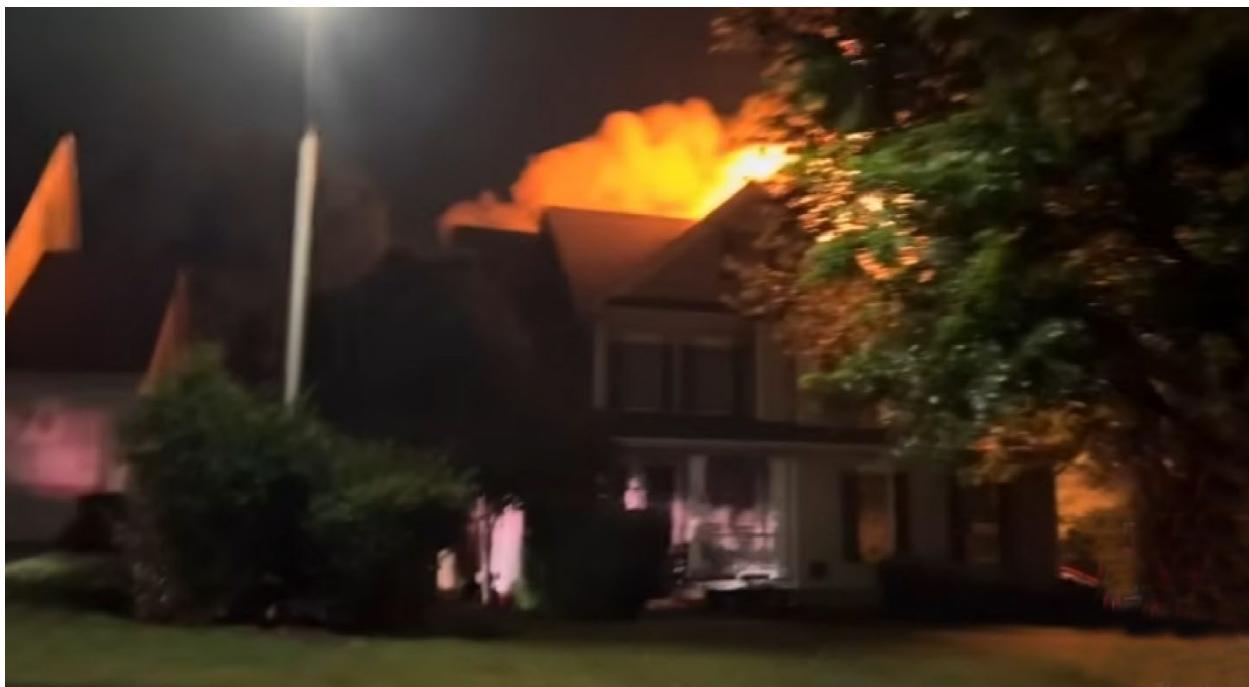
Figure 8. Conditions on Arrival

Watch the first 00:10 of the incident video (JPope537, 2025) and examine Figure 8, illustrating conditions on arrival.

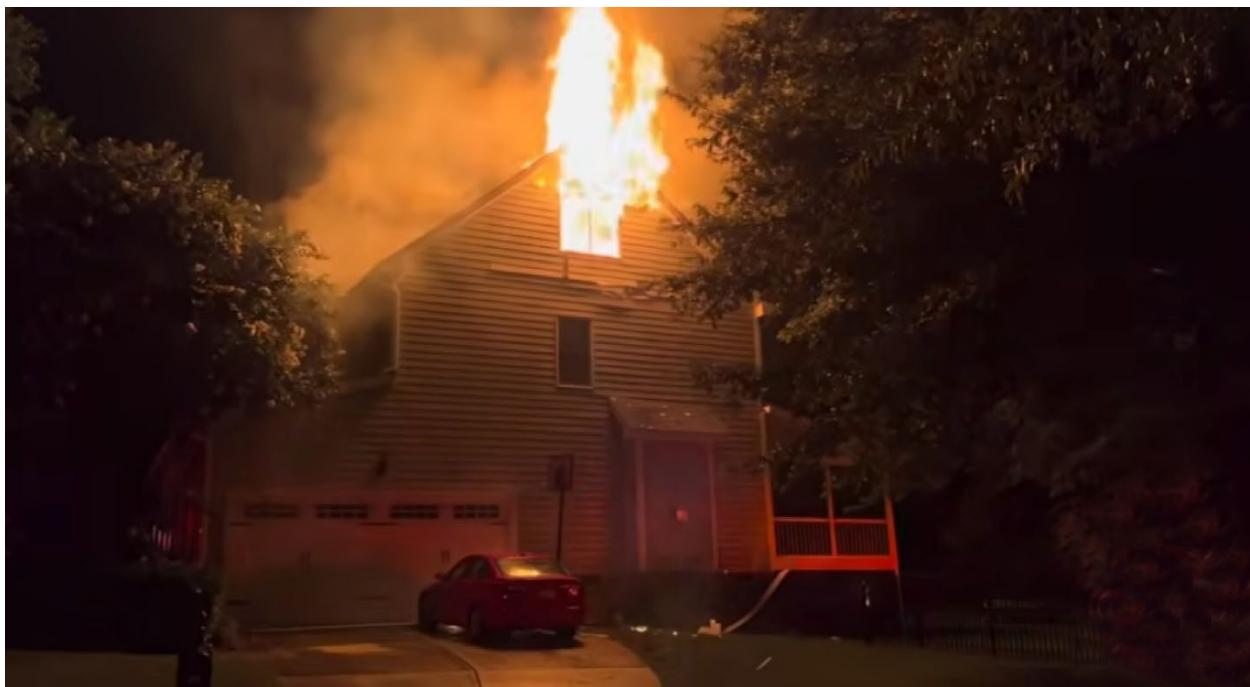
Figure 9. Conditions on Side Delta

Watch the [incident video](#) (JPope537, 2025) from 00:30 to 01:05 and examine Figure 9 illustrating conditions on Side Delta when you arrive. Conditions on Sides Bravo and Charlie are consistent with those observed on Sides Alpha and Delta with gray smoke from the eaves and attic.
