# In-Station Training

## TM 25-38 Residential Fire

This incident involved a residential fire at 475 Dakota Drive, New Kensington, Pennsylvania on September 8, 2024, at 12:55 (Matto, 2025; WTAE-TV Pittsburgh, 2025; & Engel, 2025). Review the map and photos (Figures 1-5) to gain an understanding of the building and area involved.

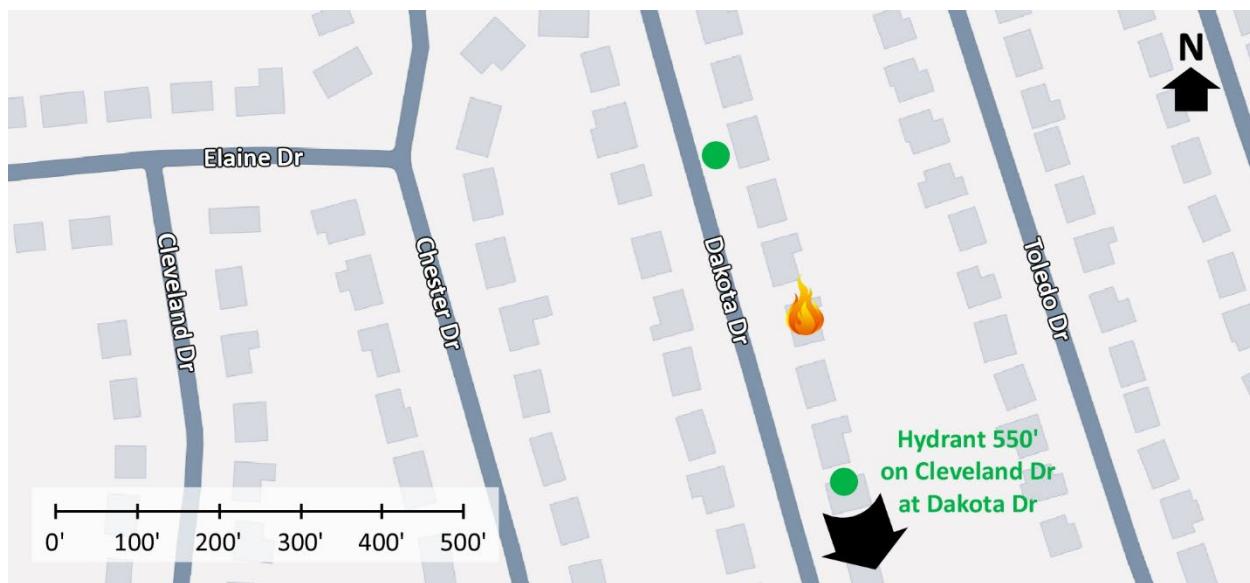
Figure 1. Map of the Incident Area

The closest hydrant is on Dakota Drive to the north of the incident in front of 463 Dakota Drive, and a second hydrant is available to the south on Cleveland Drive at Dakota Drive as illustrated in Figure 1.

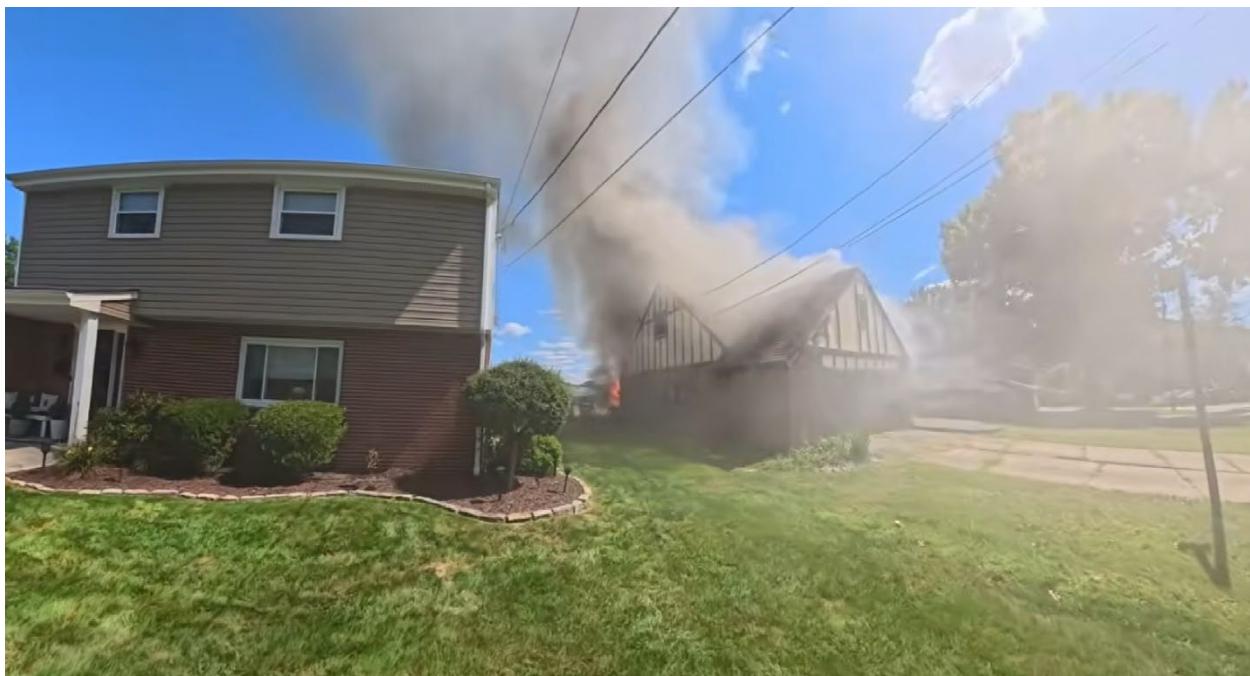
Figure 6. Conditions on Arrival-Alpha/Bravo Corner

Watch the [incident video](#) (Matto, 2025) from 00:43 to 01:15 and examine Figures 6 and 7, illustrating conditions on arrival.

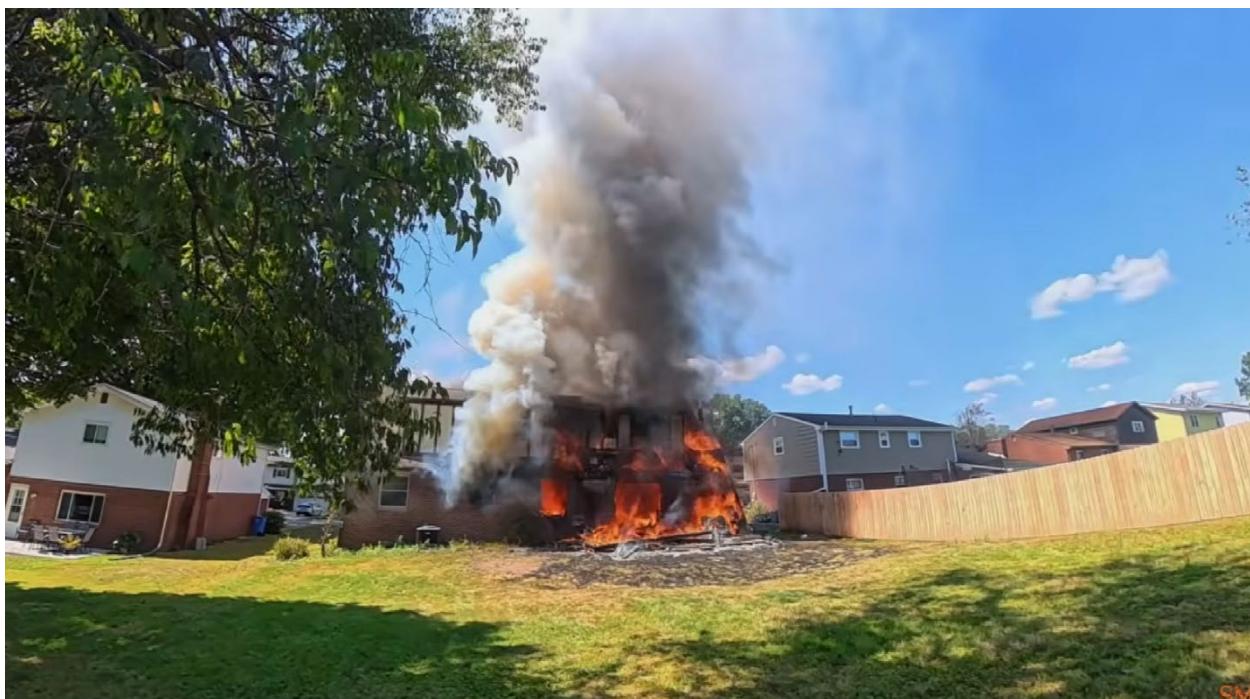
Figure 8. Conditions on Side Charlie

Watch the [incident video](#) (Matto, 2025) from 01:15 to 02:16 and examine Figure 8 illustrating conditions on Side Charlie.

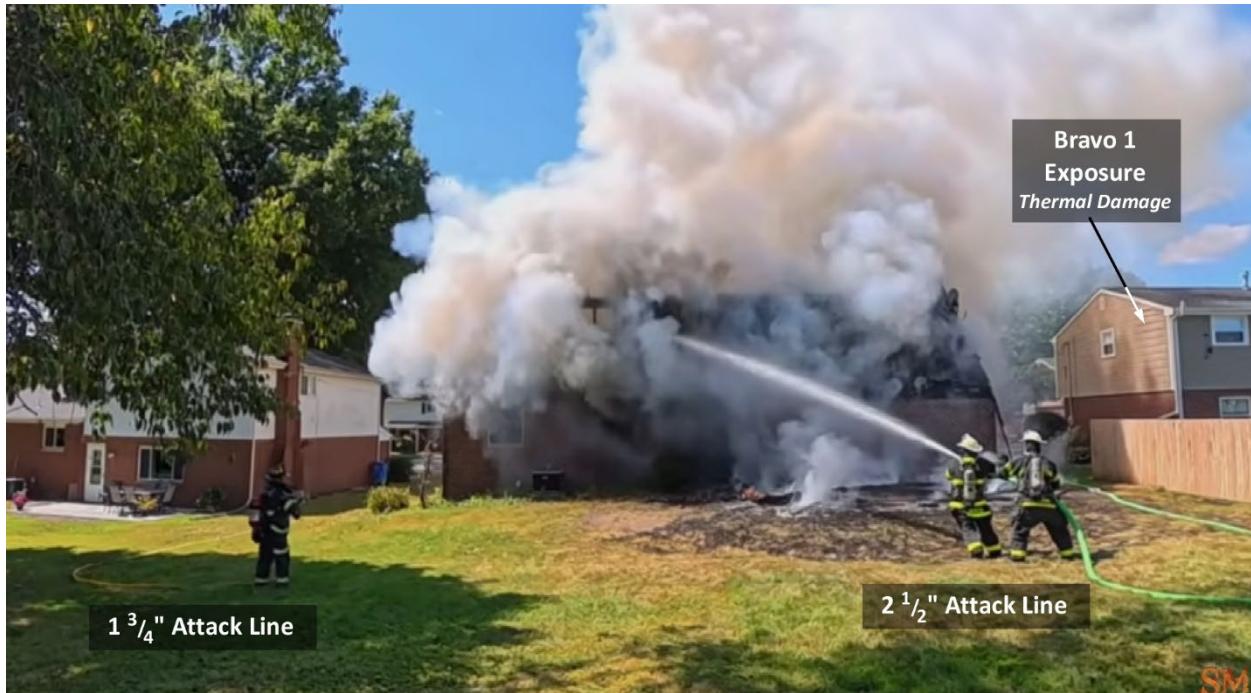
Figure 9. Exterior Water Application from Side Charlie

The first arriving company deployed a 2 ½" attack line to Side Charlie for fire control. Another company stretched a 1 ¾" attack line to Side Charlie and placed into operation to assist with fire control. Watch the [incident video](#) from 02:45 to 06:45 and examine Figure 9 before answering the next several questions.

The attack lines (2 ½ and 1 ¾") on Side Charlie had an estimated flow rate of 400 gpm (250 gpm + 150 gpm) and flowed more than 1200 gallons of water before the nozzle firefighter shut the 2 ½" attack line down.

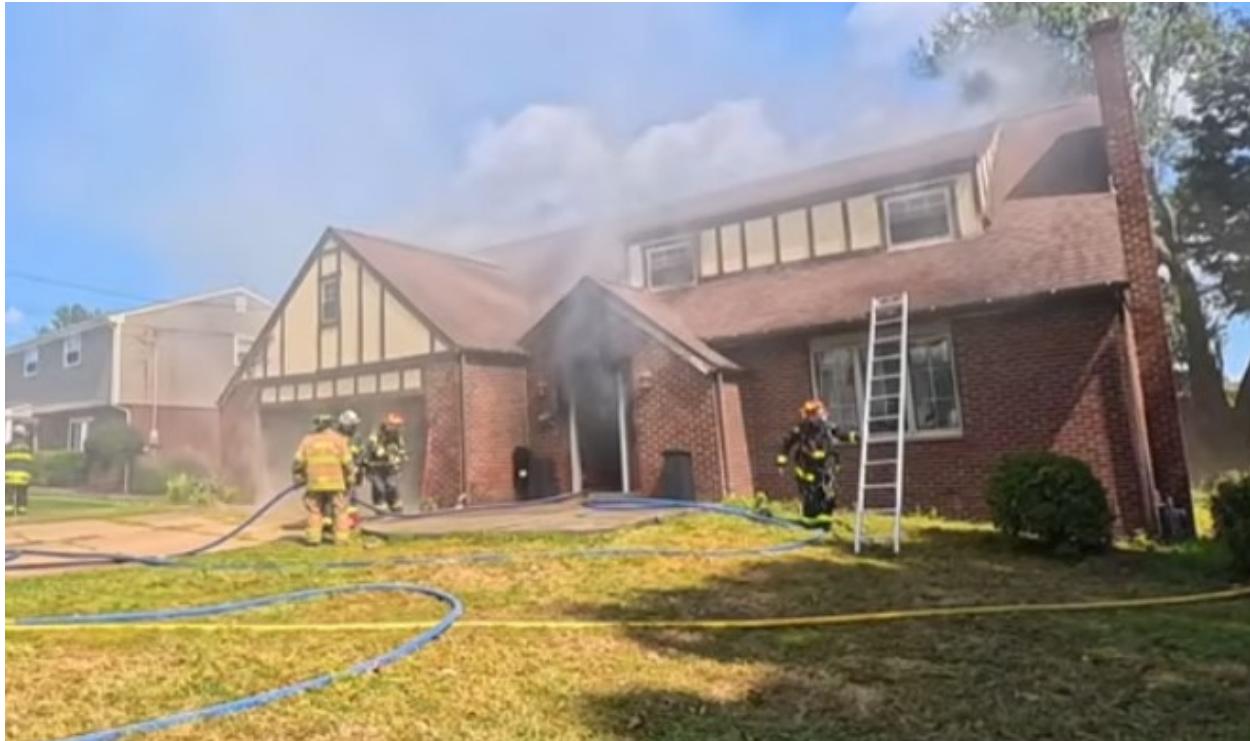
Figure 10. Conditions on Side Alpha Post Knockdown

It is important to consider context! The time to deploy an effective response force can differ between a career staffed urban fire department and a respond from home volunteer staffed fire department. Company staffing and response time can vary considerably. When sufficient resources were on-scene, companies stretched two attack lines through Side Alpha for fire control on Floors 1 and 2.

17. Was the choice to stretch attack lines through Side Alpha consistent with your incident action plan (or did you stretch through Side Charlie after knockdown)? What would be the advantages and disadvantages of these two options?
