# In-Station Training

## TM 25-39 Vacant Row House Fire

Chief Ed Hartin

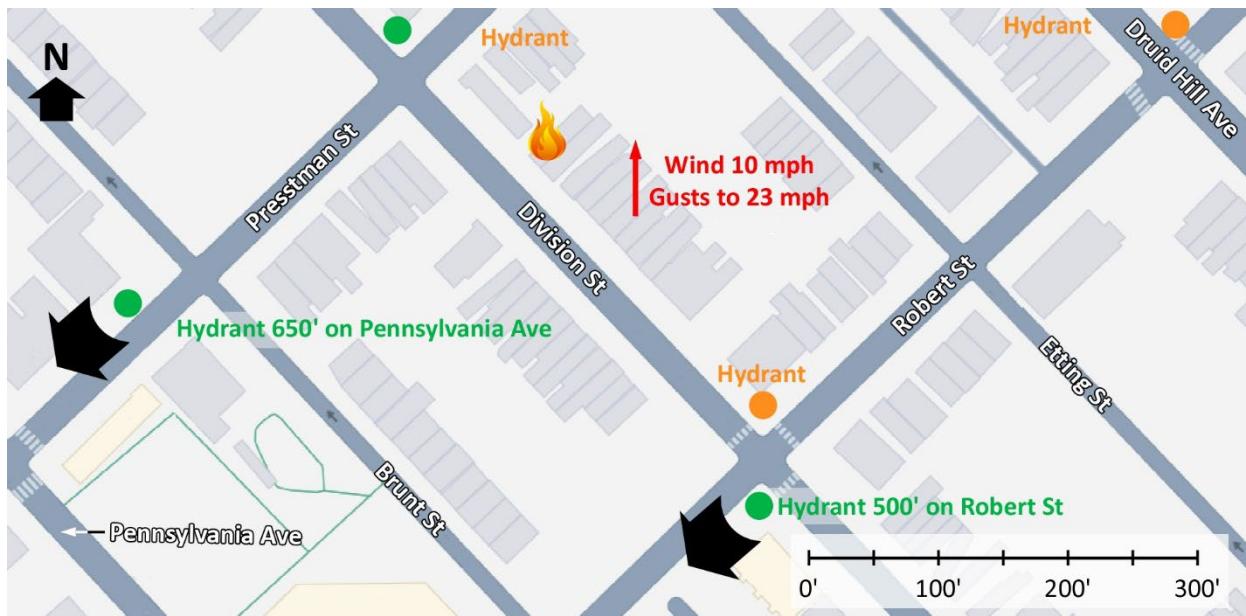
Figure 1. Map of the Incident Area

The closest hydrants are on Division Street at the ends of the block (Presstman Street and Robert Street), and additional hydrants are in the area as illustrated in Figure 1.

This incident involved a vacant row house fire at 1927 Division Street, Baltimore, Maryland on September 4, 2025, at 15:23 (Tall28guy, 2025; Baltimore City Fire Department, 2025; & Broadcastify, 2025). Review the map and photos (Figures 1-7) to gain an understanding of the building and area involved.

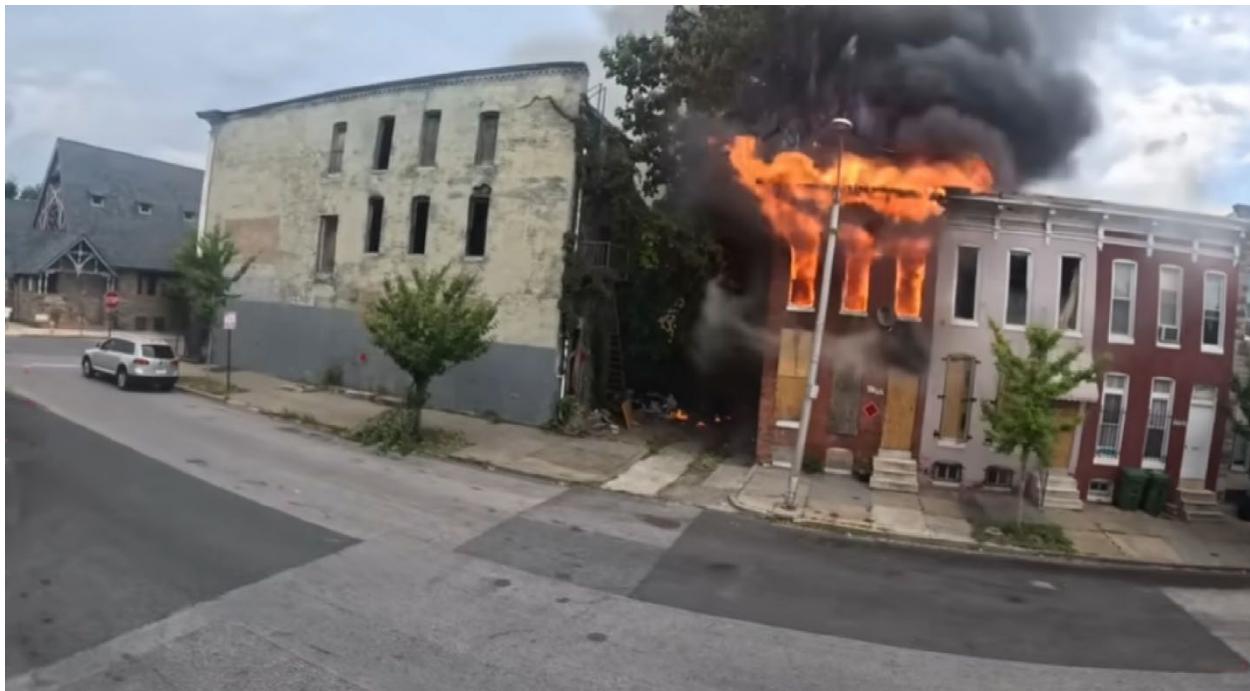
Figure 8. Conditions on Arrival

You arrive and identify that the actual fire location is 1927 Division Street. Examine Figure 8, illustrating conditions on arrival and watch the [incident video](#) (Tall28guy, 2025) from 01:32 to 02:15. Note that the initial segment of incident video was shot from the Alpha/Delta perspective (opposite the direction of travel of the first arriving ladder company).

Conditions on Side Bravo are consistent with those observed from Side Alpha. On Side Charlie, smoke is showing from Floors 1 and 2 of the Main Fire Occupancy and from Floor 2 of the Delta 1 Exposure.

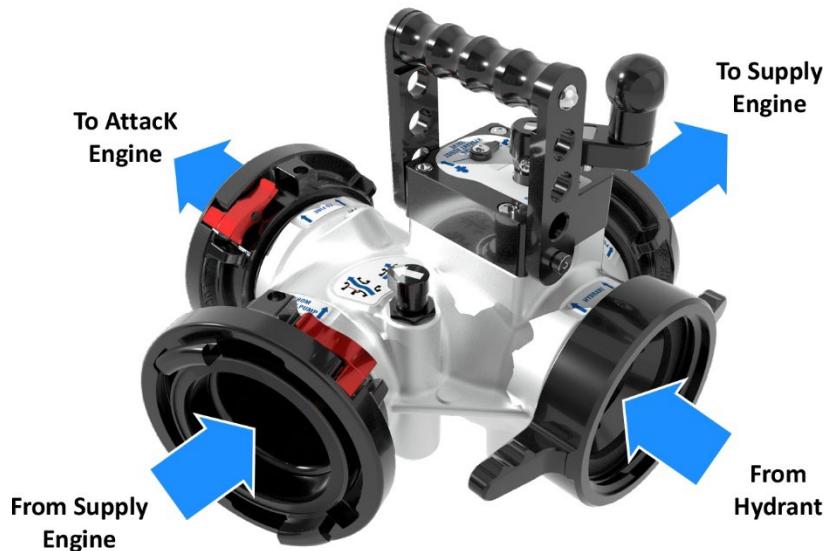
Figure 9. Task Force Tips Oasis Hydrant Valve

Companies operating at this incident encountered multiple water supply challenges including low pressure and flow as well as inoperative hydrants. The Baltimore City Fire Department uses 4" supply lines with [Task Force Tips Oasis™ Hydrant Assist Valves](#) (TFT, 2024a) as illustrated in Figure 9 and watch [Oasis™ Hydrant Assist Valve: Maximize Water Supply, Pressure, and Flow Rate](#) (TFT, 2024b). This type of hydrant valve allows a company to perform a forward lay and another engine to take over and pump their supply line without having to shut the hydrant down.
