# In-Station Training

## TM 25-42 Residential Fire with Exposure

Fires with significant exposure hazards present a challenge, extension from the main fire occupancy to one or more exposures dramatically increases the complexity of an incident.

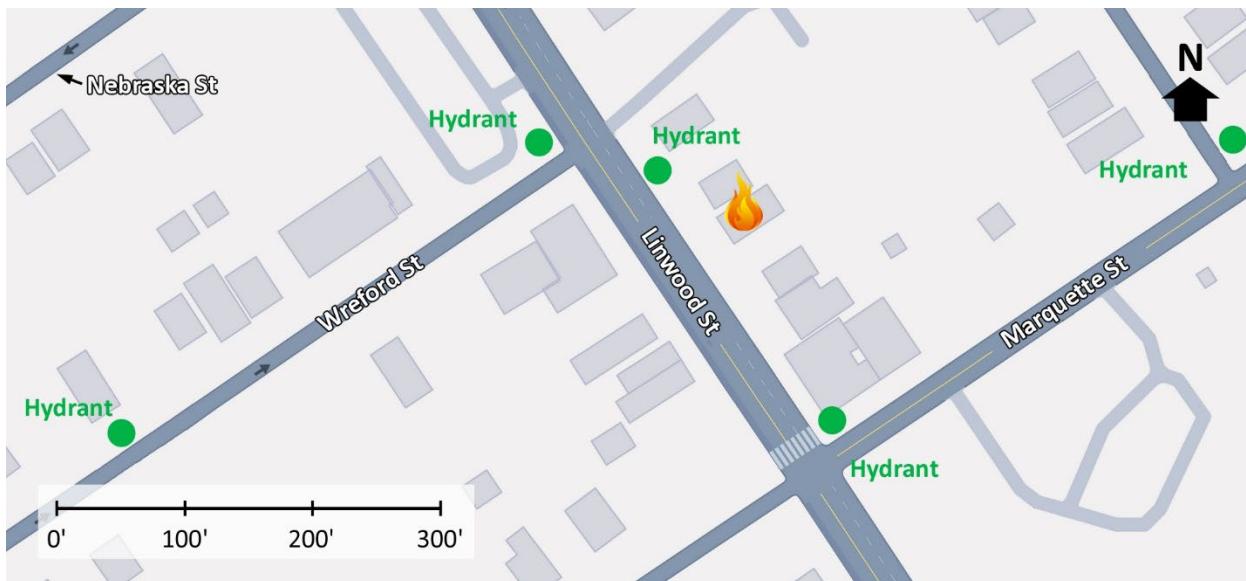
Figure 1. Map of the Incident Area

The closest hydrant is to the northwest on Linwood Street between Exposures Bravo 1 and Bravo 2. Additional hydrants are in the area as illustrated in Figure 1.

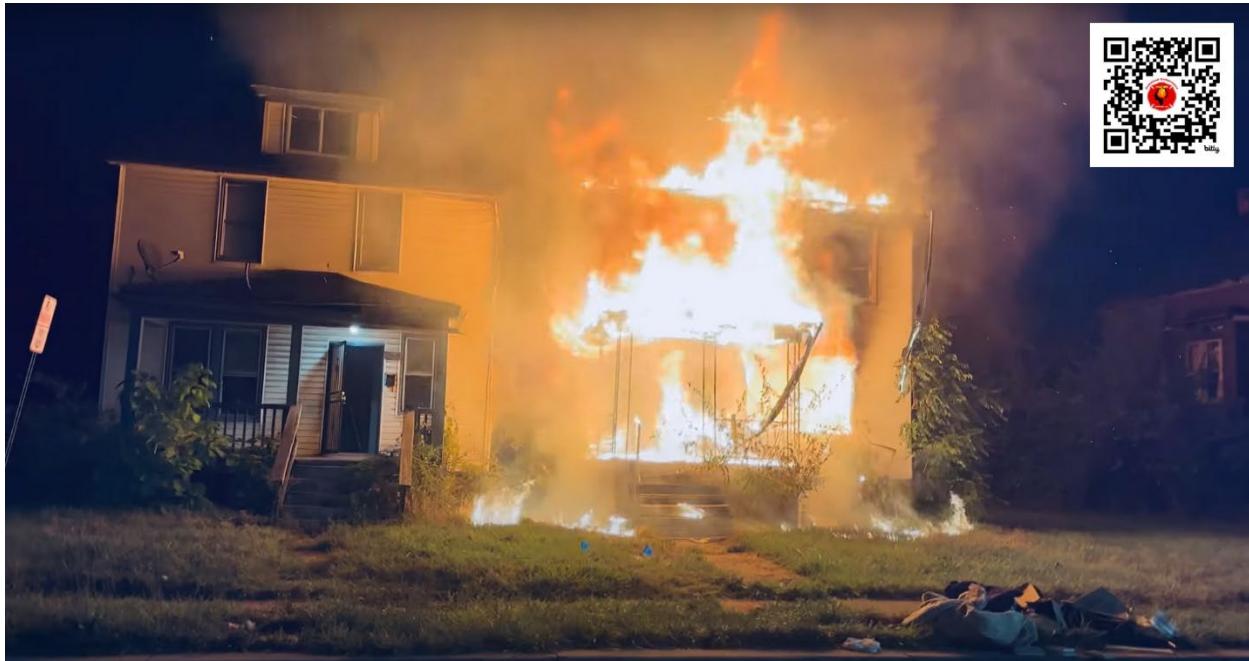
Figure 7. Conditions on Arrival

Examine Figure 7 illustrating conditions on arrival and watch the first 00:08 of the [incident video](#) (JoshFire, 2025).

Shortly after exiting the apparatus, you receive a report that bystanders have evacuated the elderly occupant of the Bravo 1 exposure. Side Delta of the Bravo 1 exposure is pyrolyzing. Fire involvement is evident on Floors 1 and 2 from Side Delta. Fire has not yet extended to Floor 1 on Side Charlie.

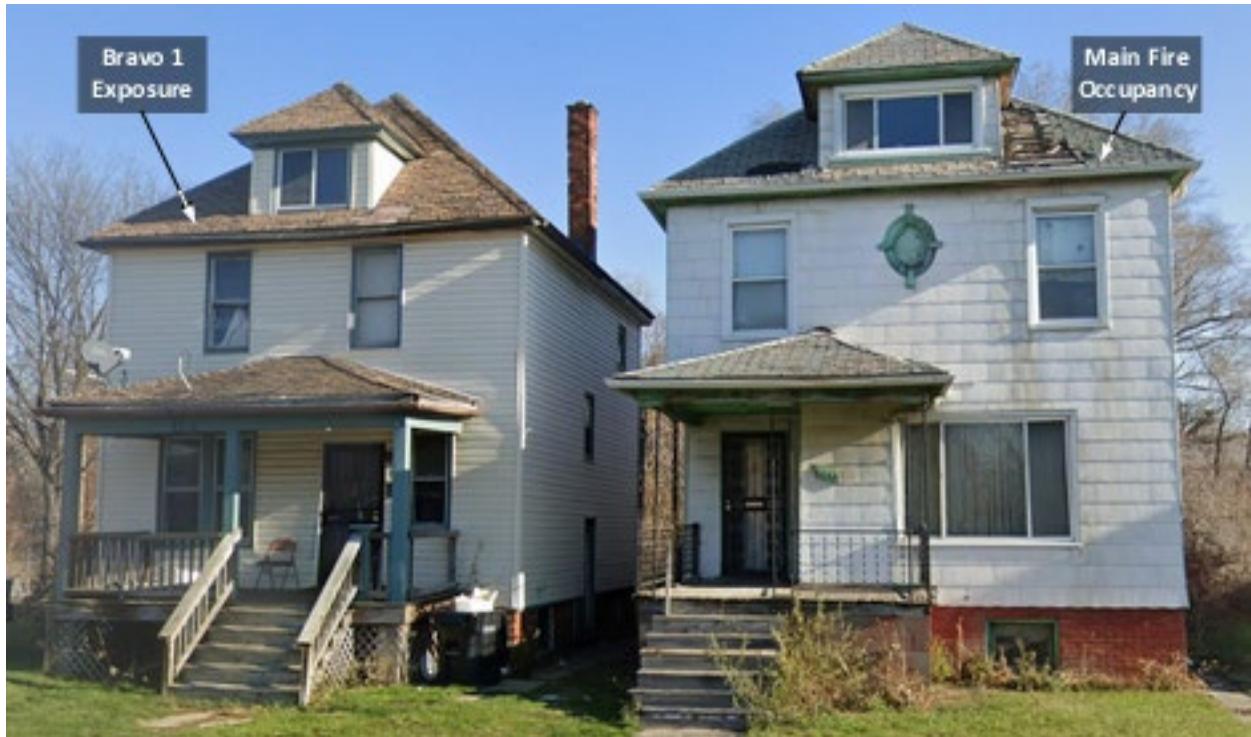
Figure 8. Potential for Extension

Use Figure 8 and discuss potential avenues of extension from the Main Fire Occupancy to the Bravo 1 Exposure and potential avenues of fire spread within the exposure should extension occur with members of your crew.

**Additional Learning:** In this incident, there was significant potential for extension of fire from the Main Fire Occupancy to the Bravo 1 Exposure. When faced with this problem, it is important to not only address extension to the exterior of the exposure, but also to ensure that fire has not penetrated to structural voids, attic, and interior of the building.
