In-Station Training

TM 25-44 Commercial Fire

Purpose

Fires involving tires, particularly when substantial amounts of tires are involved can present significant fire suppression and environmental challenges and are resource intensive.

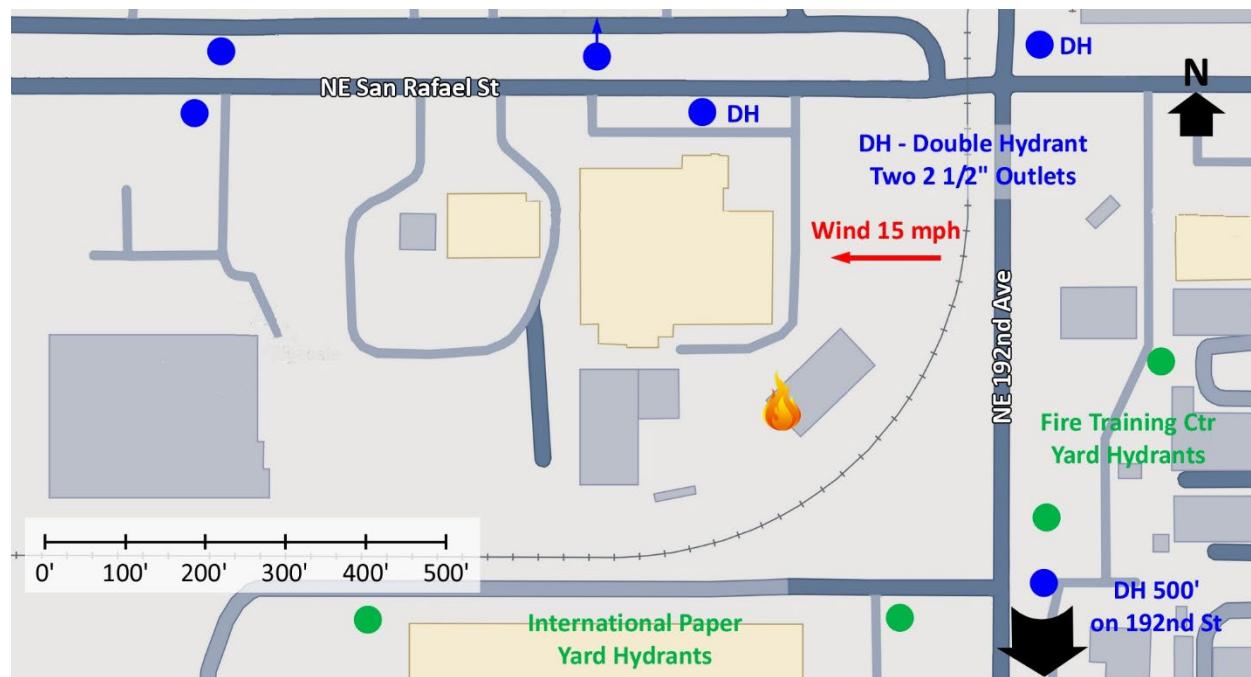
Figure 1. Map of the Incident Area

The closest hydrant is directly in front of the facility and additional hydrants are in the area as illustrated in Figures 1 and 2.

Review the map and photos (Figures 1-6) to gain an understanding of the building and area involved.

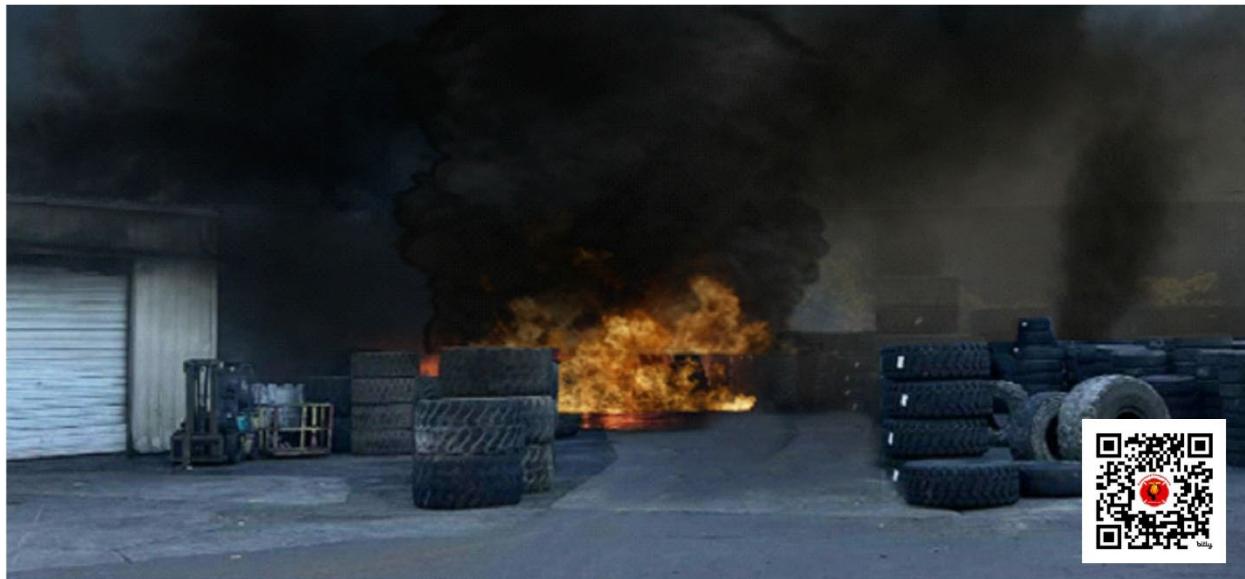
Figure 7. Conditions on Arrival

Watch the first 00:53 of the [incident simulation video](#) (Hartin, 2025) and examine Figure 7 illustrating conditions on arrival.

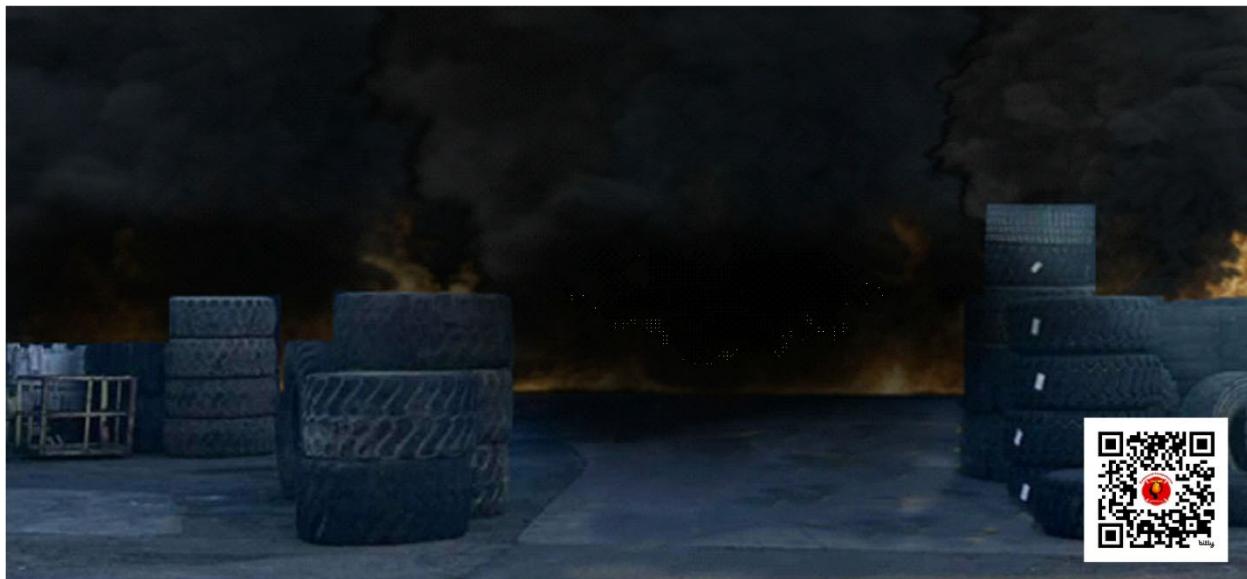
Figure 8. Changing Conditions

As you begin initial operations, conditions change. Watch the [incident simulation video](#) from 00:54 to 01:30 and examine Figure 8.

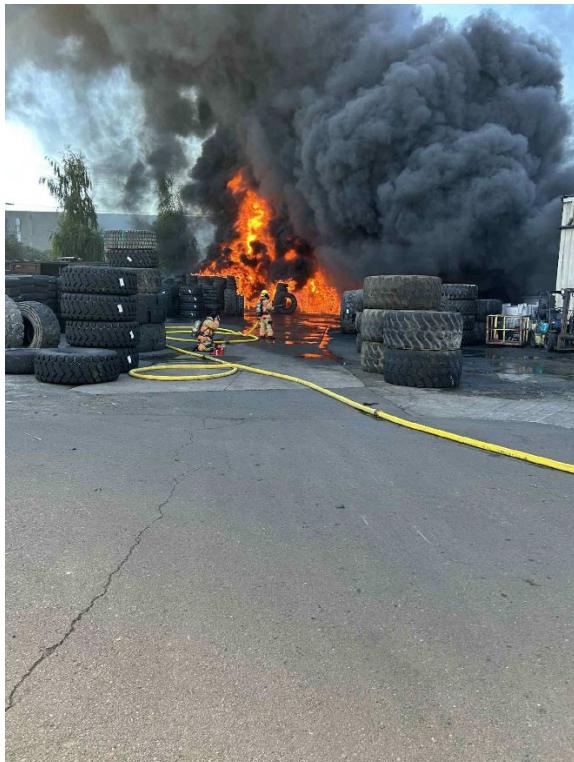
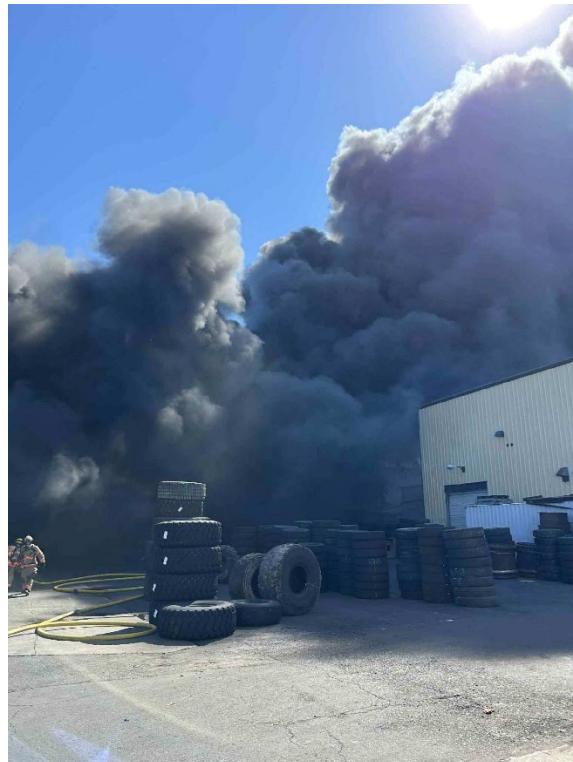
Figure 9. Actual Conditions on Arrival

The first arriving engine pulled into the facility and stretched a 2-1/2" attack line to a position just to the right of Exposure Bravo 1 for application of water to piles of large tires that were involved in fire. The first arriving engine did not establish a water supply (believing that there was a hydrant inside the facility). After determining that this was not the case, IC #1 tasked the second arriving engine with doing so. The first arriving command officer arrived prior to any of the additional companies and assumed command.

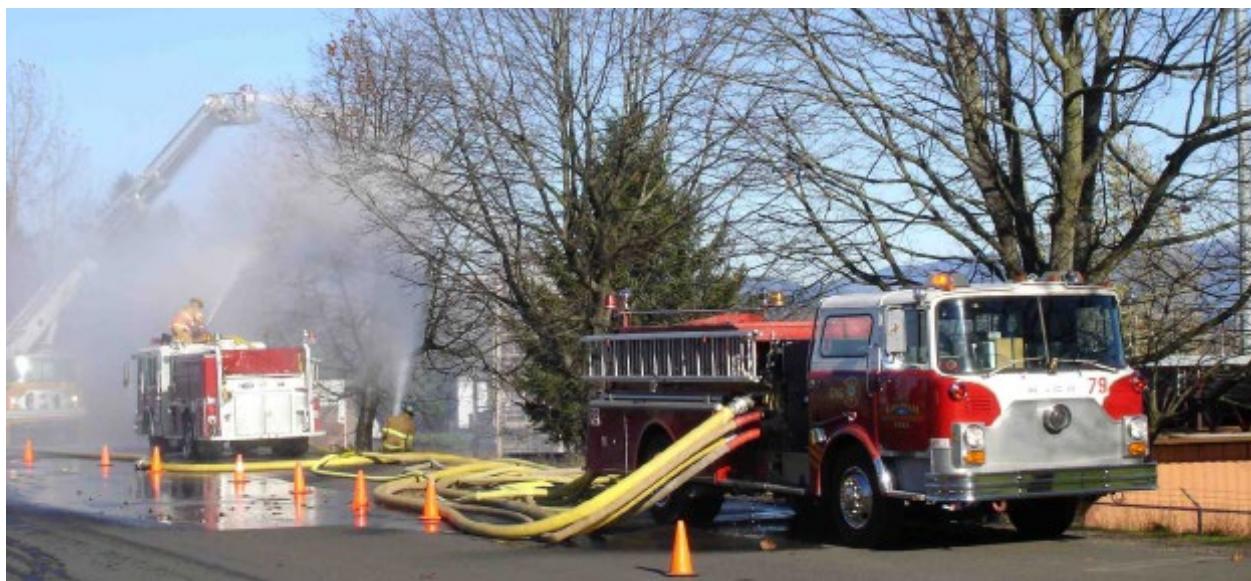
Figure 10. Gresham Fire Department Engine 79 (Training Division) Pumping for Maximum Flow

It may seem unlikely that you could develop significant flow from a hydrant that only has two 2 ½” outlets, but Figure 10 illustrates a 1978 Mack CF 1500 gpm engine developing a flow rate of 2100 gpm from the hydrant located 500' to the south of this incident during Gresham Fire Department’s Apparatus Operator Academy 2005-01! The engine was connected to the hydrant using two short sections of 5” hose (using 2 ½” x 5” adapters). The static pressure at the hydrant was 80 psi and the residual when flowing 2100 gpm was 40 psi (still a bit more flow rate from the water system, but the engine was at max capacity).
