In-Station Training

TM 25-46 Residential Fire

Conditions presenting from Side Alpha may be quite different than those observed during 360-degree reconnaissance. Identifying the location of the fire, potential avenues of fire spread, and potential for rapid fire development are critical elements of size-up.

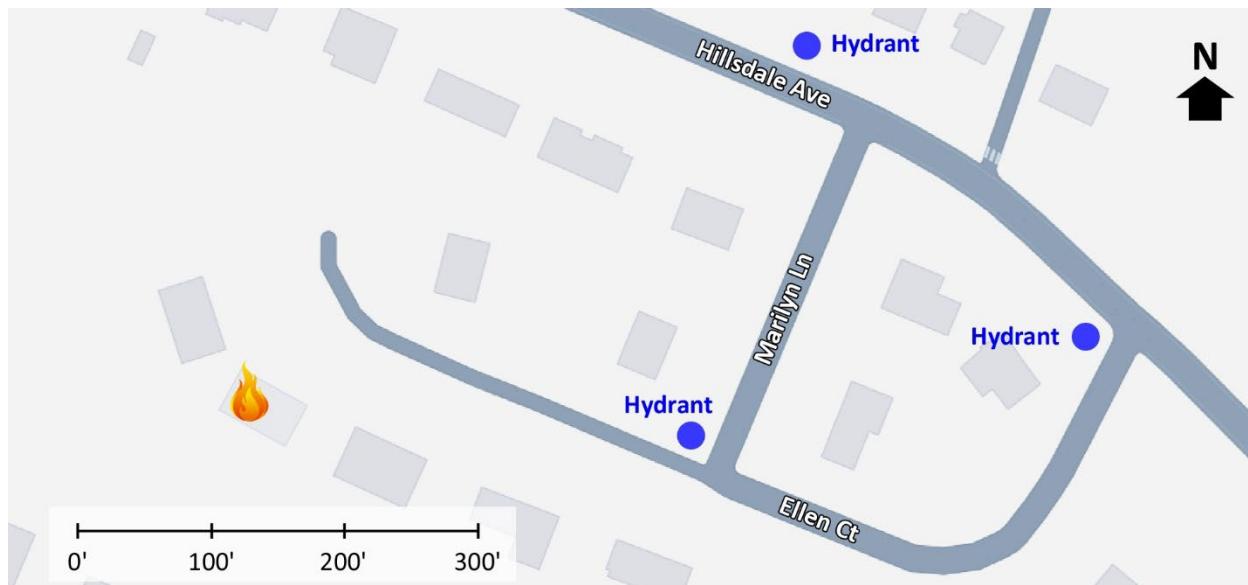
Figure 1. Map of the Incident Area

The closest hydrant is at the intersection of Ellen Court and Marilyn Lane, and additional hydrants are in the area as illustrated in Figure 1.

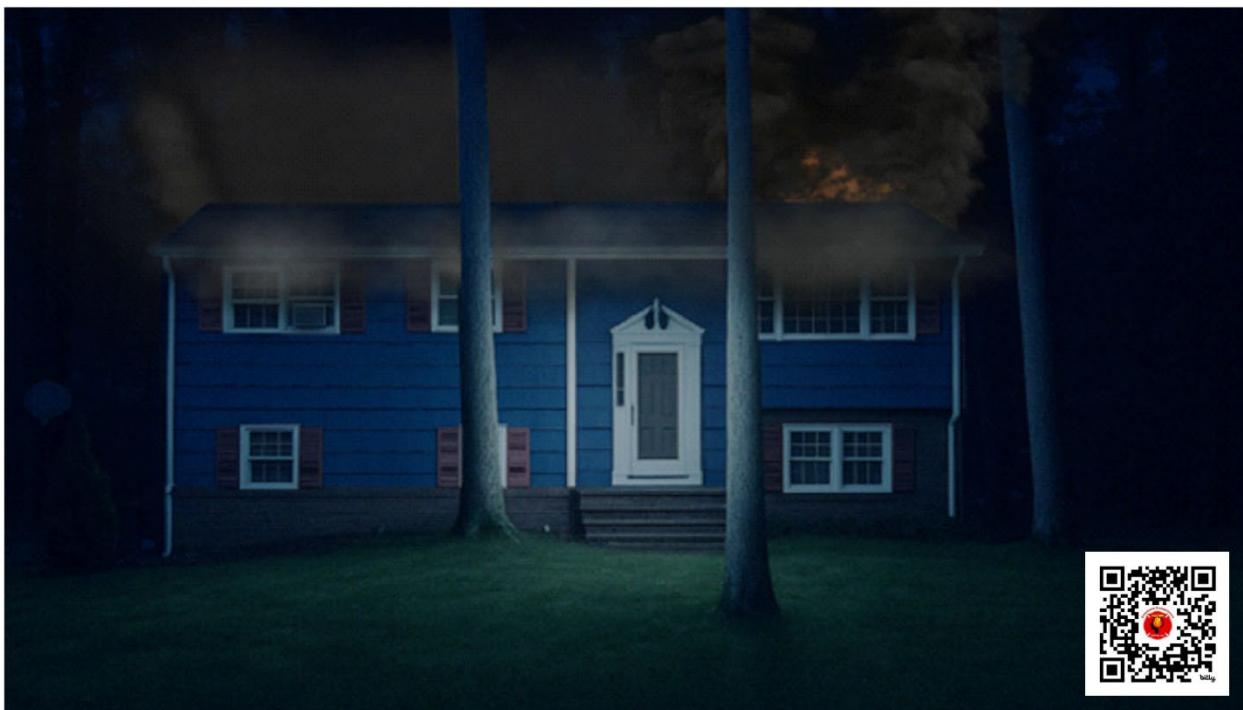
Figure 5. Conditions on Arrival

You approach this incident from the east southeast on Ellen Court. You anticipate the ladder company will arrive two minutes after you, followed by the second arriving engine and command officer. Watch the first 00:45 of the [incident simulation video](#) (Hartin, 2025) and examine Figure 5 illustrating conditions on arrival.

The occupants meet you on Side Alpha and confirm that they are all out, but that their cat is still in the house. Conditions on Sides Bravo, Charlie, and Delta are consistent with those observed from Side Alpha. A wooden deck on Side Charlie, Charlie/Delta corner is involved in fire with extension to the eaves. Flames and smoke are also showing from the gable vent on Side Delta.

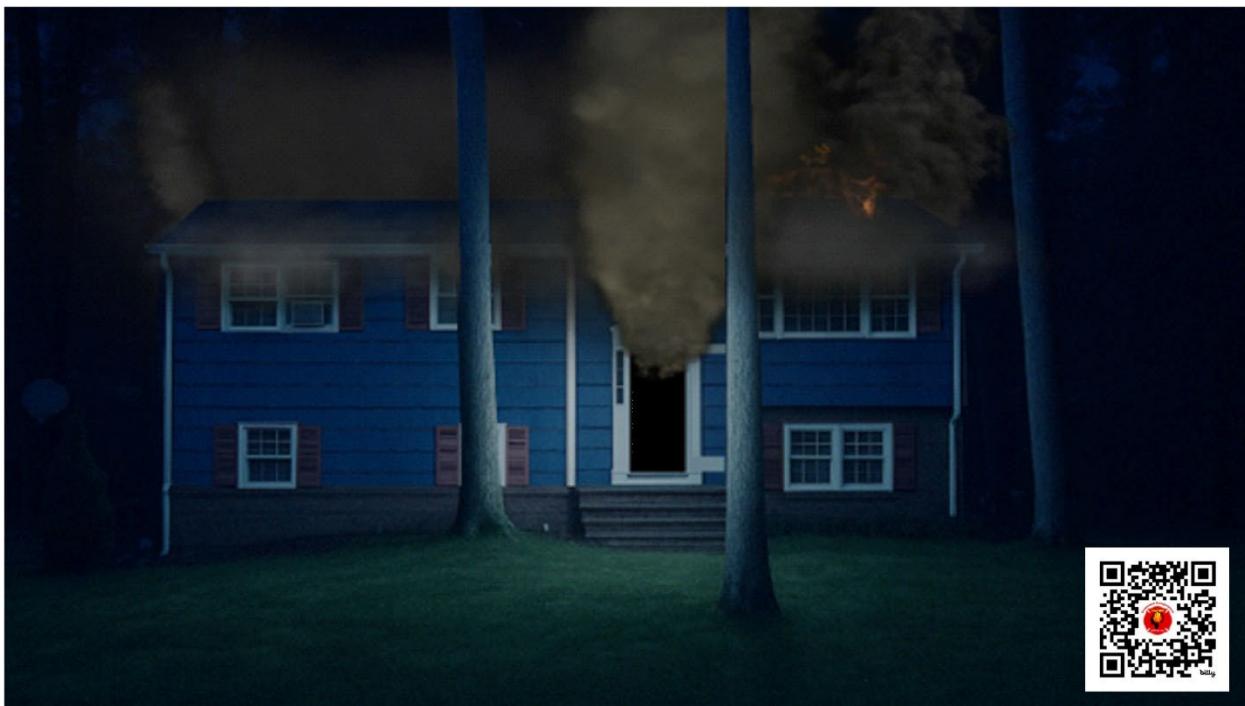
Figure 6. Changing Conditions

Watch the [incident simulation video](#) (Hartin, 2025) from 00:50 to 01:30 before answering the next several questions. Note that conditions illustrated in the simulation video may be somewhat different than encountered by the first arriving resources.

15. With an exterior fire on Side Charlie extending into Floor 2 and the attic, what are the advantages and disadvantages of stretching the initial attack line through the door on Side Alpha?
